# CATALOGUE OF CASE STUDIES

*Road safety improvements relevant to Vulnerable Road Users, Human Factors and Low- and Middle-Income Countries*

**TECHNICAL COMMITTEE C.2 DESIGN AND OPERATION OF SAFER ROAD INFRASTRUCTURE**

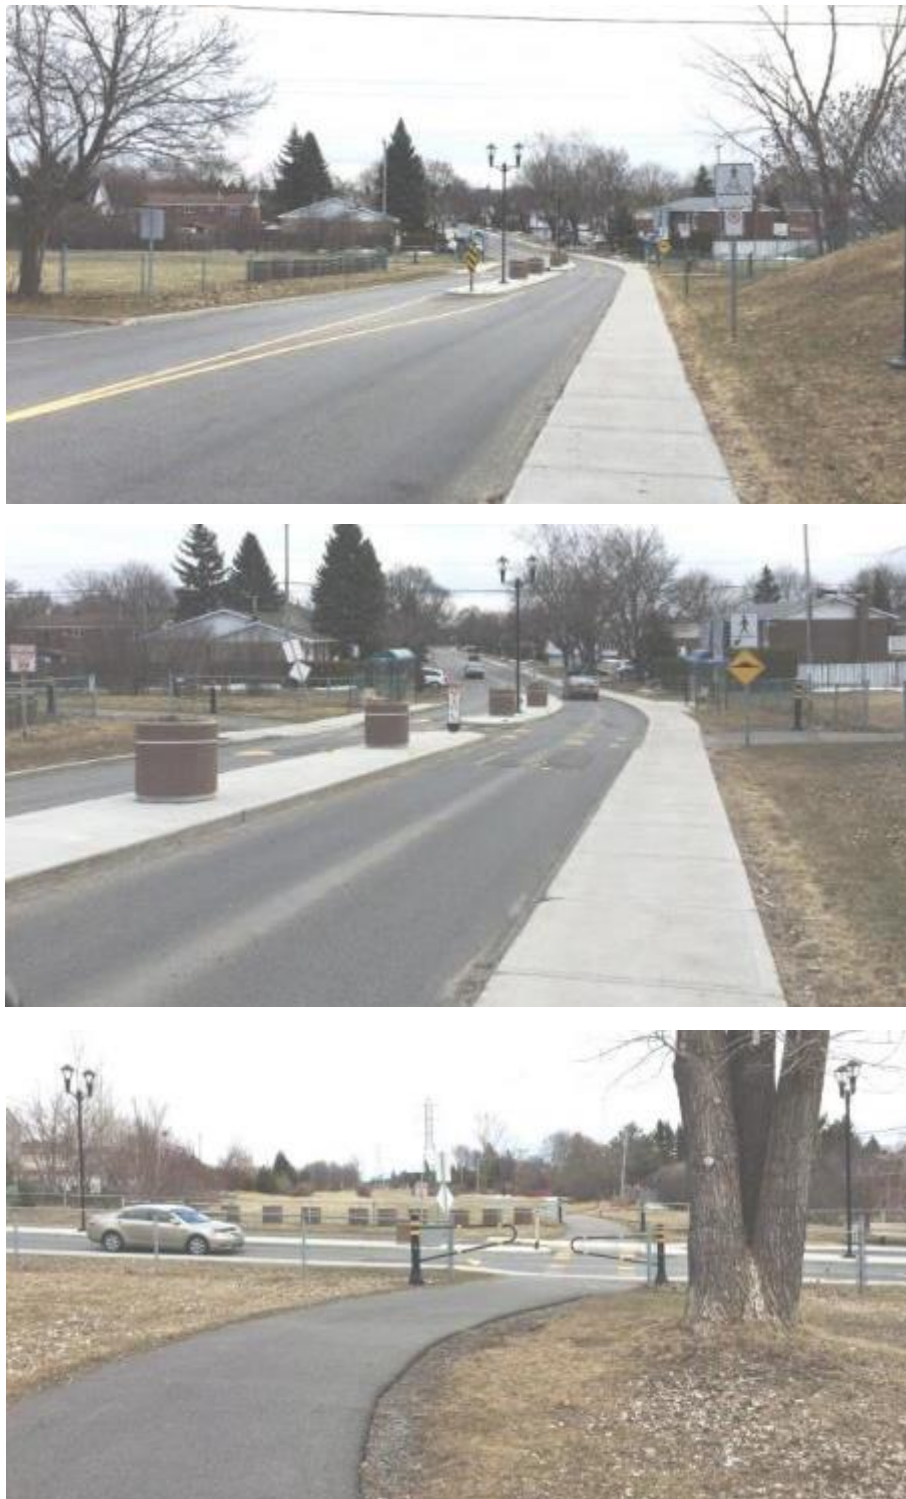
- Speed Management (SM) devices for vehicles: vertical displacement of the road alignment (humps) and road narrowing with islands;
- Speed Management device for bicycles: lateral displacement (chicane) on the bicycle path;
- Driver HF: visibility and time to react (signing and pavement marking);
- Physical characteristics of the VRUs paths: alignment and pavement surface with reduces/no irregularity.

*Figure 3.2 – Example of a mix of protecting VRUs measures when crossing path with semi-urban residential street (Montréal, Québec, Canada) (Source: Raducu Dinu)*

The following illustration gives an example where a combination of both categories is utilized to provide a safer conflict management between the vehicles and VRUs (pedestrians and bicycles) as follows:

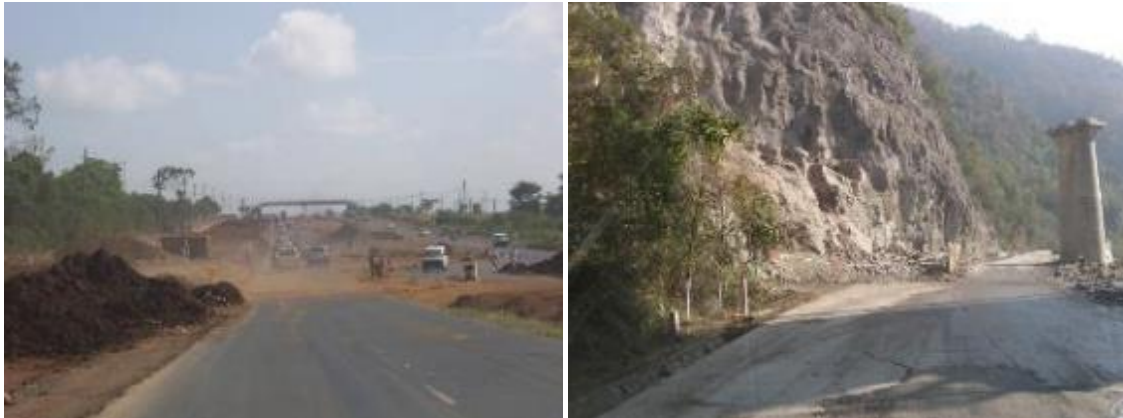
*Figure 5.1 – typical examples of inadequate work zone arrangements*

The correct application and identification of work zones has been extensively covered in guidance such as PIARC: *Improvements in safe working on roads* [6]. However, the application of these measures is rarely adopted in many LMICs, despite being aware of the international requirements.

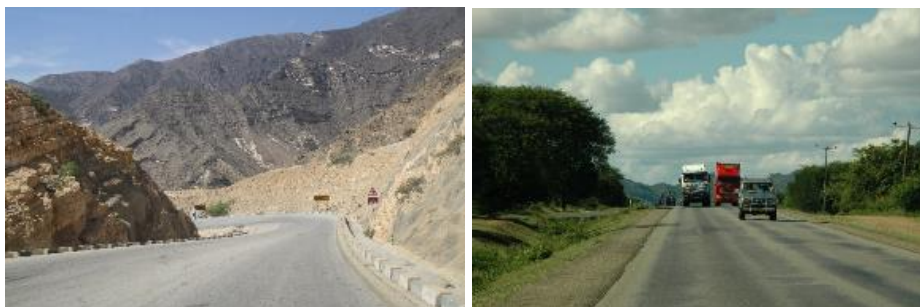
Many of these roads are narrow, with blind bends or summits (crests), and have no sidewalks / pedestrian facilities nor cycle paths. They frequently have pot holes and debris such as fallen branches and rocks, and suffer from wet and muddy conditions, meaning it takes much longer for a vehicle to stop. These factors mean that if a driver is going too fast (even if at or below the speed limit) they won't be able to react in time to people or hazards to prevent a crash. It also means that if a driver loses control, they are likely to end up in the path of an oncoming vehicle or run off the road, before they can recover.

Figure 5.2 - Typical rural corridors

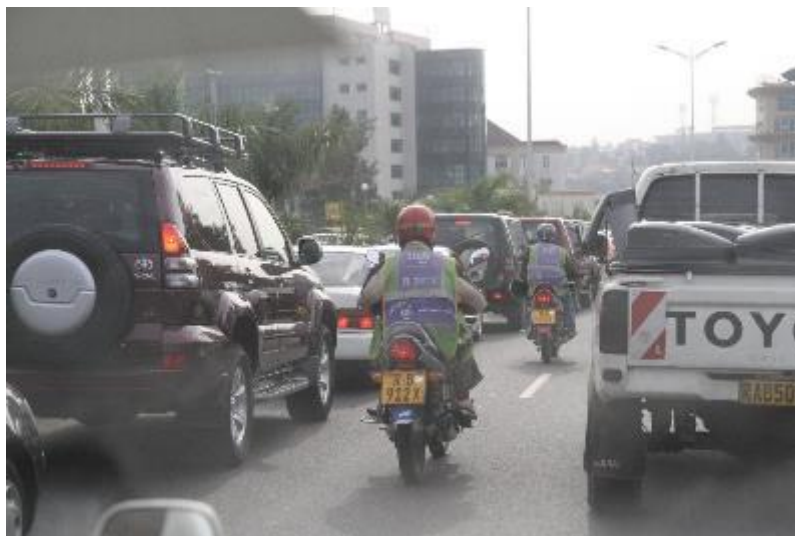
*Figure 5.3 - motorcycles in a mixed urban traffic lane.*

Within urban areas dealing with large numbers of motorcycles in a confined road space is difficult. Where measures will deter vehicles they are less effective in controlling motorcycles.

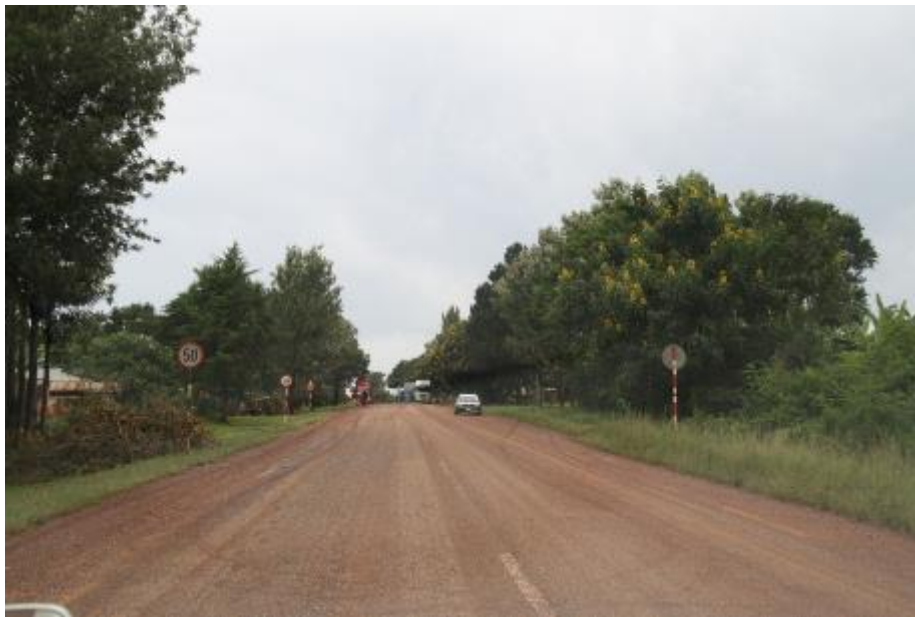
*Figure 5.4 - Linear settlement with no physical 'gateway' or change in cross section though village*

Linear settlement roads often result in unsafe conditions, with pedestrians and vehicles entering and exiting the road from abutting property frontage. Safe System principles suggest that each property entry to a roadway should be considered as a minor intersection, with the possibility of

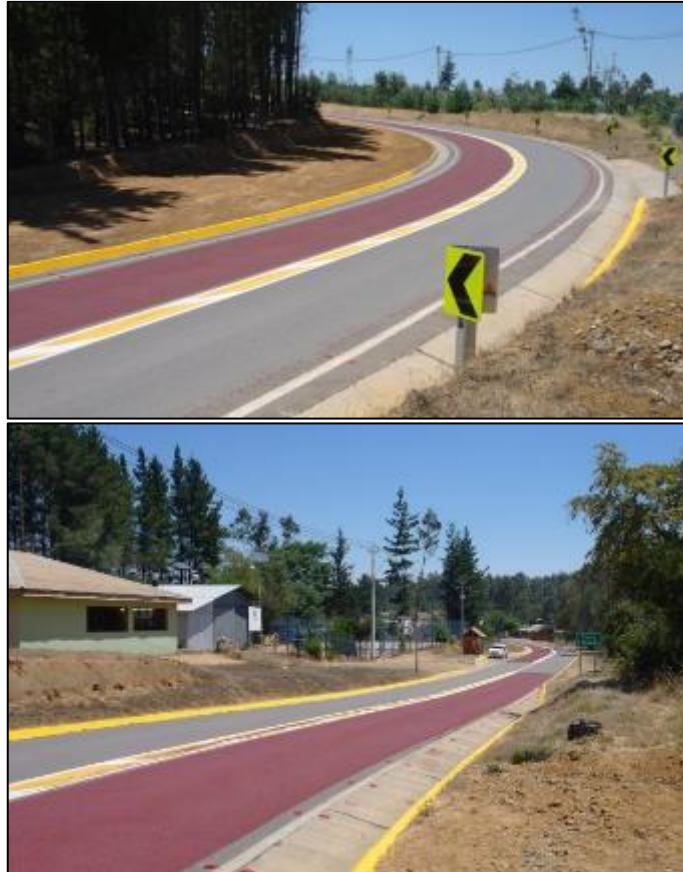
- **Lane narrowing:** consist of painted medians or central hatching with retroreflective studs, whose width depends on the design and the type of roads where it is applied. The width of the circulation space should be between 2.75 and 3.20 meters when it is planned to leave space for only one vehicle.

*Figure 6.1 - Lane narrowing on horizontal curve with high friction surface, near to (left) and on front (right) the school.*

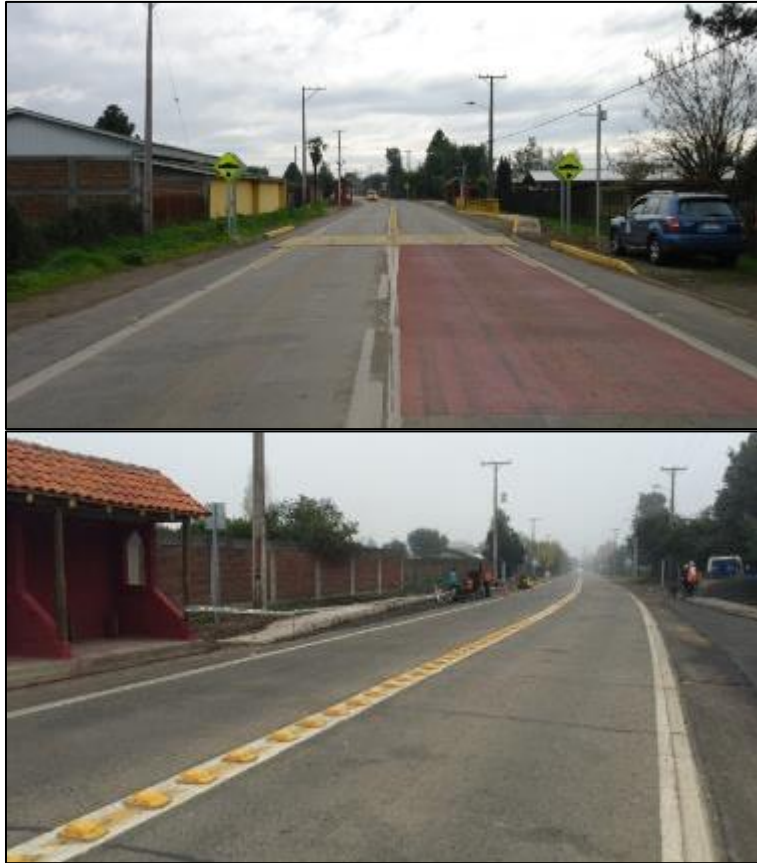
- **Speed humps:** Is the most coercive element to obtain a reduction in speed and increase the safety of pedestrian circulation paths, intersections, etc.
- **Speed cushion:** corresponds to a pyramidal, rectangular trunk-shaped speed hump disposed centrally in each circulation lane. Its height varies between 5.0 and 7.0 cm; the width of its base, between 1.5 and 1.7 m, and its length, between 2.0 and 2.5 m. The cushions can be installed individually, individual series, in pairs or series of pairs.

*Figure 6.2- Speed hump (5 cm height), near to (left) and on front (right) the school.*

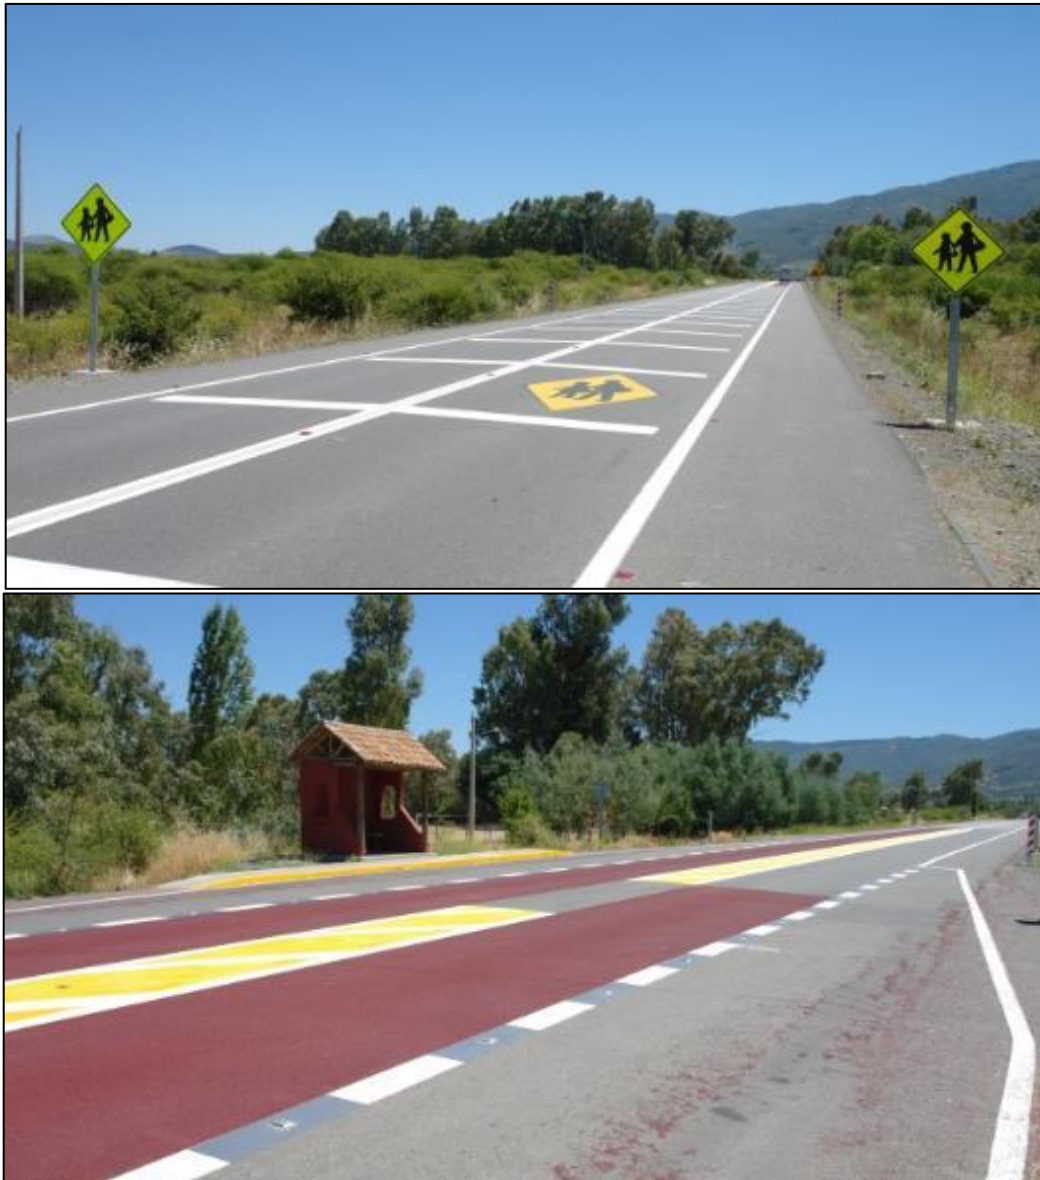
- **Transverse lines:** They are a series of lines markings demarcated transversely - either in the whole road or in each track of the road according to the direction of traffic - with the purpose of generating in the driver the perception of going at a speed greater than the real, which induces reduce it. The distribution of the lines obeys a logarithmic spacing.

*Figure 6.3 - Transverse lines on both lanes and high friction surface, near to (left) and on front (right) the school.*

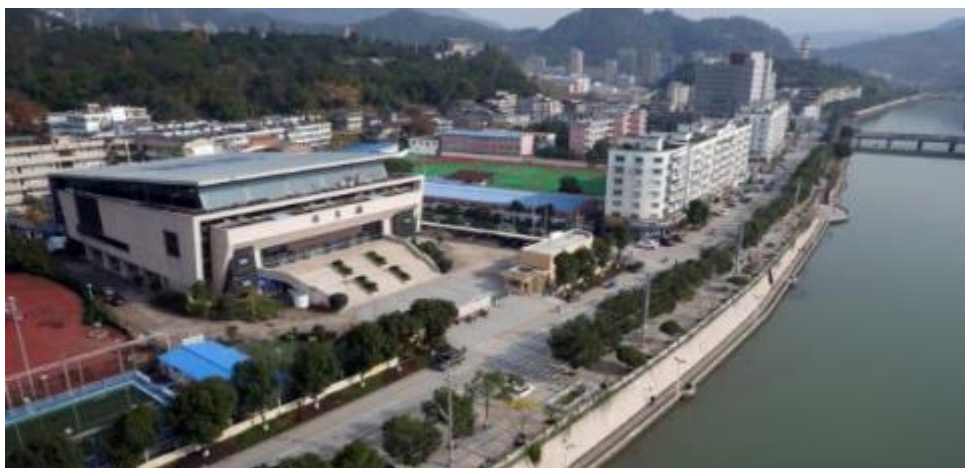
The project is located at K56+030 on the G322 line of Zhejiang Province. This section is a level-2 highway which through the village with lots of pedestrians crossing the road, as shown in Figure 6.4. There is the Wencheng Sports Center on the north side of the road and a fitness trail on the other side of the road. The existing signs and markings are less visible at night. There is a high probability of traffic accidents between motor vehicles and pedestrians.

*Figure 6.4 - The K56+030 on the G322 line before implementation*

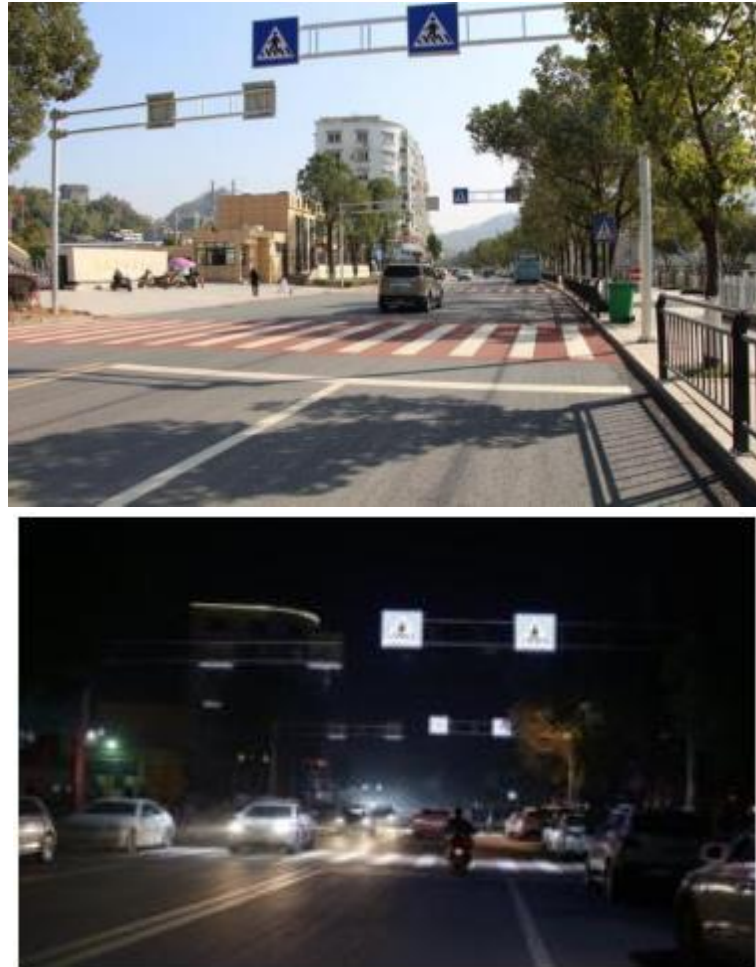
The project started in December 2016 and completed in June, 2017. The objective is to effectively improve the visibility of signs and markings at night, control the speed of vehicles, reduce conflict and protect pedestrians by adding LED lighting facilities for crosswalk, active light-emitting traffic signs and color anti-skid markings. As shown in Figure 6.5.

- Add 2 sets of LED lighting facilities for crosswalk to remind the traffic to pay attention to pedestrians. A set of lighting facility includes LED lights and 4 active light-emitting traffic signs that are installed on cantilevered structure. It provides lighting for both the crosswalk and the pedestrians crossing the road.
- Lay color anti-skid markings (570m<sup>2</sup>) for the warning and speed control of the vehicle in the village.

*Figure 6.5 - Setting 2 sets of LED lighting facilities and active light-emitting traffic signs*

It has a significant effect on traffic safety. The observation point is opposite the Wencheng Sports Center. It took one hour for the observation (16:00-17:00). In the observation after the implementation, the vehicles slow down while crossing the crosswalk. There is no significant conflict between motor vehicles and pedestrians. There were 4 serious traffic accidents occurred on this section before the implementation, caused by collisions between cars and pedestrians or electric two-wheeled vehicles. No such accidents occurred within 6 months after the implementation.

The LED active light-emitting road traffic signs are able to satisfy the long distance visibility under the unfavourable conditions such as the night, rain fog and so on by adopting a series of reflective material and technologies. The colour anti-skid marking also play a good role in warning and speed control. It can reduce the possibility of collisions between motor vehicle and pedestrian, so as to improve the safety of pedestrian crossing the road. During the implementation, we find it is an effective measure to protect pedestrian by setting up proper pedestrian barriers, as shown in Fig 3. It can effectively prevent motor vehicle from occupying sidewalk, reduce collision with pedestrians if vehicle out of control, it also helps regulate pedestrian crossing behaviour and protect pedestrian safety.

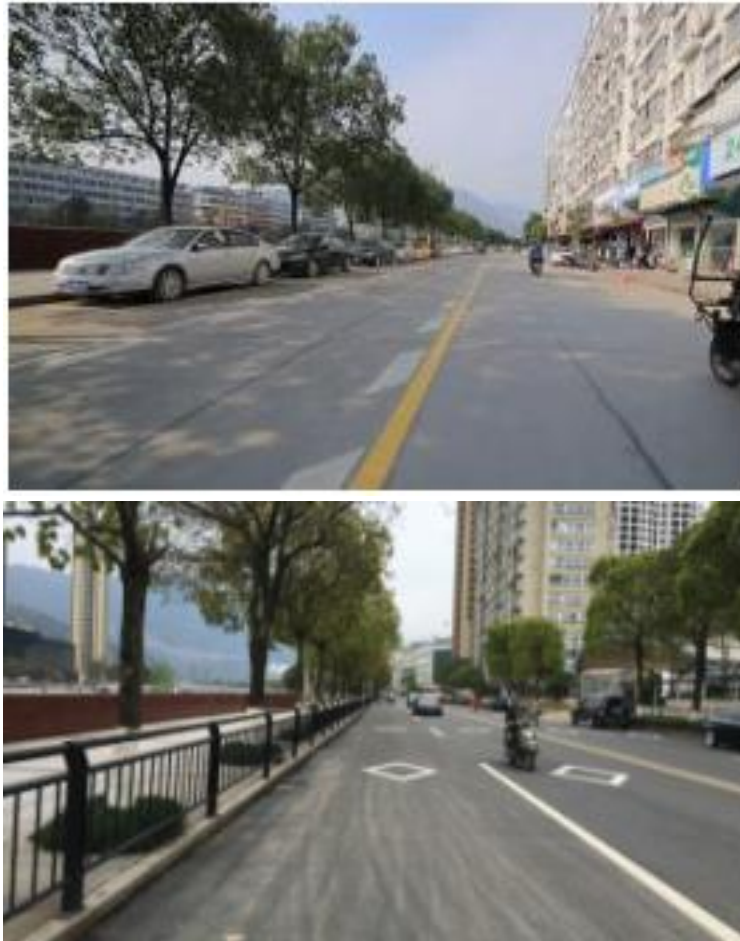
*Figure 6.6 - Setting up the pedestrian barrier*

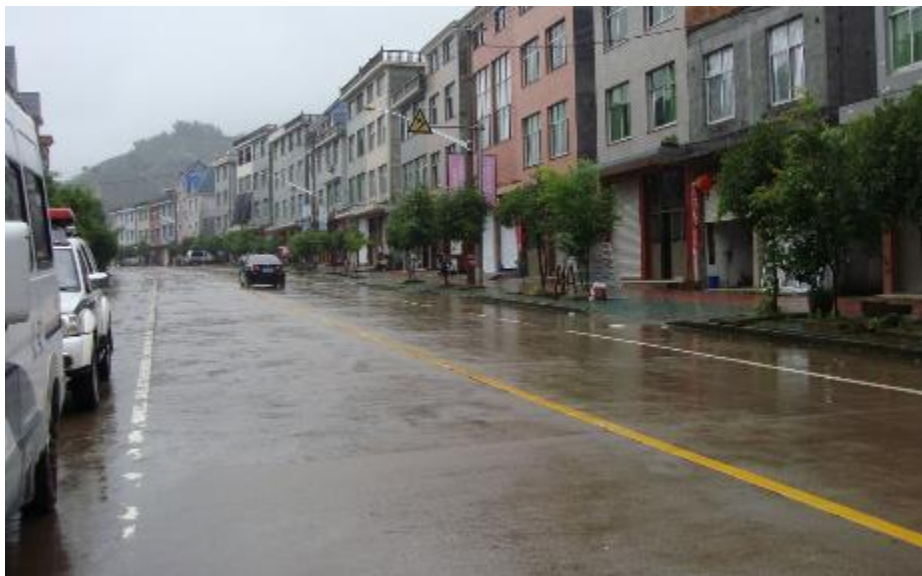
It is a two-lane road with a speed limit 50km/h, located at the rear of a long straight slope to the village of Yongan. Vehicles enter the village with a high speed which is very dangerous to pedestrians crossing the street, as shown in Figure 6.7. There were two accidents between vehicles and pedestrians crossing the street during 2015 to 2016. In those accidents, the vehicles didn't avoid pedestrians because there were no traffic signs; while, the pedestrians didn't use crosswalks or other facilities when they crossed the street.

*Figure 6.7 - The view of the road before the implementation*

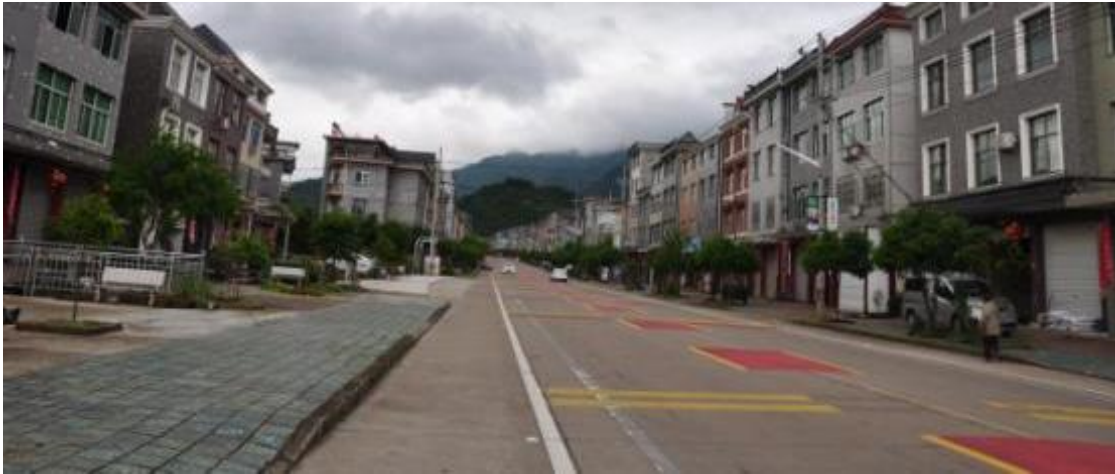
- Lay the discontinuous colored antiskid pavement (in red) along the longitudinal center line of the road and deceleration vibration markings (in yellow) along cross section of the road, as show in Figure 6.8.

*Figure 6.8 - Lay the coloured antiskid pavement and deceleration vibration markings*

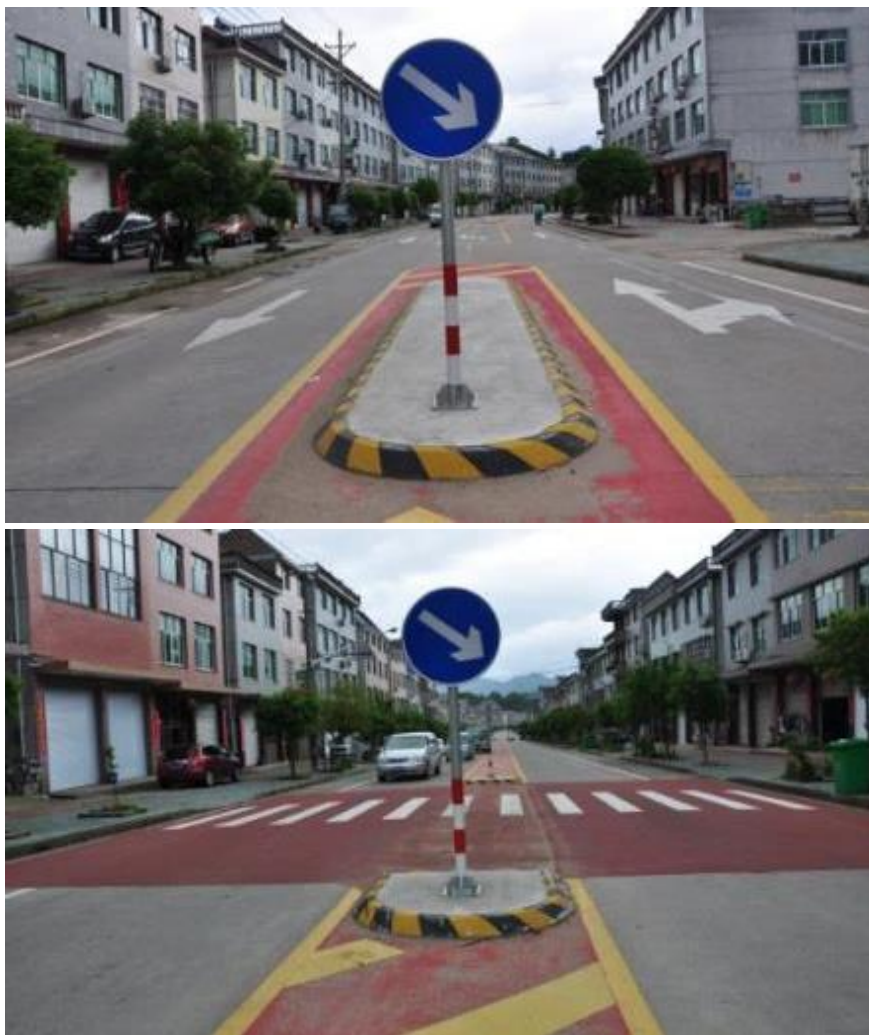
- Most of the residents are resettled persons who migrated from the mountainous areas into the villages and towns, and most of them are the elderly people. Therefore, a pedestrian refuge island is set up on this road section to provide a safe waiting area for passing pedestrians, as shown in Figure 6.9.

*Figure 6.9 - Set up a pedestrian refuge island*

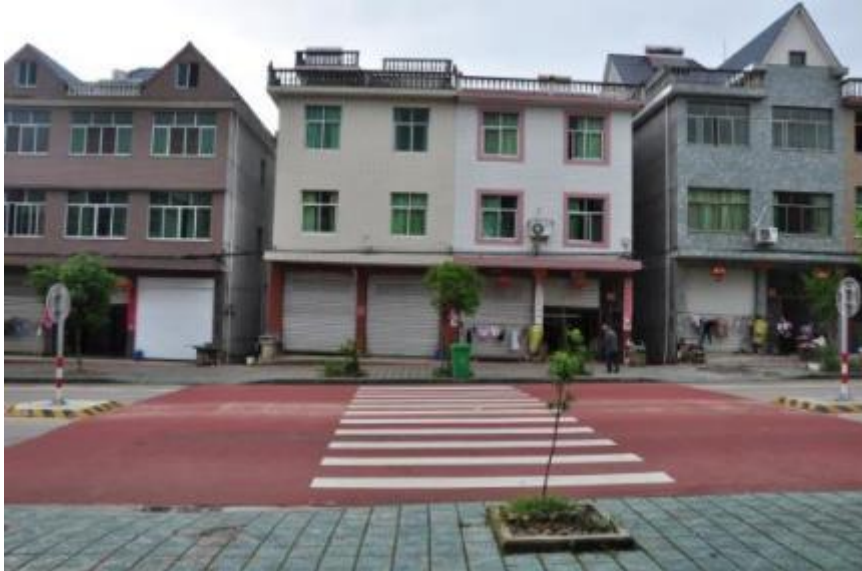
- Combine the sidewalk markings with the colour pavement antiskid paint to increase pedestrian safety when crossing the street, as shown in Figure 6.10. Some of the signs are interrupted by trees, as shown in Figure 6.11. Trim the trees to facilitate drivers to recognize the content of the signs.

*Figure 6.10 - The sidewalk area*

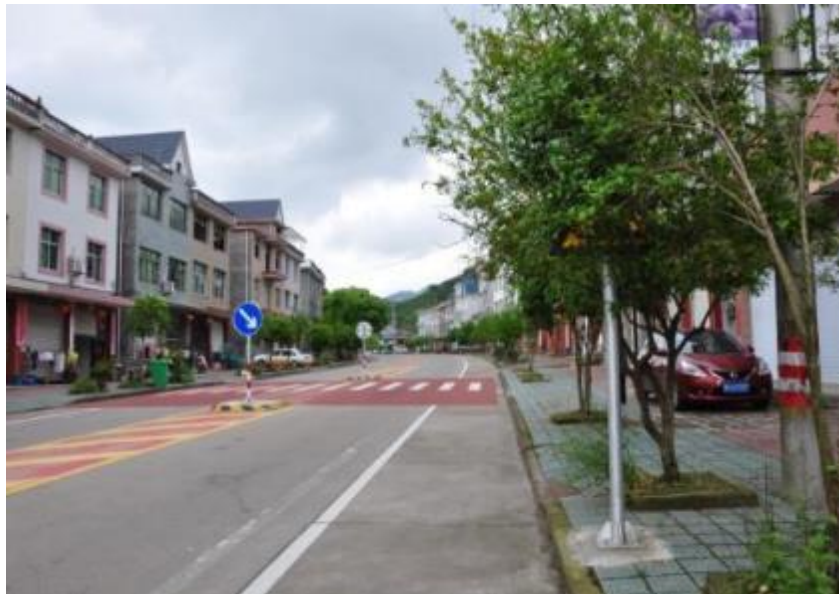
*Figure 6.11 - The hidden sign*

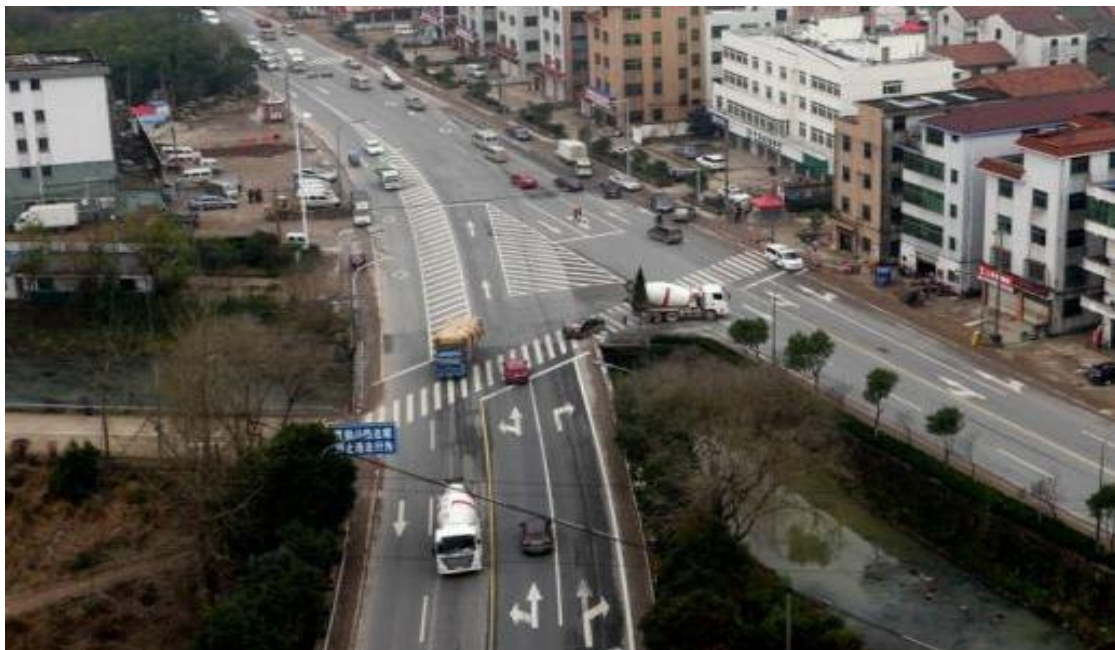
The implementation section is located at the intersection of S210 and S103 Hangjin lines in Zhejiang Province. Two four-lane roads cross in a small angle of 14 degree, and the range of this intersection is too wild, meanwhile, the distance of the stop line is too long. The total pavement width of the original pedestrian crossing is 37m. The elderly and children cannot cross the intersection within the green time and there is no pedestrian waiting zone for them. There is a conflict between crosswalk and lane markings for turning vehicles. Both roads have large traffic, according to traffic statistics in 2015, the average daily traffic volume of the main road is 19,295, the equivalent number is 22,605. The average daily traffic volume of the crossed road is 21,686, the equivalent number is 25,406. The degree of urbanization in the surrounding areas is high, non-motorized vehicles are densely crowded, and there are many branch roads in the two provincial roads, and the roadside interference is relatively large. Lane organization and signal setting are not reasonable. As shown in Figure 6.12.

*Figure 6.12 - The intersection of S210 and S103 Hangjin line before implementation*

The range of this intersection is too wild. The traffic lights were unreasonable. The crosswalk was too long for the elderly and children to cross the intersection within the green time. There is a conflict between crosswalk and lane markings for turning vehicles. There was a safety hazard in setting the crosswalk at the left turn lane of S210 and the right turn lane of S103. It is necessary to satisfy the safety of pedestrians and improve the traffic efficiency.

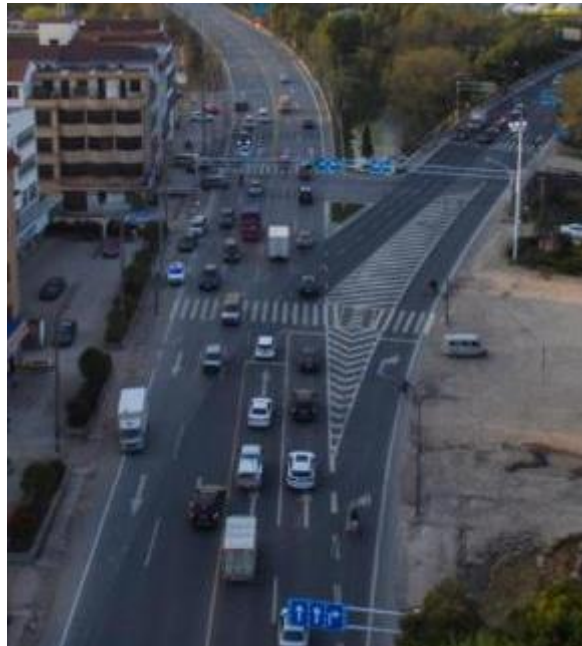
- Reduce the range of intersection and shorten the distance of the stop line from 200m to 88m, as shown in Figure 6.13.

*Figure 6.13 - Shorten the distance of the stop line*

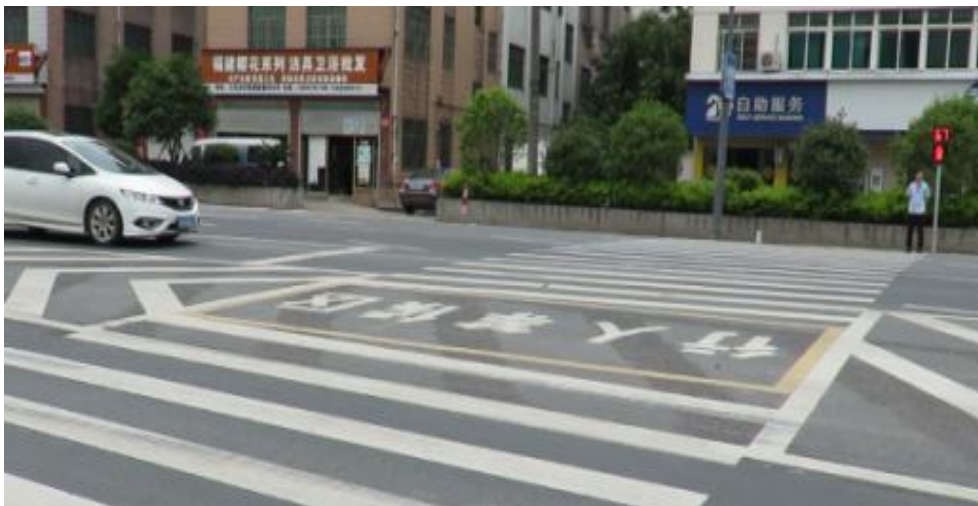
- Optimize the location of the crosswalk, balance the needs of pedestrian and tuning vehicles and add a pedestrian waiting area, as shown in Figure 6.14.

*Figure 6.14 - Add a pedestrian waiting area*

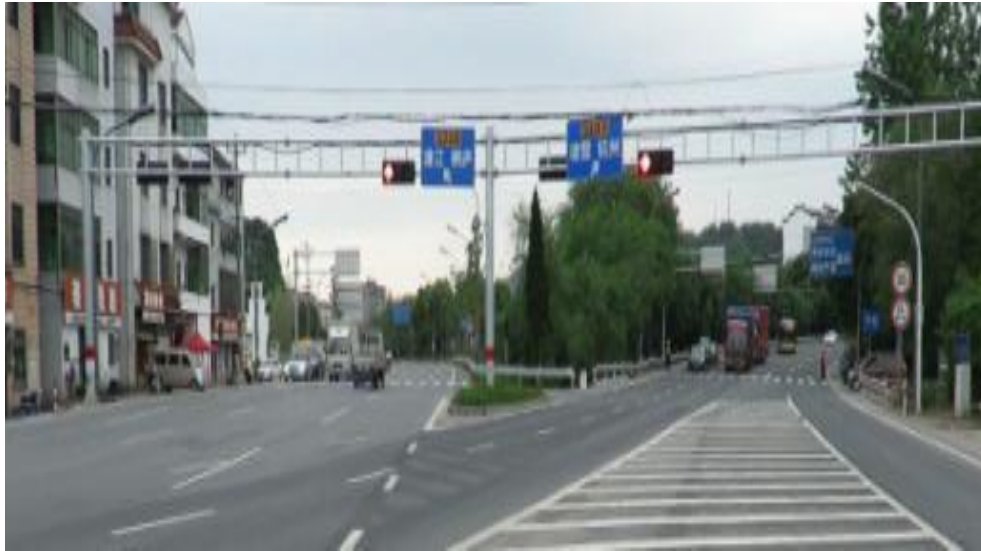
- Set up a physical transportation channelization island with a size of  $54\text{m}^2$ , set up traffic lights of door structure, add sidewalk lights, adjust the traffic light phase, and optimize the electronic police system settings, as shown in Figure 6.15.

*Figure 6.15 - Perfect the traffic lights*

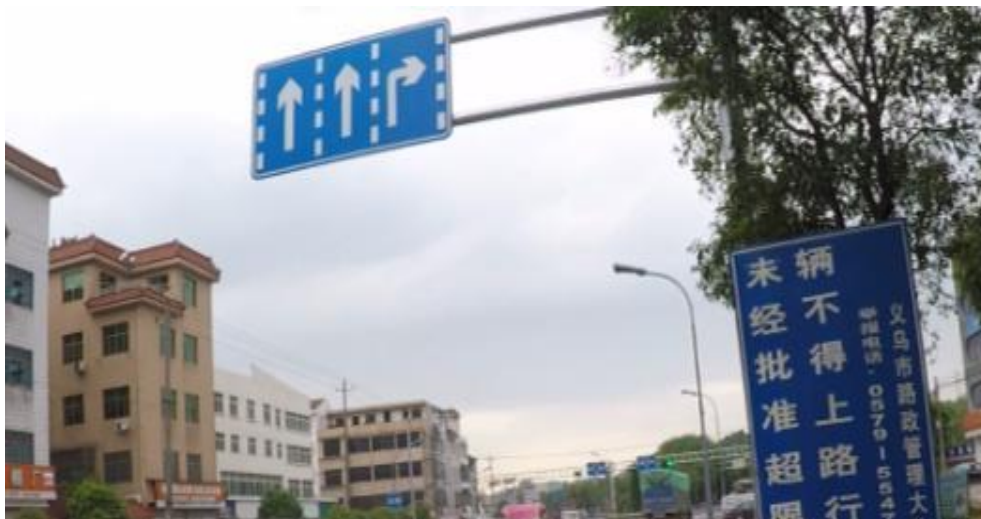
- Reorganize lanes according to traffic flow and signal settings, update markings and signs and add safety facilities such as lane separation signs and pedestrian direction signs, as shown in Figure 6.16.

*Figure 6.16 - Setting lane separation signs*

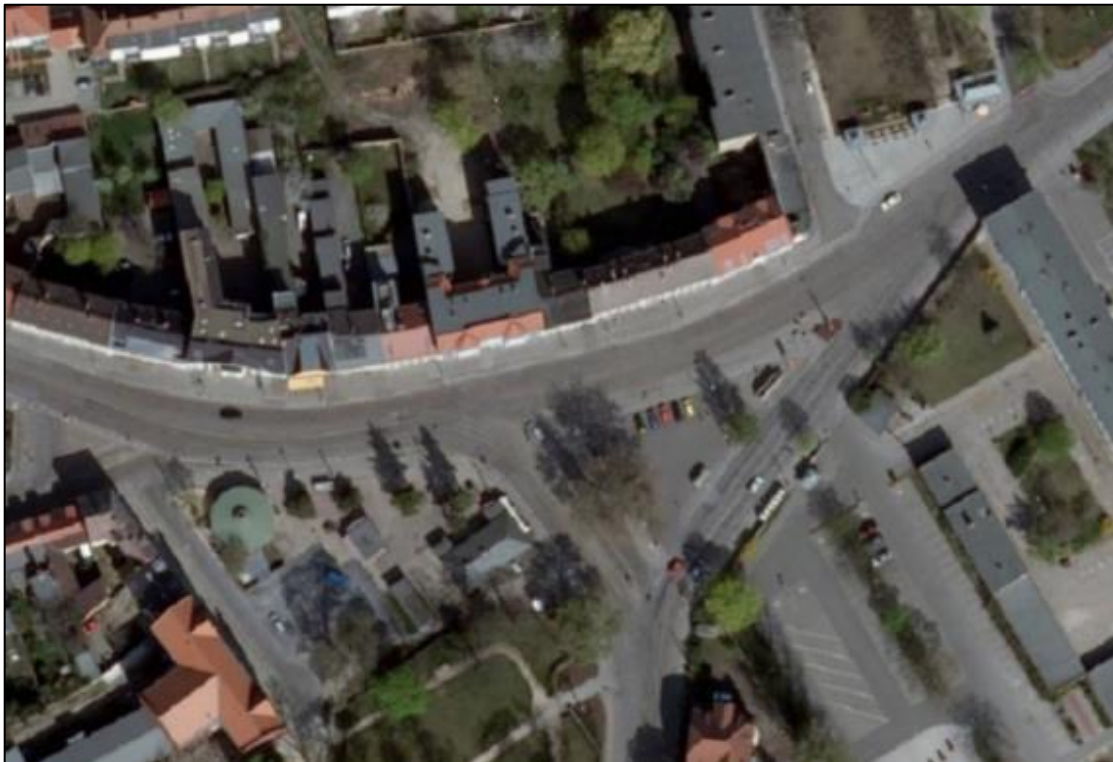
*Figure 6.17 - Nicolaiplatz before remodeling (Source: Stadt Brandenburg, ARGE NP Consult)*

Before the redesign, the function and geometry of Nicolaiplatz was significantly influenced by the traffic facilities before the remodeling (see picture 1). The Bus- and Tram stops were spread over the entire square and the whole traffic infrastructure was disordered and unclear for both, motor vehicle traffic and local public transport. Furthermore, all facilities were outdated and not in a good condition.

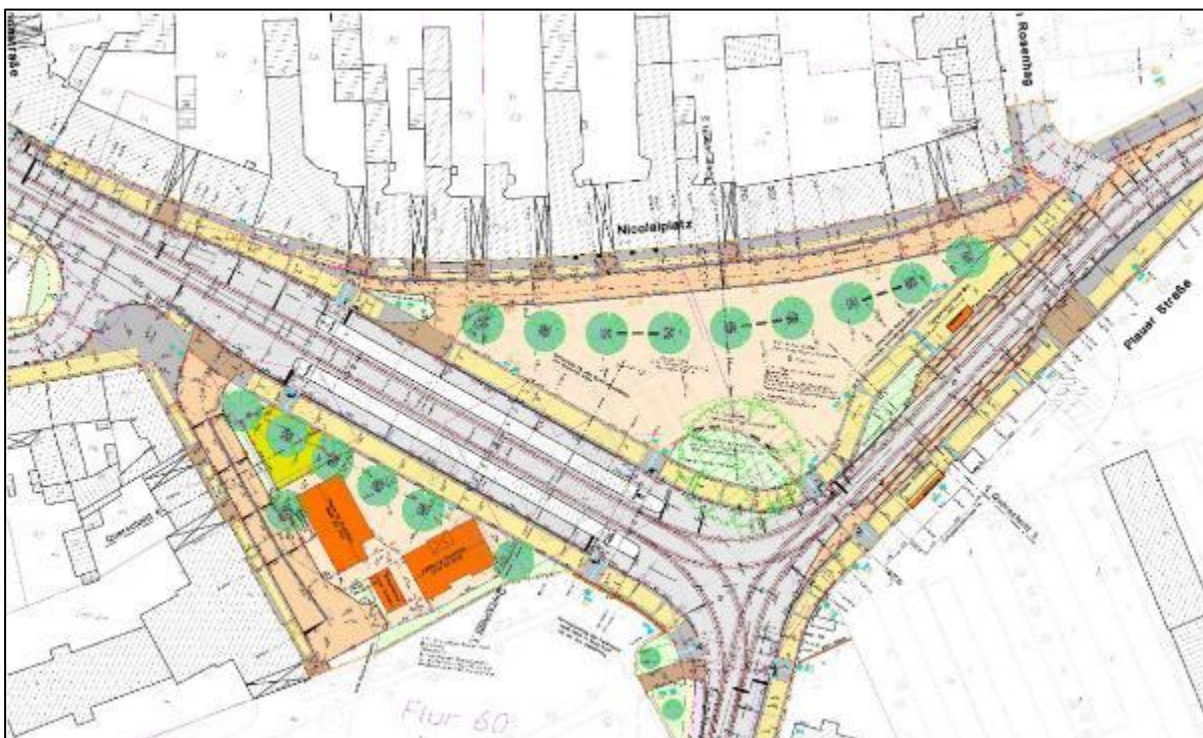
The redesigned Nicolaiplatz (see picture 2) was taken into service in December 2013.

Figure 6.18 - Nicolaiplatz after remodeling (Source: Stadt Brandenburg, ARGE NP Consult)

The usability of Nicolaiplatz was improved significantly by the redesign. Now it has the character of a real square. It can be recognized as a “Gate” into the historic center of Brandenburg.

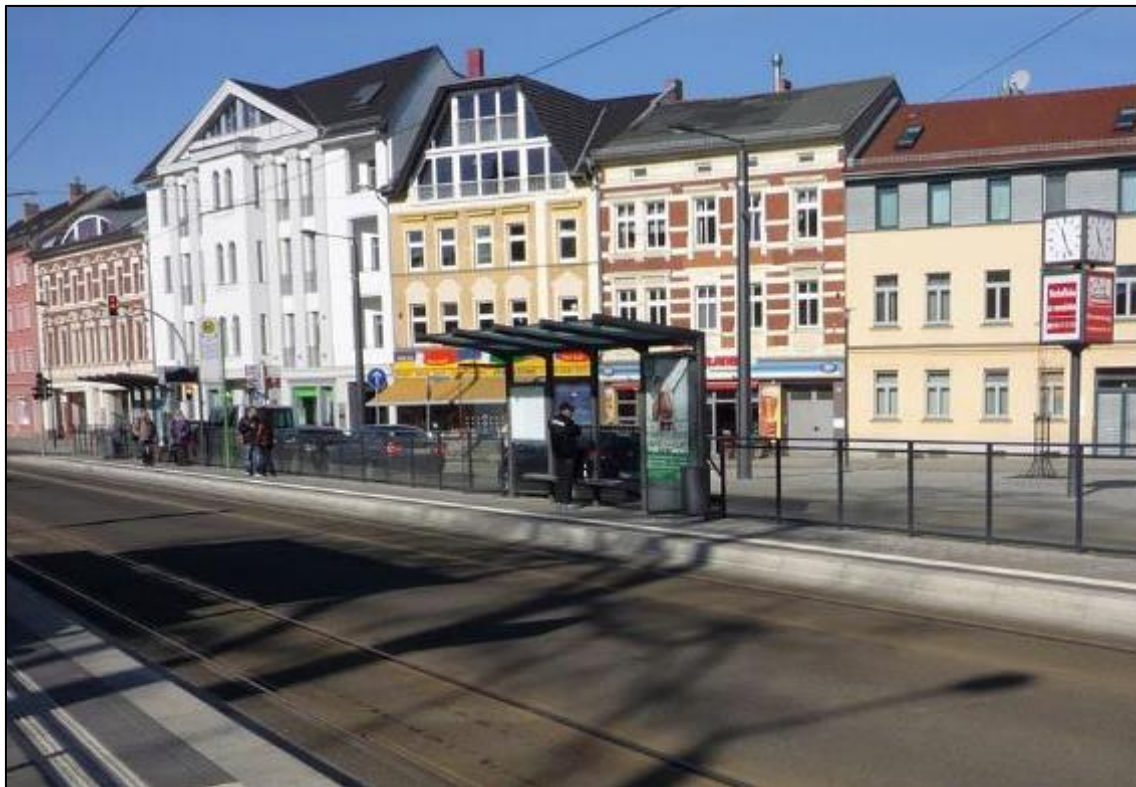
Figure 6.20 - New combined tram/bus stop in the western arm of the junction (Source: [www.teamteibrant.de](http://www.teamteibrant.de))

A key accomplishment of this remodeling was the improvement of the public transport facilities. Before the redesign the tram stations and bus stops were all around the old Nicolaiplatz, so it was very complicated for passengers to change from one vehicle to another. Furthermore, there was only one signalized pedestrian crossing, which made changing even more uncomfortable and dangerous. After the remodeling, there is a combined tram and bus stop in the western arm of the junction, where passengers can change without any problems (see picture 4)

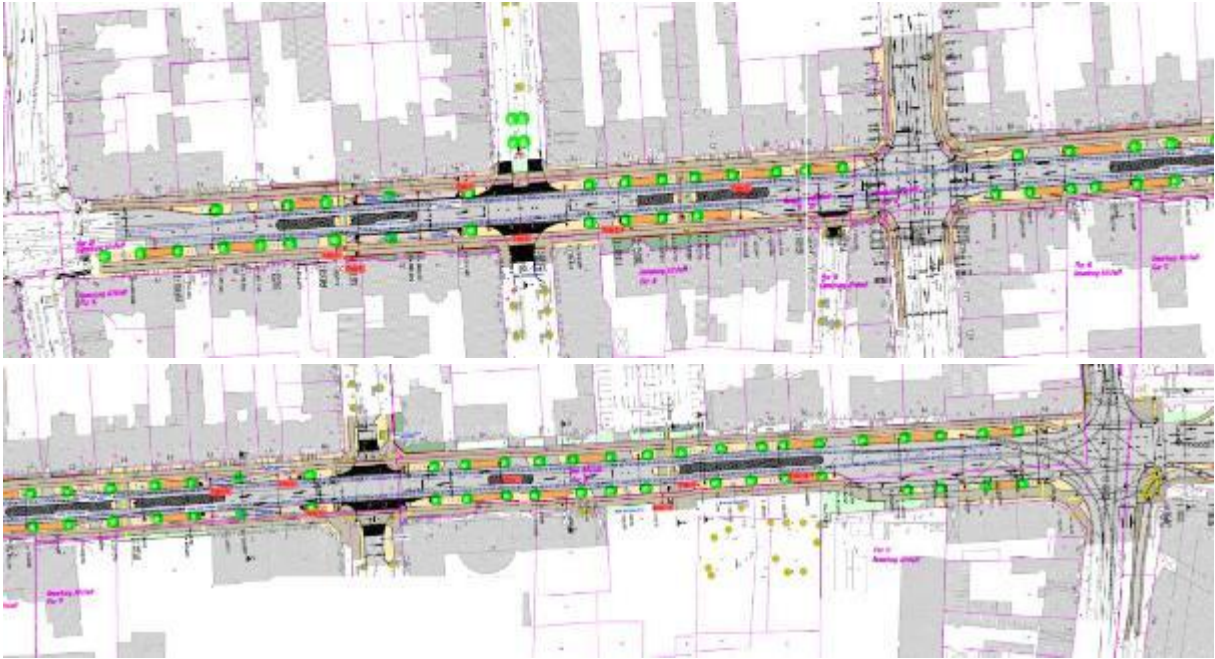
Figure 6.22 - Site plan after the redesign, source: Stadt Cottbus

The design concept is based on a continuous three-lane road cross section (see Figure 6.22). An important feature is a 3.25m wide central strip, which takes over several functions on the course of the street. In addition, the cross section provides for a common lane in each direction of travel for motor vehicles and trams. The maximum speed limit is 30 km/h.

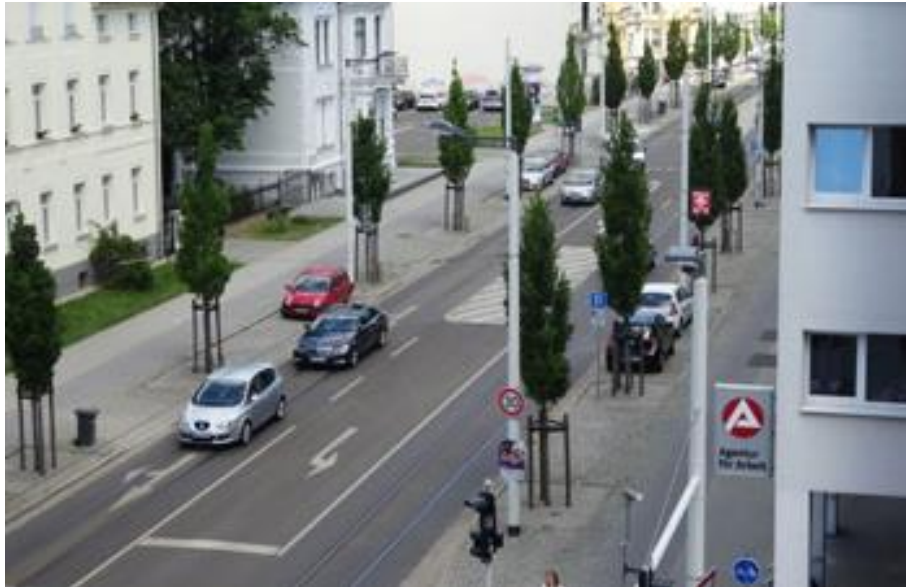
Figure 6.23 - Three-lane road cross section after the reorganisation, source: Stadt Cottbus

The three-lane road cross section allows flexible use of the 3.25m wide medial strip throughout:

- This is paved throughout the route sections in natural stone format (large pavement) and bordered with flat boards. It is used here to structure the cross-section in terms of design and as a linear element to improve the traversability of the roadway.
- At places with special crossing needs, it includes barrier-free “middle-islands” equipped with guidance systems for visually impaired people.
- At intersections and junctions, it changes its function into left-hand turn strips for motor vehicle traffic, so that all relevant driving relationships can be guaranteed (see Figure 6.23).
- It offers the possibility of being used as an escape route when vehicles are stationary or in emergency situations.

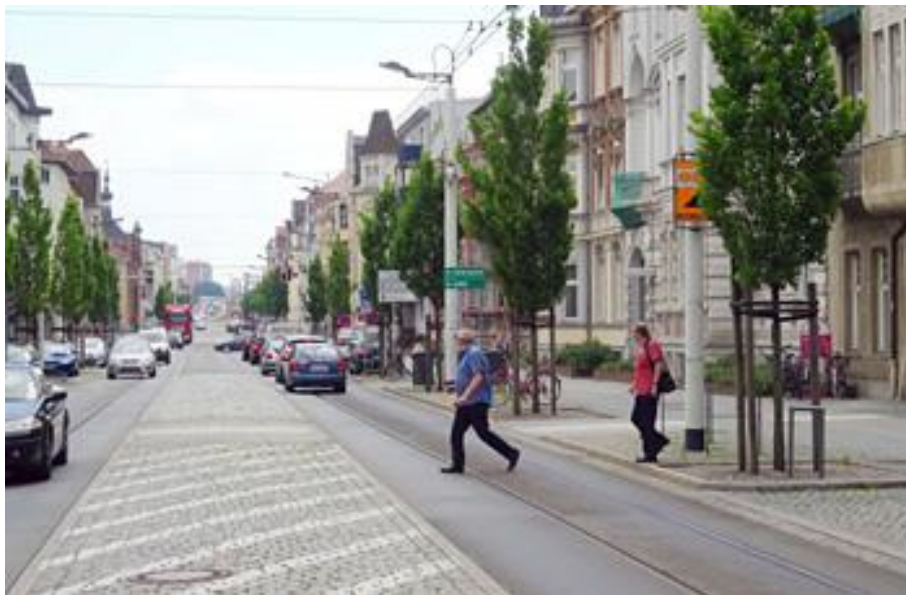
Figure 6.24 - The medial strip as a crossing aid for pedestrians, source: Stadt Cottbus

The width of 3.25m offers pedestrians and cyclists a high degree of safety and comfort when crossing the road (see Figure 6.24). Even prams, bicycles with trailers and freight bicycles can be accommodated comfortably on such a width without compromising safety.

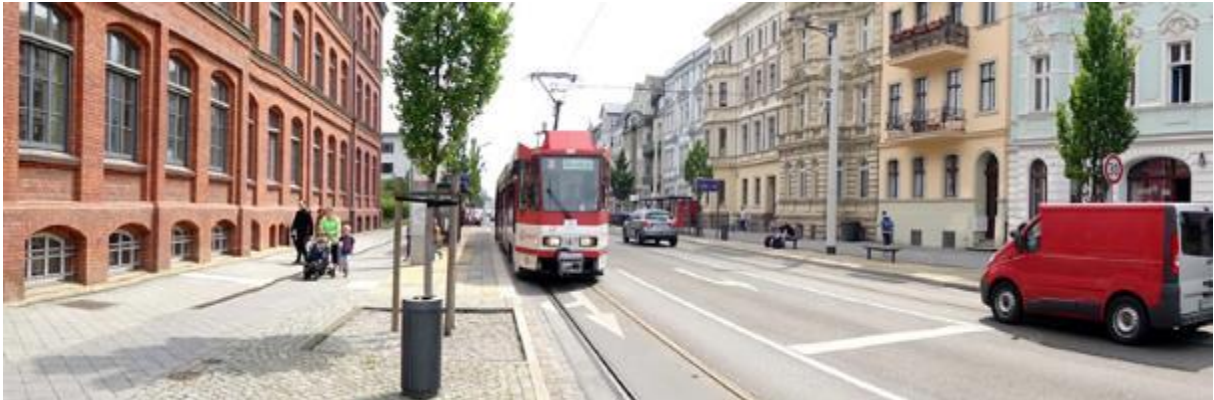
*Figure 6.25 - Clear structuring and identification of areas for the individual modes of transport, source: Stadt Cottbus*

The side space shows a clear separation between the individual functions. A 2.5m wide multifunctional strip connects to the roadway. It houses more than 50 longitudinal parking stands, which have significantly improved car access in the redesigned section of the street. Next to that the multifunctional strip also serves for delivery, accommodates the alley-like tree planting and the masts for street lightning, serves in the area of the public transport stops for undisturbed waiting, getting in and out and also offers space for bicycle parking facilities, benches, signage, parking ticket machines and other necessary installations. The areas for the various modes of transport are clearly structured in terms of road cross-sections (see Figure 6.25)

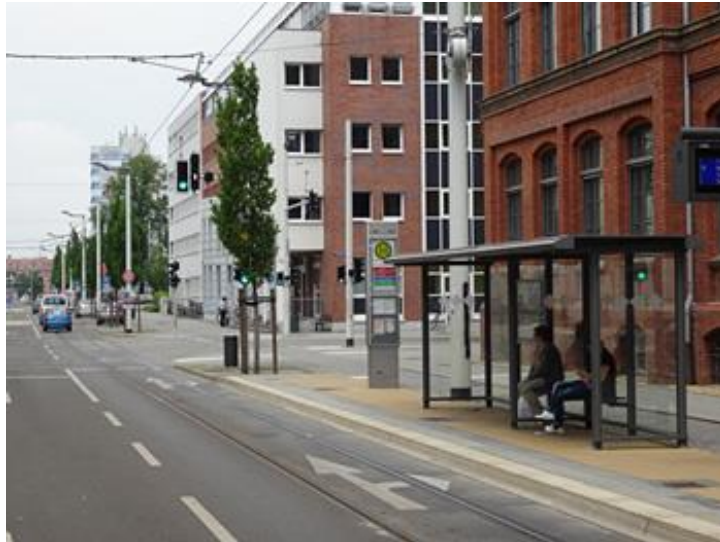
Figure 6.27 - Combined tram-bus station, source: Stadt Cottbus

The stops for buses and trams are combined for both means of transport. The total length of 38m is based in the special Cottbus tram vehicles (see Figure 6.27 and Figure 6.28). The stops are equipped with spacious bus shelters for weather protection, seats and dynamic passenger information displays. The transparency of the waiting shelters supports social security for waiting passengers at night. The position of the street lightning also contributes to this.
