# CATALOGUE OF CASE STUDIES

*Road safety improvements relevant to Vulnerable Road Users, Human Factors and Low- and Middle-Income Countries*

**TECHNICAL COMMITTEE C.2 DESIGN AND OPERATION OF SAFER ROAD INFRASTRUCTURE**

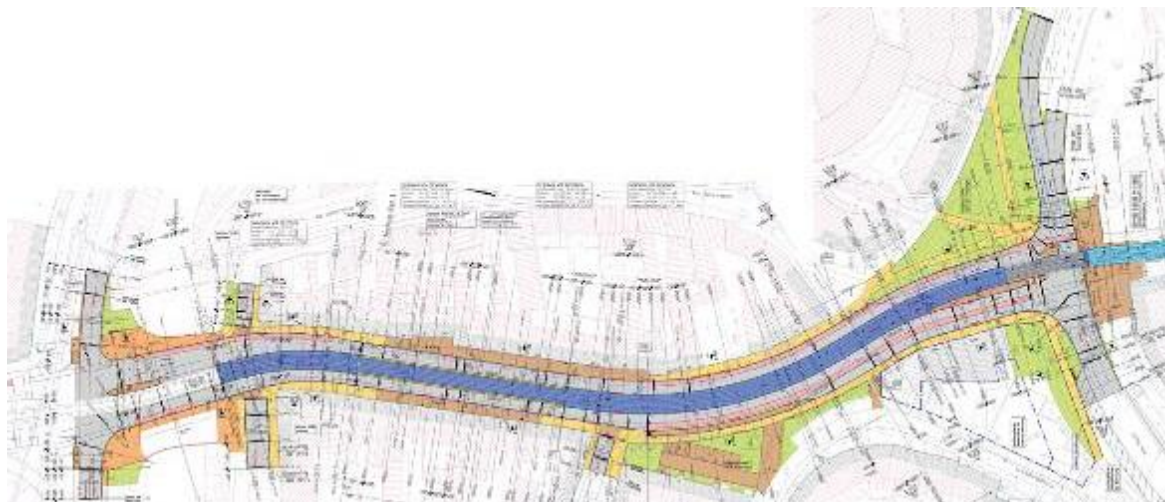
Figure 6.30 - Plan of the redesigned Johannesstraße, source: Stadt Erfurt, Amt für Stadtentwicklung und Stadtplanung, Abteilung Verkehrsplanung

Figure 6.30 shows a plan of the redesigned Johannesstraße. The Figure 6.31 and Figure 6.32 show the different profiles of the Johannesstraße in the area of the tram station before and after the redesign.

The redesigned tram station “Boyneburgufer” is located in the middle of the street and has a length of about 60 m. 75 cm wide “step out” boards support the barrier free access to the low floor tram cars. The front position of the tram cars can be located by people with visual impairments by guide strips.

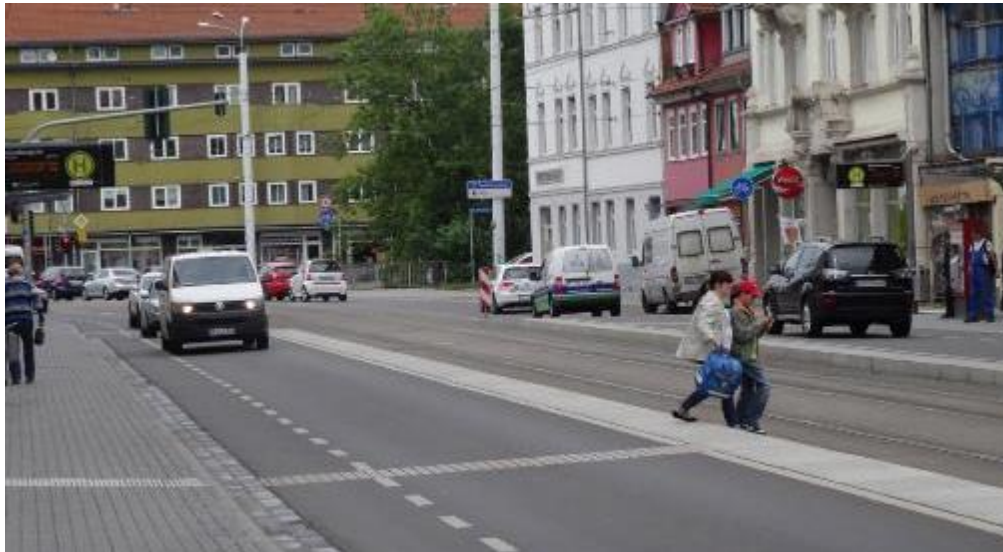
Figure 6.34 - Pedestrians are crossing the tramway, source: Walter Braun, Verkehrskonzept, Aachen

Apparently, it is not possible, to preclude wrong behaviour of the users only by a good road design, especially if otherwise a detour is necessary.

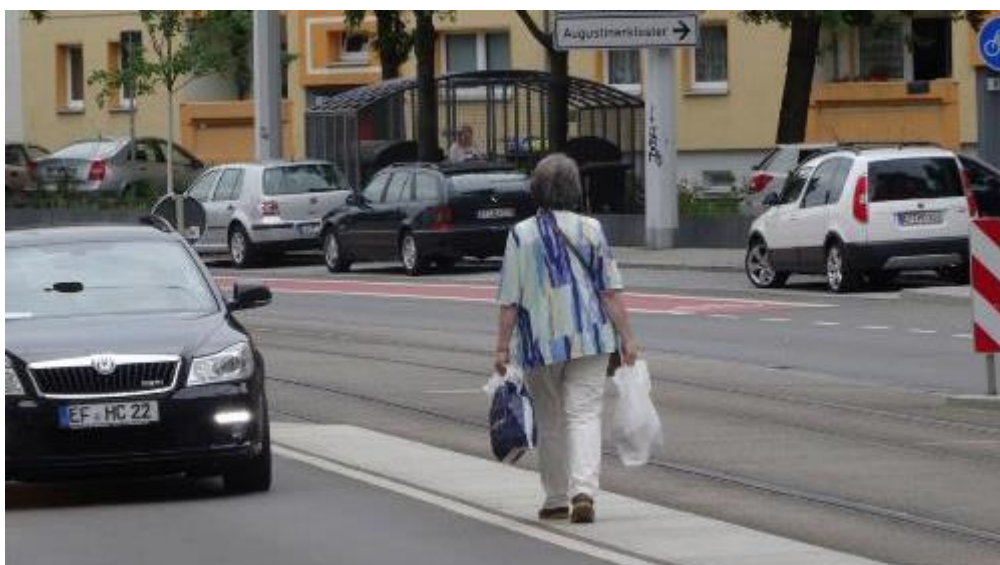
Figure 6.35 - A pedestrian is using the "step out" area as a footpath, source: Walter Braun, Verkehrskonzept, Aachen

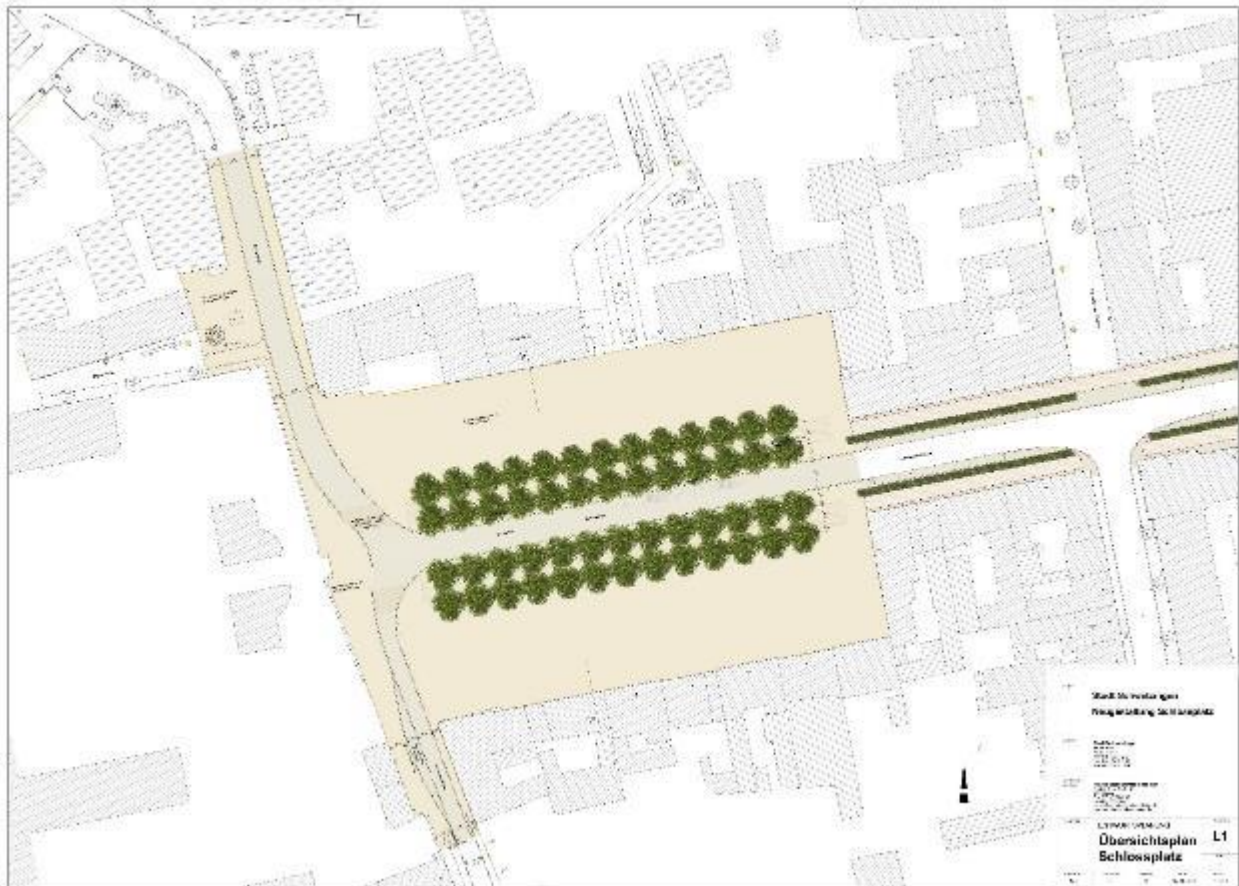
Figure 6.39 - Final design planning, source: Stadt Schwetzingen

The final design planning (see Figure 6.39 and Figure 6.40) includes the following measures and elements:

- Integration of lanes for vehicular traffic, including a bus stop
- A slight displacement of the traffic lanes in front of the castle
- Deconstruction of the light signal system
- Use of high quality materials (natural stone slabs) for pedestrian areas
- Distinction between pedestrian areas and vehicular traffic by using bollards made from granite
- Ordering a “traffic calming area” (StVO-Sign No. 325)
- Planting a two row tree avenue, consisting of 52 trees in total

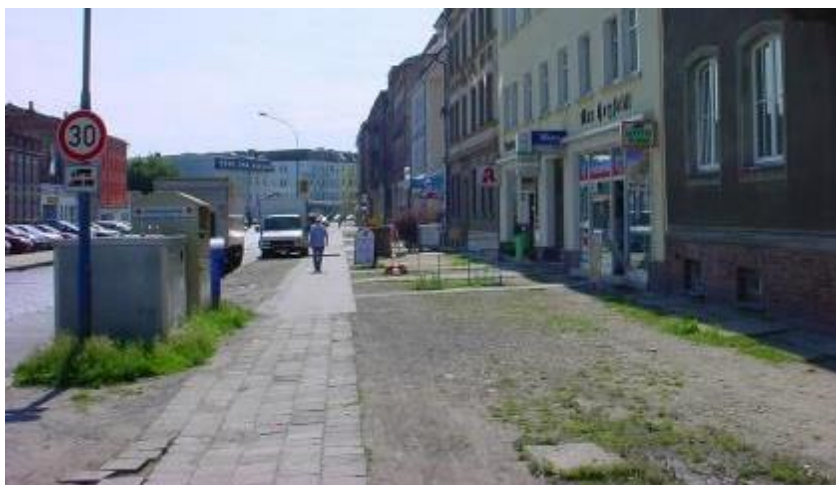
Before the redevelopment, the quality of the “Frankendamm” was inadequate. The unstructured road space was characterised by a wide carriageway, poor crossing possibilities and unattractively designed ancillary facilities. In addition, poor surface quality led to unevenness and water accumulation on the road and pavements. Shops in the area of commercial use had increased significantly (see Figure 6.41 and Figure 6.42).

Figure 6.41 - Unattractive side space before the reorganisation, source: Hansestadt Stralsund

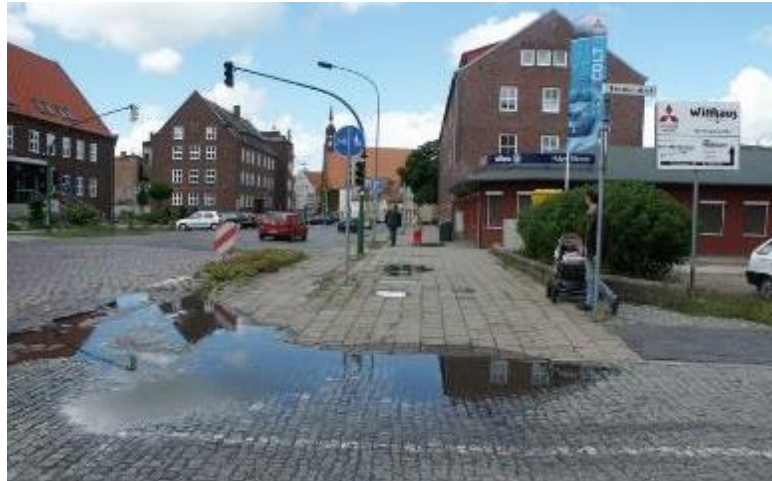
Figure 6.42 - Water accumulation before the reorganisation, source: Hansestadt Stralsund

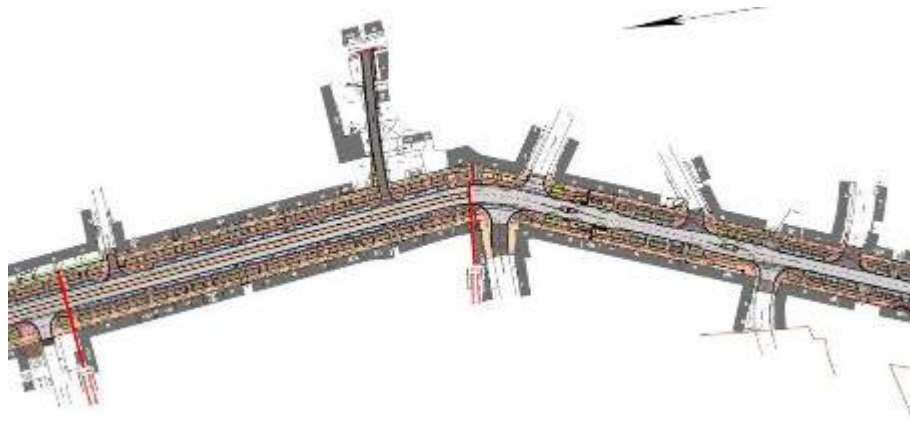
Figure 6.44 - Layout plan of the redesign section 2; source: Hansestadt Stralsund

1. two-strip track cross-section with continuous parking strips, cycle path on the building side next to the footpath, avenue-shaped tree plantations integrated into the parking strip (see Figure 6.43)
2. Two-strip track cross-section with continuous central reservation, cycle path between longitudinal parking strips and rows of trees, a wider footpath on the building side with multifunctionally used common areas between the tree beds, front gardens in one section (see Figure 6.44)

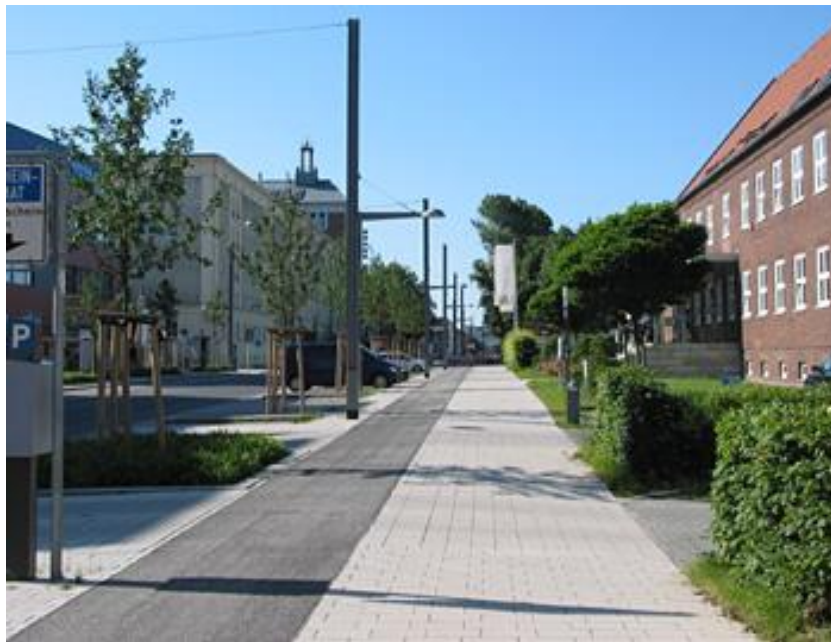
- cycle traffic routing: cycle traffic is guided continuously along cycle paths in the side space (see Figure 6.46) offers a high level of driving comfort. The cross section of the cycle path changes position in the area of junctions, either towards the guide close to the road ahead of a junction or away from the road and towards the guide close to the pavement behind a junction. Crossing the junctions close to the road increases the visibility and thus the road safety of cyclists in front of vehicles turning off.

*Figure 6.46 - Cycle path after the reorganisation, source: Hansestadt Stralsund*

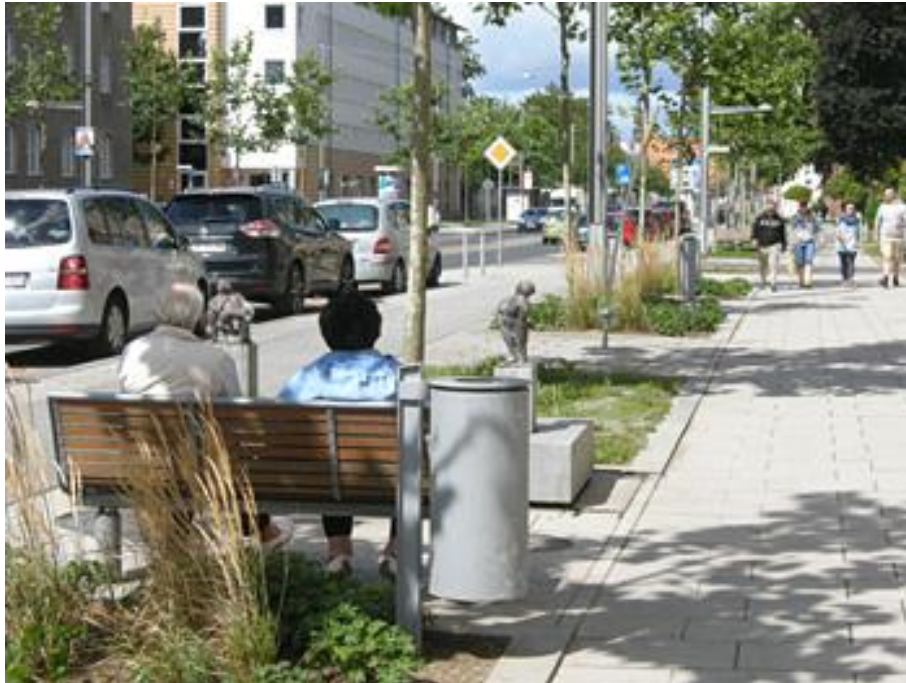
- design in the central supply area: to increase the quality of the lounge and make the side space more attractive, benches, wastebaskets, bicycle racks, art objects and play stations are housed at regular intervals on multifunctional areas between the tree beds (see Figure 6.47).

*Figure 6.47 - Design in the central supply area after the reorganisation, source: Hansesund Stralsund*

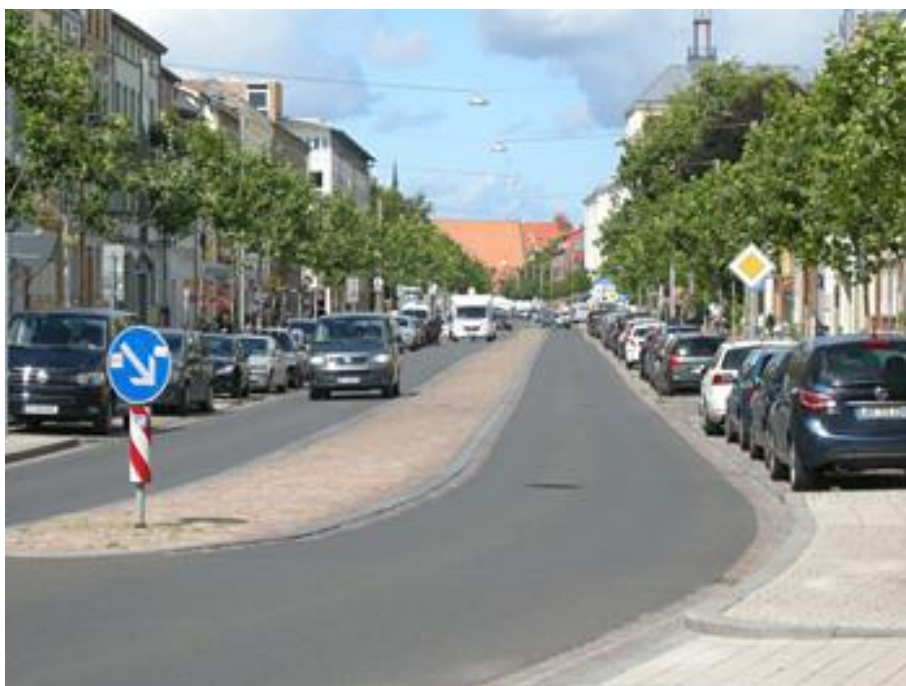
- medial strip and center island: in the central supply area a three-lane road cross section was deliberately chosen, which in its central position as a paved central reservation facilitates the crossing of the roadway, makes it possible to turn left in access roads to the property and downstream junctions without obstructing the following traffic (see Figure 6.48). In the other sections at bus stops, junctions and other relevant points with crossing requirements, such as at the sports field, central islands are to increase the safety of pedestrians at certain points.

*Figure 6.48 - Medial strip after the reorganisation, source: Hansesund Stralsund*

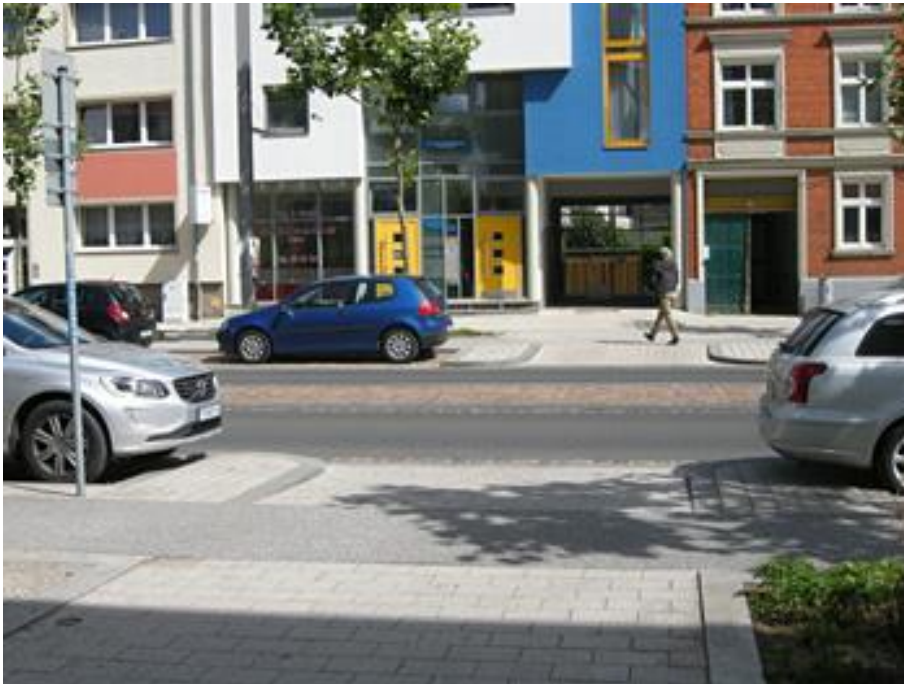
- Junction areas and property access roads: a clear design was chosen for the benefit of pedestrians and cyclists in property access roads and subordinated road junctions (see Figure 6.49).

*Figure 6.49 - Junction areas after the reorganisation, source: Hansestadt Stralsund*

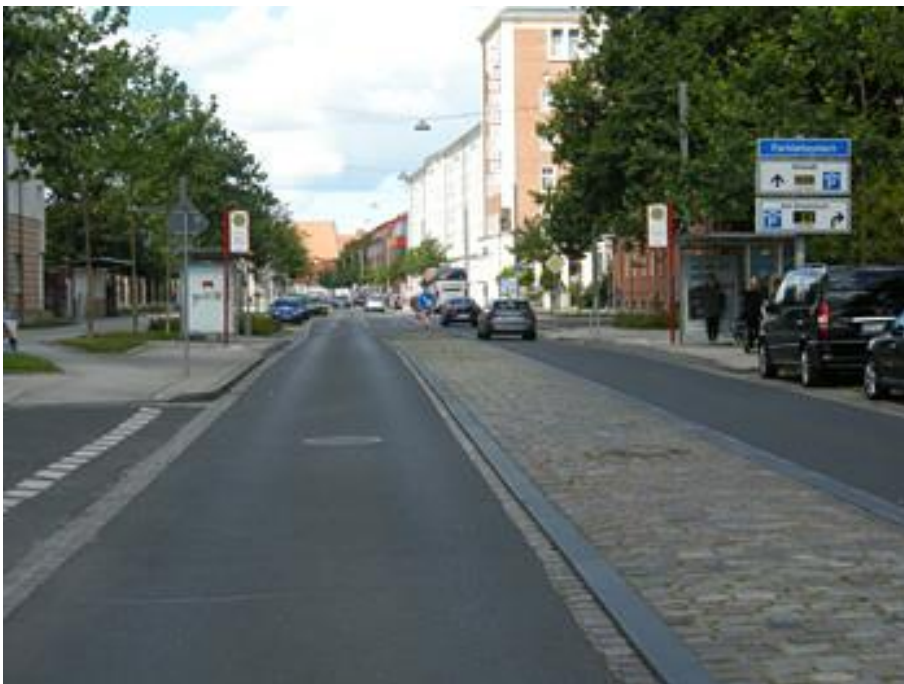
- Bus stops: All bus stops are barrier-free and equipped with weather protection. Usually the stops are in the form of a bus stop cap, at one point bus stop bay was built to prevent longer traffic holdups at that point (see Figure 6.50).

*Figure 6.50 - Bus stations after the reorganisation, source: Hansestadt Stralsund*

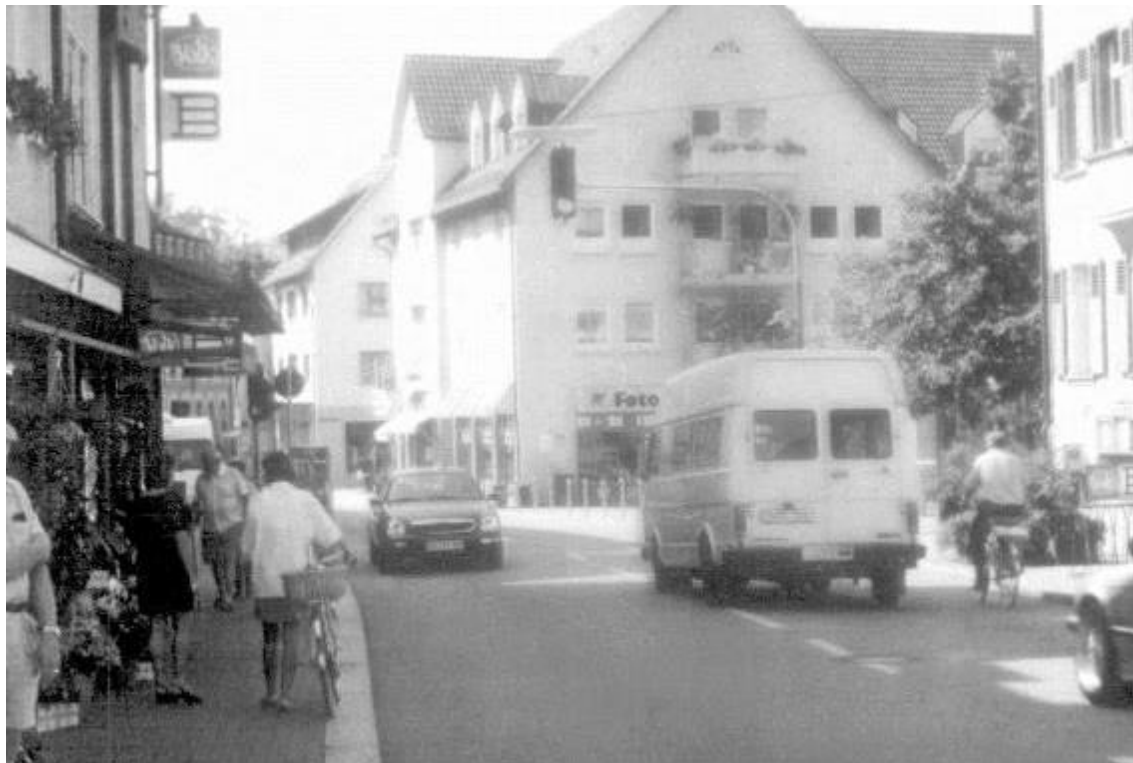
- - 87% through-going traffic
- - huge noise- und exhaust-gas- pollution
- - large vehicle-areas in contrast to small sidewalks
- - bad conditions for pedestrians and cyclists without habitations or design elements

*Figure 6.54 - Before situation: unattractiveness for pedestrians and cyclists (source: BSV Büro für Stadt- und Verkehrsplanung Dr.-Ing. Reinhold Baier GmbH, Aachen)*

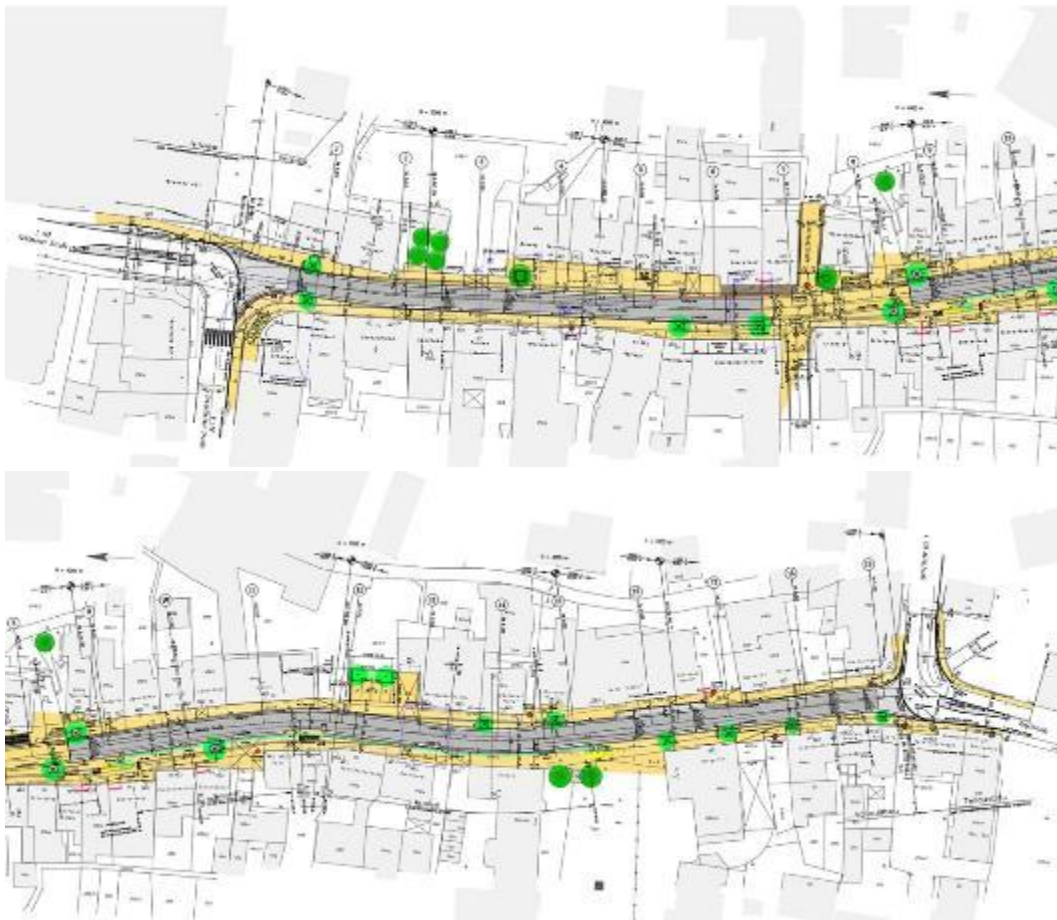
Figure 6.55 - The redesigned main street on the floor plan (source: BSV Büro für Stadt- und Verkehrsplanung Dr.-Ing. Reinhold Baier GmbH, Aachen)

The redesign of the centre of Wehr was implemented on 2003 (see Figure 6.55)

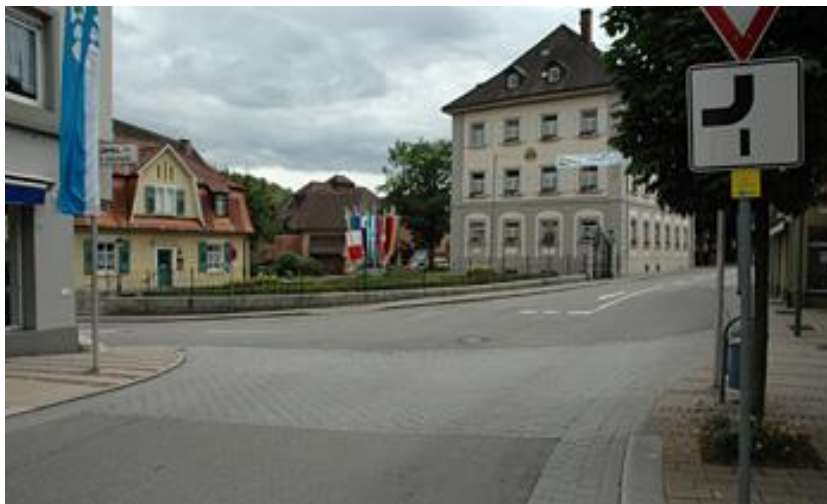
*Figure 6.56 - Design of the entrance areas (source: BSV Büro für Stadt- und Verkehrsplanung Dr.-Ing. Reinhold Baier GmbH, Aachen)*

At the entrances, the traffic routing was changed to a deviating right of way in order to assign a subordinate function to the main road in the urban road network. Pavement at roadway level that emphasise the course of the bend of the right of way and transversal pavement strips in the side area should additionally support their effect (see Figure 6.56).

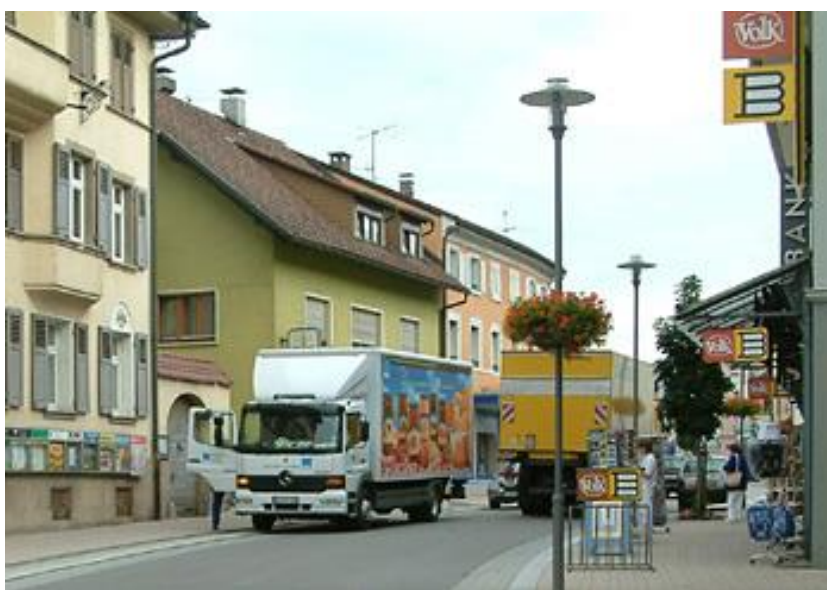
*Figure 6.57 - Delivery traffic on the main road (source: BSV Büro für Stadt- und Verkehrsplanung Dr.-Ing. Reinhold Baier GmbH, Aachen)*

Parking is limited throughout the entire section to 13 longitudinal parking levels, which are operated with parking discs on weekdays from 6 a.m. to 6 p.m. with a maximum parking period of 30 minutes. Delivery and loading processes take place on the road (see Figure 6.57).

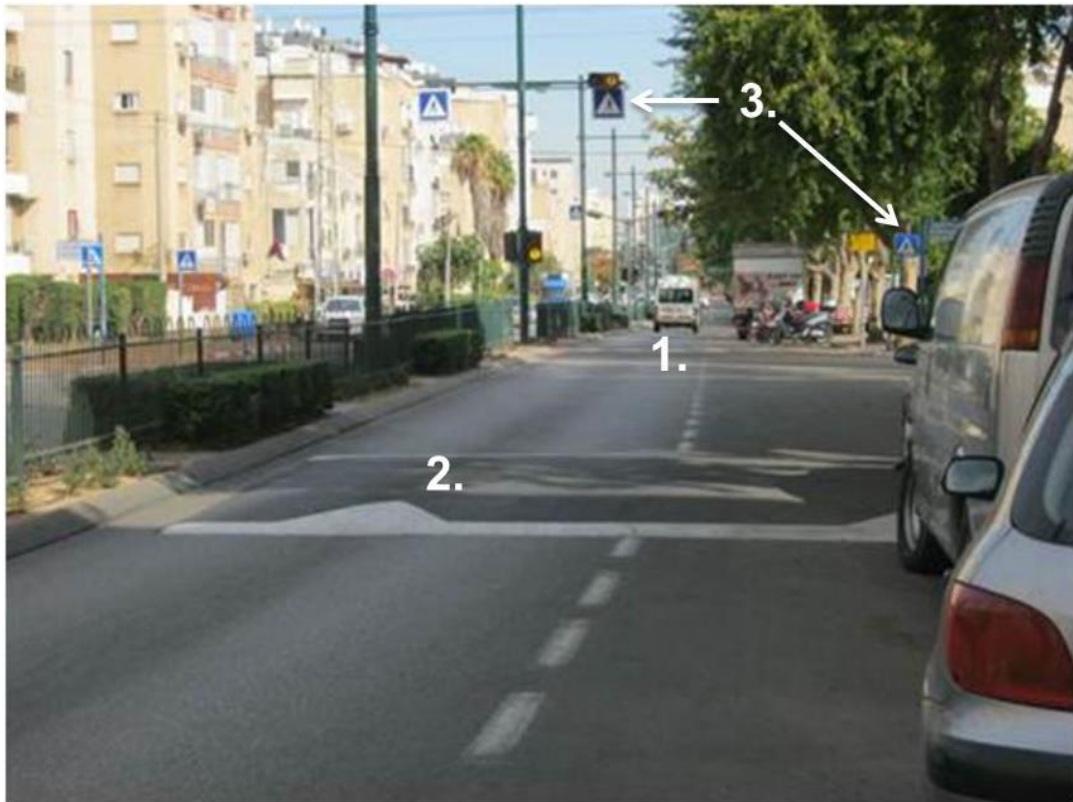
Figure 6.59 - Main components of a raised crossing arrangement, on the example of Site B in Israeli study.

Notes: 1 – a trapezoidal speed hump in the crosswalk area; 2 – a circular speed hump before the crosswalk; 3 – traffic signs and overhead amber flashing lights.

In the Israeli case studies raised pedestrian crossings were installed at non-signalized mid-block crosswalks situated on urban arterial and collector roads, with high traffic volumes. A raised crossing is built by installing a trapezoidal speed hump on the crosswalk (1), constructing speed humps before the crossing (2) and adding traffic signs (3) - see Figure 6.59 below. At three sites included in the paper, there were high shares of child pedestrians, below the age of 18.

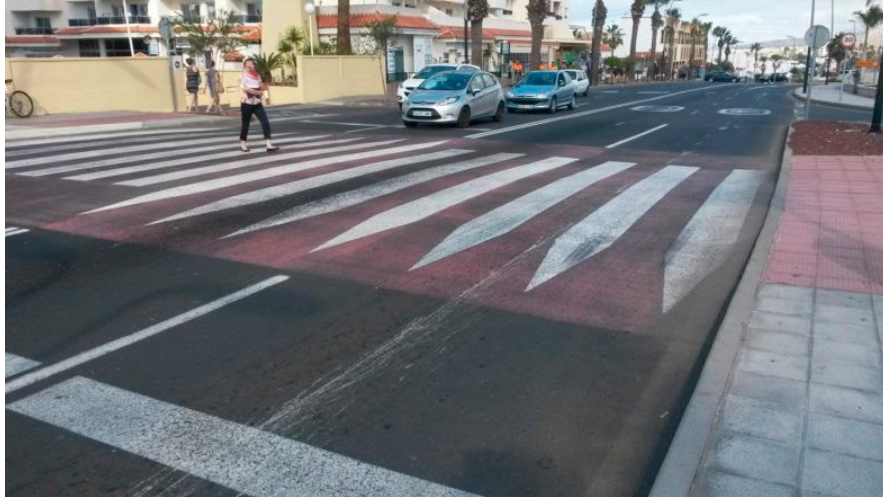
*Figure 6.60 - Speed-reducing devices and stop lines or yield bars 8 to 10 m before the crosswalk Playa de las Americas Arquitecto Gomez Cuesto, Tenerife.*

At approaches with two lanes or more, multiple-threat conflicts occur due to vehicles overtaking stopped ones in the adjacent lane. These conflicts are a threat especially to children, as they often are hidden behind the stopped vehicle if it has stopped too close to the crosswalk. To provide a stronger message for alerting drivers to stop and to stop early, and not to overtake a stopped car in an adjacent lane, *advanced yield bars or stop lines* are needed. For those, a distance to the crosswalk of about 10 m is recommended. However, installing yield lines is not yet an option available in many countries. For example, according to Finnish and Israeli regulations, yield or stop lines cannot be installed except for at signalized crosswalks, though it is already used at unsignalized crosswalks in, for example, Spain, the United States and Japan – see examples in Figures Figure 6.60Figure 6.61Figure 6.62 and Figure 6.63.

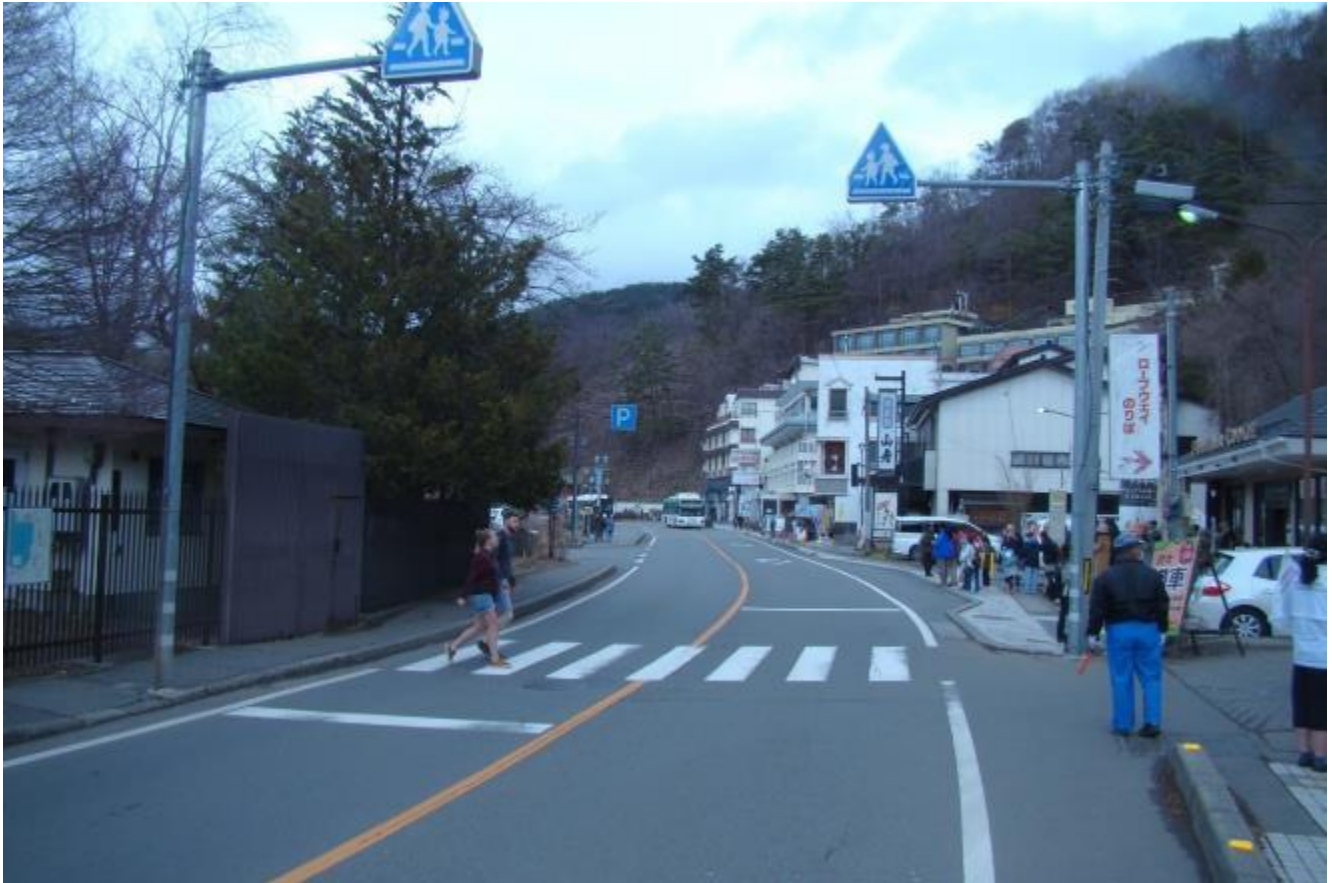
Figure 6.63 - Stop lines 5 to 10 m before an unsignalized crosswalk in Kawaguchiko, Japan.

At approaches with two lanes or more, multiple-threat conflicts occur due to vehicles overtaking stopped ones in the adjacent lane. These conflicts are a threat especially to children, as they often are hidden behind the stopped vehicle if it has stopped too close to the crosswalk. To provide a stronger message for alerting drivers to stop and to stop early, and not to overtake a stopped car in an adjacent lane, *advanced yield bars or stop lines* are needed. For those, a distance to the crosswalk of about 10 m is recommended. However, installing yield lines at unsignalized crosswalks is not yet an option available in many countries. For example, according to Finnish and Israeli regulations, yield or stop lines cannot be installed except for at signalized crosswalks, though *the policy with advanced stop lines is already used in, for example, Spain and Japan, and advanced yield lines in the United States* – see examples in Figure 6.60, Figure 6.61, Figure 6.62 and Figure 6.63.

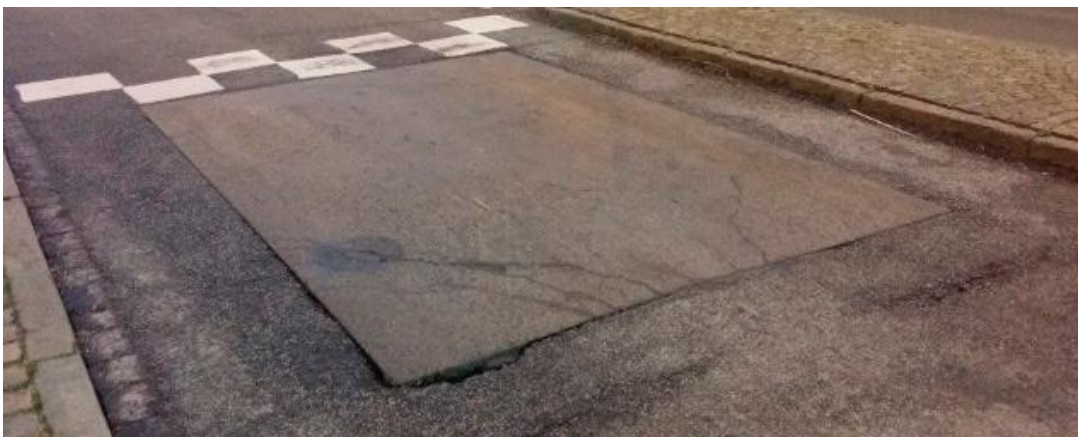
Figure 6.64 - Cracks on one of the two speed cushions at Tessins väg (photo by Rolf Lysenius, February 2018).

For all types of speed-reducing devices, the long-term effectiveness will vary not only with the design but also with factors such as the strength of the material, and how well the devices are constructed and maintained. See for example Rosander, Lyckman & Johansson (2007). Especially the transition point between a prefabricated part of a speed cushion and the asphalt has to be designed to be smooth to avoid shocks that deteriorate the speed-reducing device. Figure 6.64 shows cracks on one of the two speed cushions at the test site at Tessins väg and Figure 6.65 shows how to avoid that through the “Norwegian solution” as described in an e-mail from Salerno, 2018.

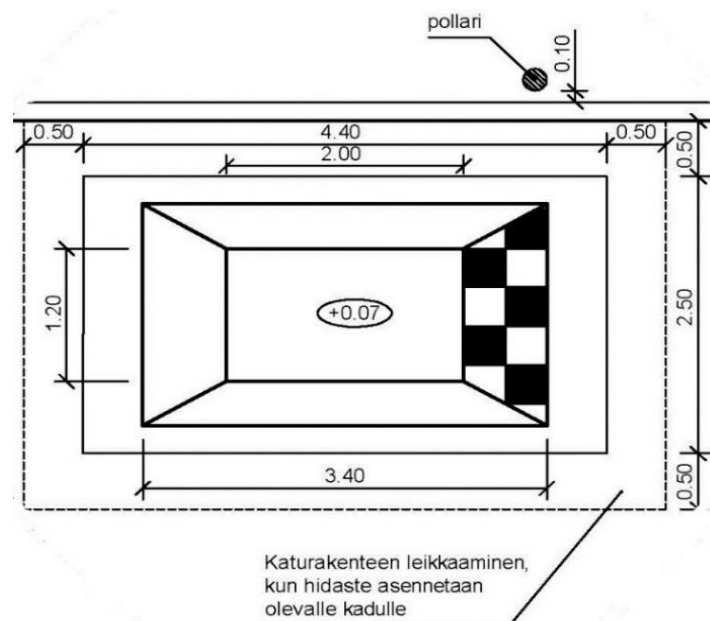
Figure 6.66 - Finnish speed cushion design detail. Note: The outer area is also cut when installing the speed cushion (mail from Salermo, City of Helsinki, 2018).

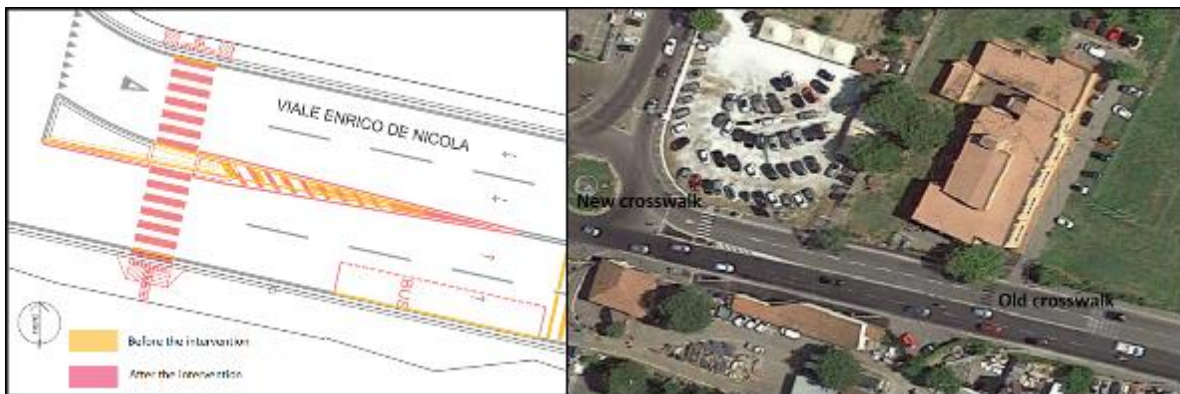
Figure 6.69 - Intervention on site 2, moving of the crosswalk position close to the roundabout intersection [4] [5]

- one required a change in the position of the crosswalks to place it where a refuge island could be more easily implemented and where vehicle speeds were lower (Figure 6.69 and Figure 6.70).
- one has requested the modification of the trajectory of a lane to insert the refuge island: this deflection has the double effect of a measure of "traffic calming", as it leads to a reduction in the speed of vehicles along that lane (Figure 6.71).

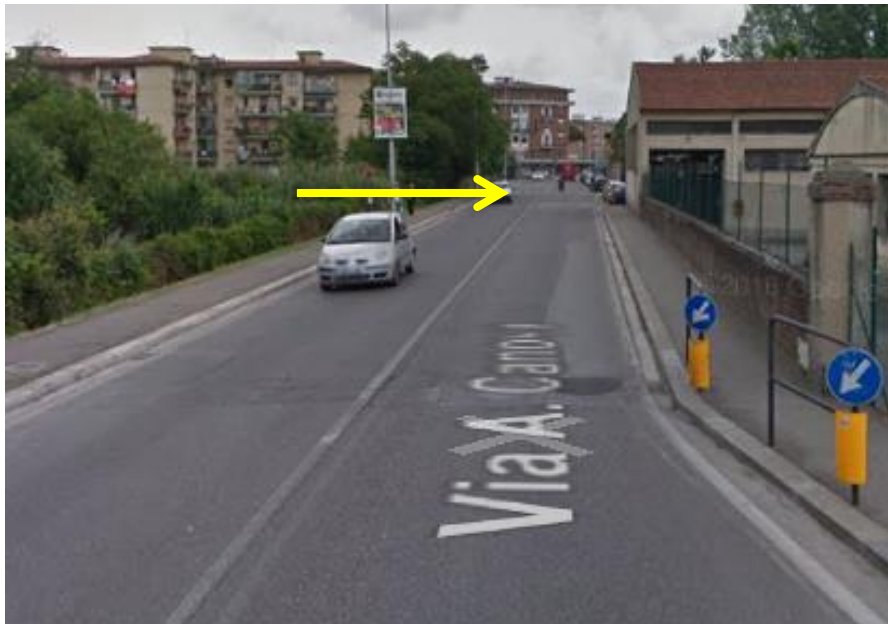
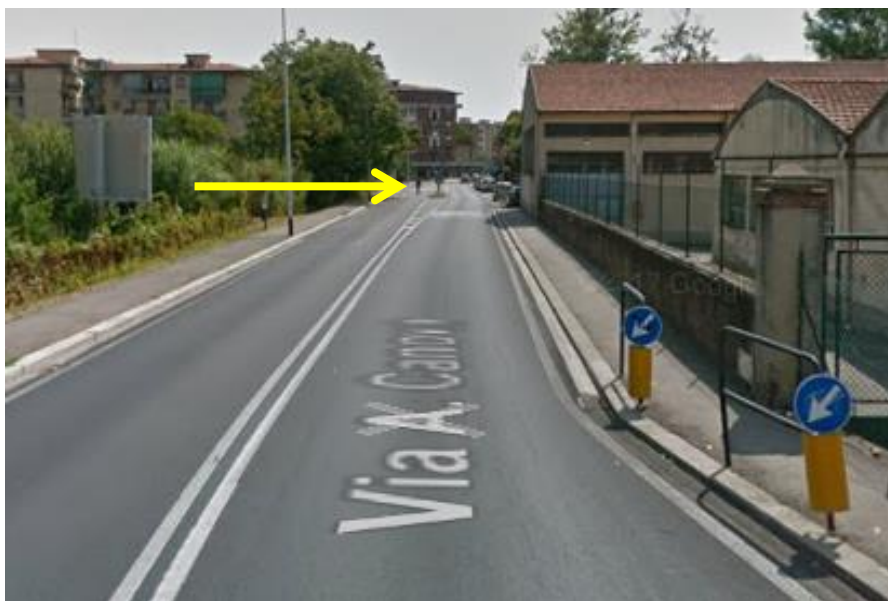
*Figure 6.72 - Intervention on site 1, details of the crosswalk view at a 100 m distance: the white stripes are not visible in either picture, but in the second it is possible to clearly see the pedestrian refuge island [5]*

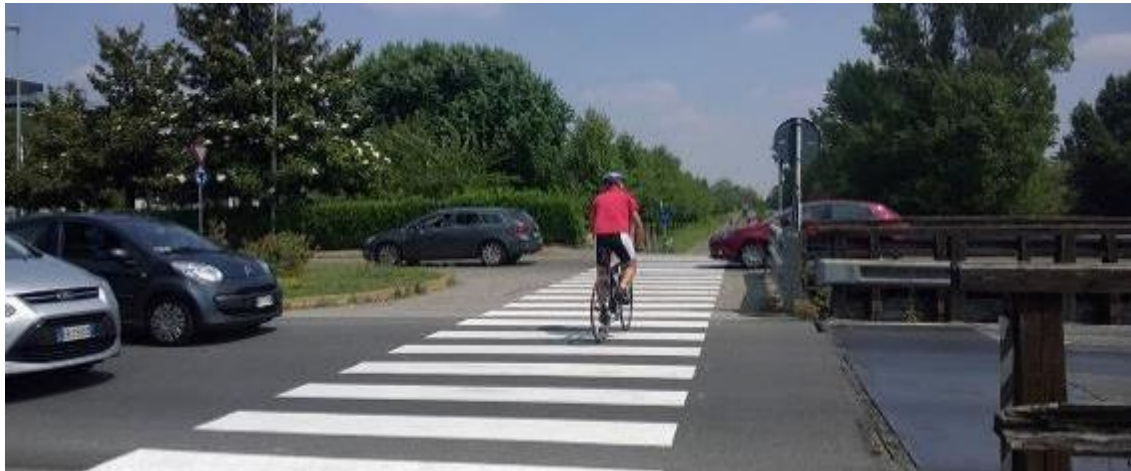
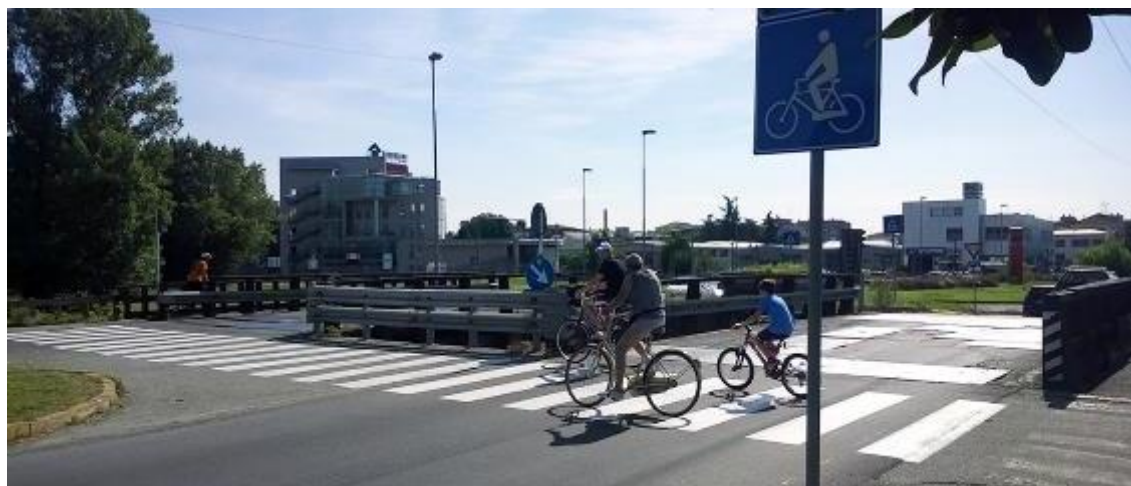
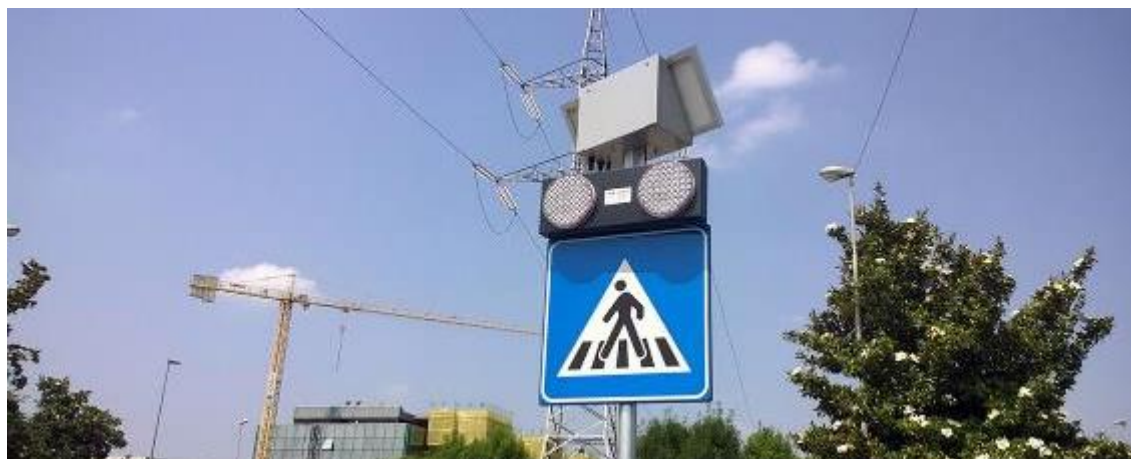
*Figure 6.82 - Photos showing the cycling crossing, vertical road signs, and flashing traffic lights at the project junction following the first phase completion (May 2014)*

The main accomplishment of the infrastructural project is surely the increased visibility of the cycling crossing, which caused an immediate and localised improvement for the safety of cyclists, who could be (and feel) more protected while crossing the Alzaia Naviglio Pavese junction.

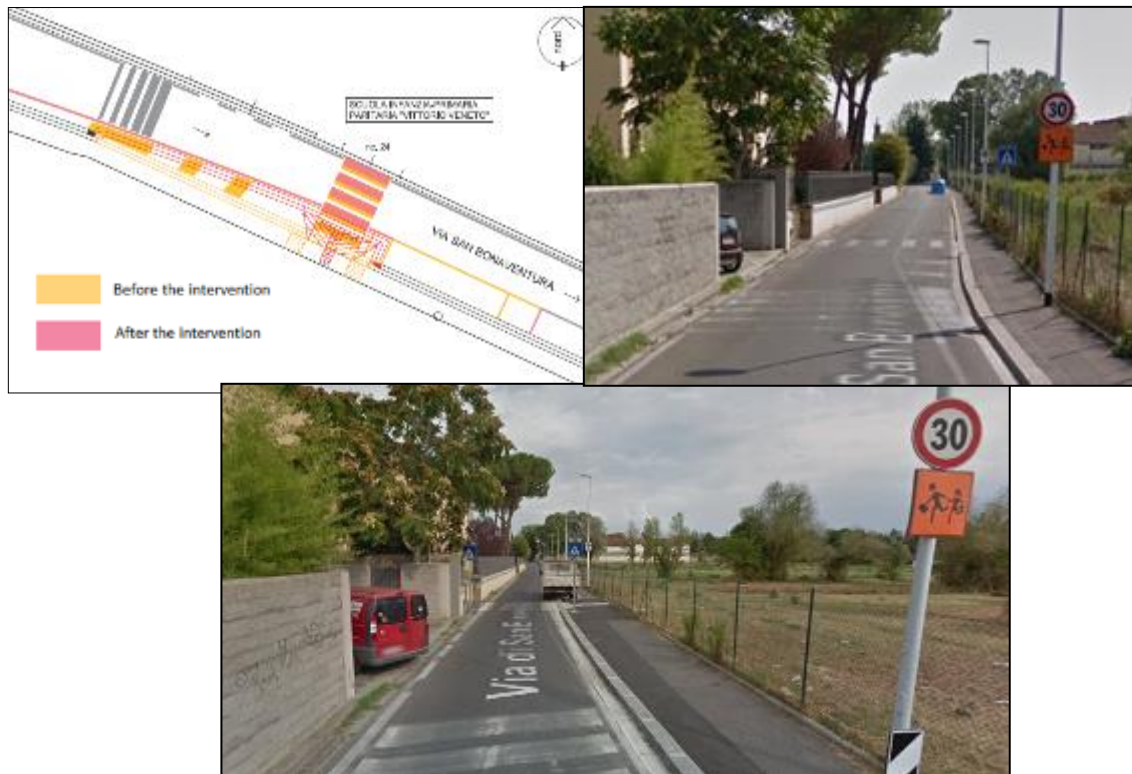
Figure 6.84 - Site 1. On the right top the situation before the intervention, on the bottom the situation after the intervention [1] [2]

The aim of the interventions was to improve the visibility of pedestrians who are about to cross the road, through the advancement of the sidewalk both in correspondence and in the zone immediately preceding the zebra crossing.

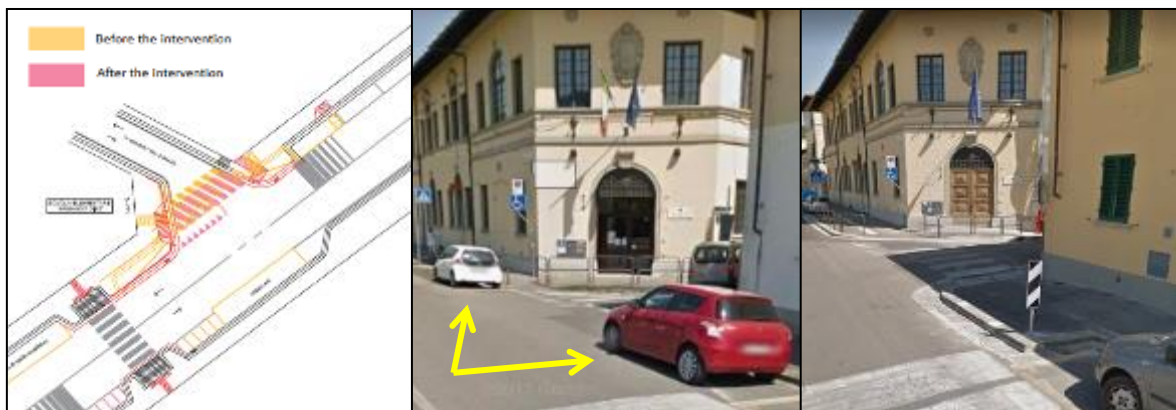
Figure 6.85 - Site 2, situation before the intervention (in the centre) highlighting two cars parked immediately before the two zebra crossing, and situation after the intervention (on the right) [1] [2]

Two of the three crosswalks interested by the intervention are crosswalks in correspondence of schools. Although no fatal or particularly serious accidents were detected along these road segments, however, it was noted as a consequence of users reports and experts' analysis, that some deficiencies related to road safety are present, particularly concerning the difficult visibility of pedestrians in the process to cross. This is even more aggravated by the fact that very often the pedestrian was represented by a child, whose smaller figure can more easily remain hidden behind a car parked immediately before the crosswalks.

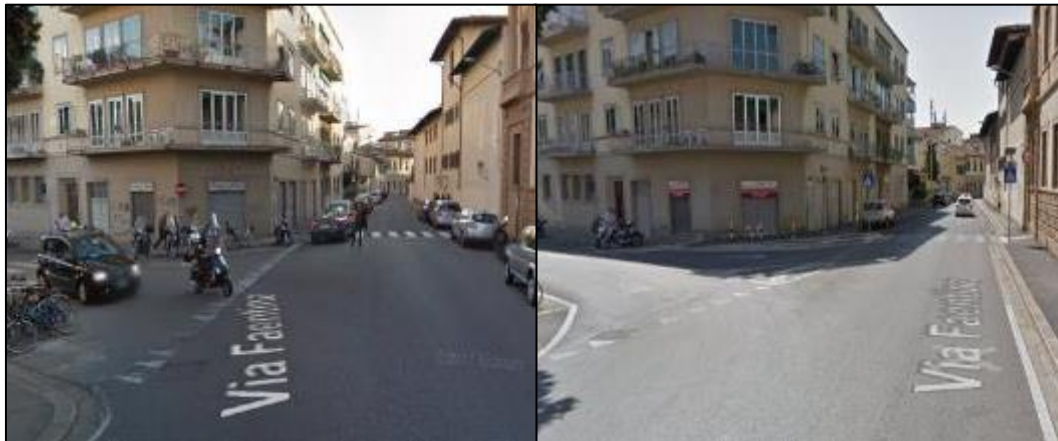
Figure 6.87 - Site 3, on the left situation before the intervention, on the right situation after the intervention [2]

The intervention in the third site also allowed to redefine the road section. The lane crossed by the zebra crossing, has a single direction of travel. Before the intervention, the lane was too wide. This not only encouraged drivers coming from Via Faentina to increase speed, but also gave the opportunity to vehicles coming from Via Cuoco, who turned left, to partially enter the lane, remaining in the middle of the yield line, creating critical issues not only to the passage of vehicles from Via Faentina, but also to the pedestrian crossing, obscuring the view of any pedestrian waiting to cross.

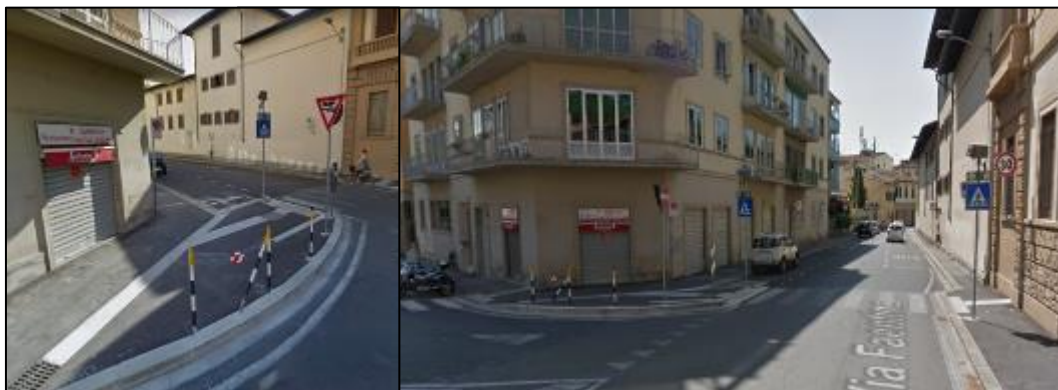
Figure 6.88 - Site 3, details of the intervention [2]
