# CATALOGUE OF CASE STUDIES

*Road safety improvements relevant to Vulnerable Road Users, Human Factors and Low- and Middle-Income Countries*

**TECHNICAL COMMITTEE C.2 DESIGN AND OPERATION OF SAFER ROAD INFRASTRUCTURE**

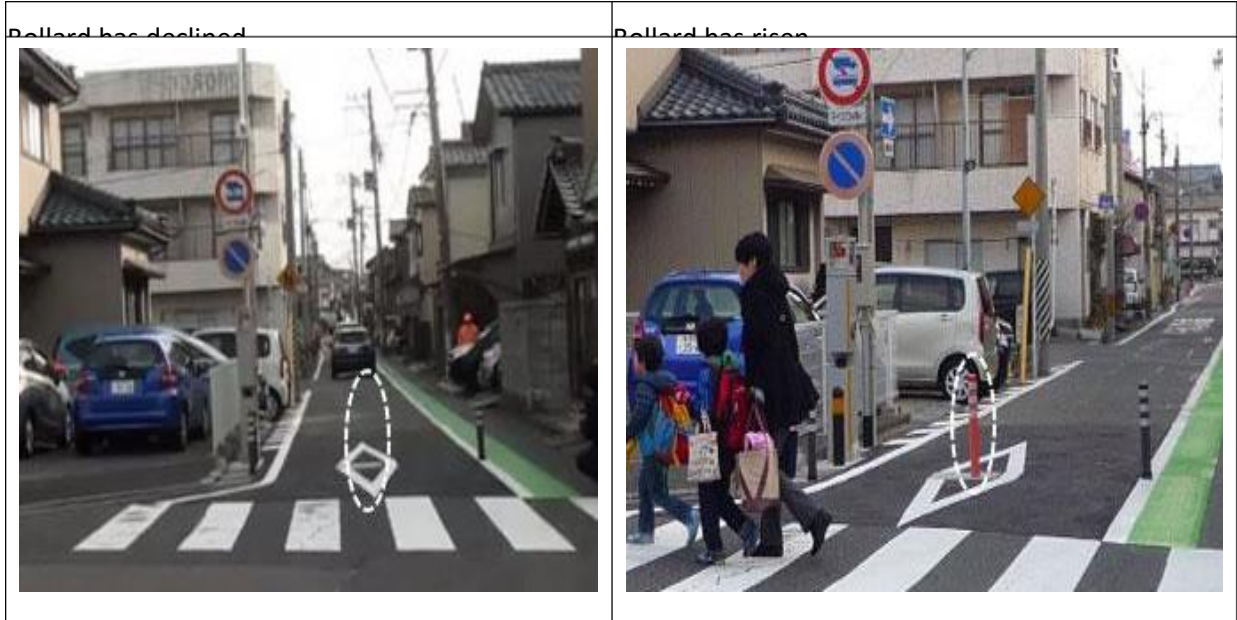
Always descending except in the traffic regulation time zone. Large vehicles (excluding micro) can not be passed at all times  
 Figure 6.89 - Installation status of Soft Rising Bollard. Made by MLIT HP  
 Regulations on traffic on weekdays 7: 30-8: 15 (school time zone)  
<http://www.mlit.go.jp/road/road/traffic/sesaku/torikumi.html#2-2-4>

The Rising Bollards made of steel used in Europe may cause damage to vehicles and road structures and serious accidents at the time of a vehicle collision. Therefore, in Japan, we are developing and spreading "soft" Rising Bollard which rubber bollard is used.

Even for "soft" rising bollard made of rubber, it completely restrained the passage of general vehicles during school hours (100% decrease). As a result, it is considered that the safety of the students going to school has been secured in the target road.

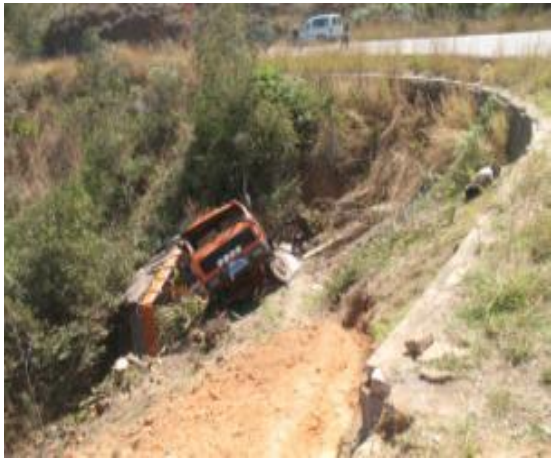
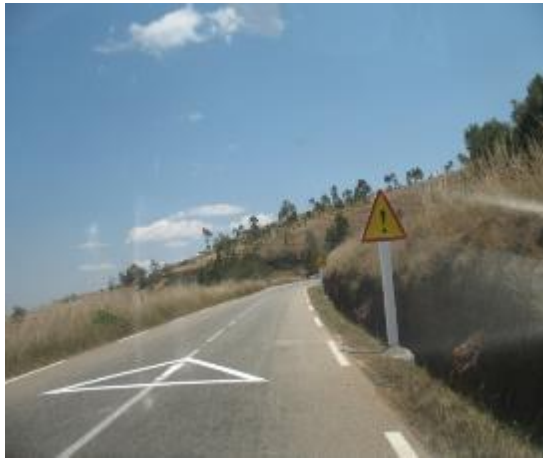
PK 71+500_RN4	
BEFORE	AFTER

<p><b>At this point:</b> if two trucks intersect: one of the trucks (on the side of the photo) falls in this ravine. Cause: narrow road, excessive speed, lack of visibility: since double turn</p>	<p>panel: attention and donkey + sign mark attention</p>

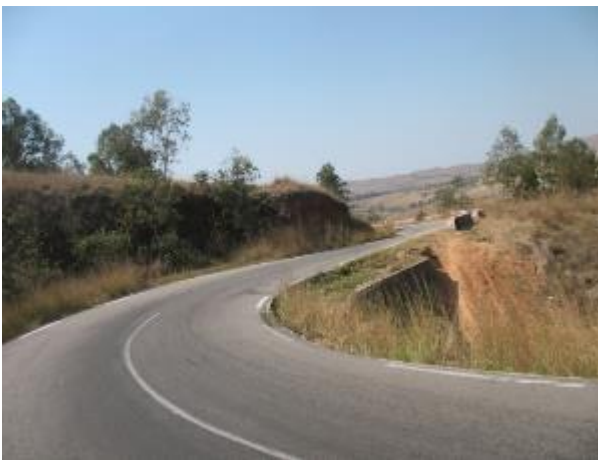
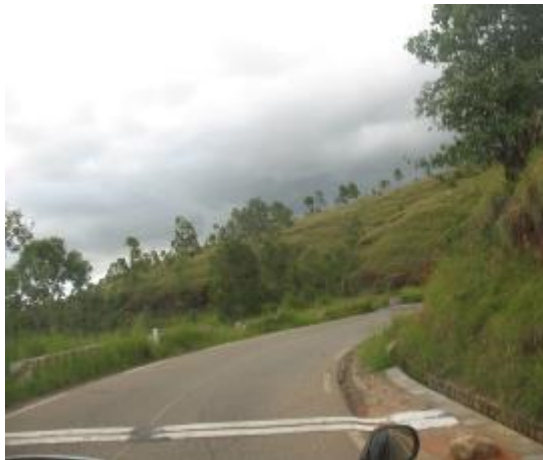
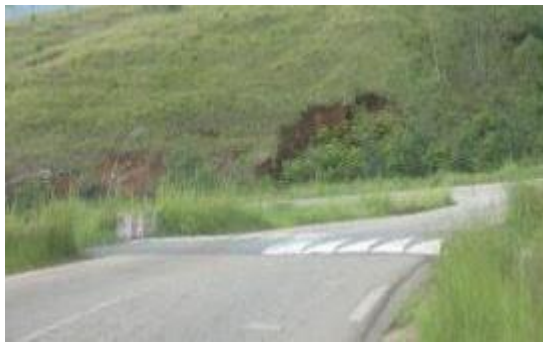
<p>Reverse Direction view</p>	<p>set up two horns</p>

<p>and speed breaker</p>

<p><i>On the opposite side: we also put these same facilities</i></p>
	<p><i>Project: widening the roadway at this point</i></p>
<p>PK 105+000_RN4</p>	
<p>BEFORE</p>	<p>AFTER</p>

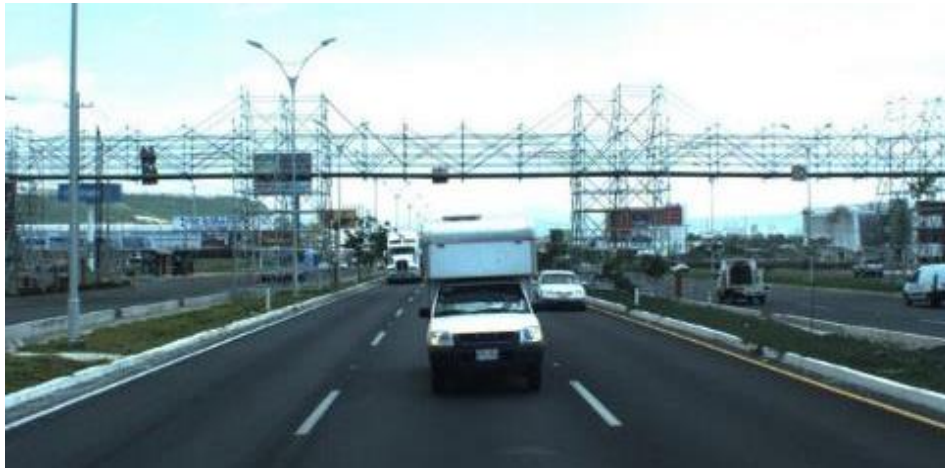
*Figure 6.90 - Provisional Pedestrian Crossing-Grade Separation detected during the RSI*

So far, there has been a recorded reduction in the run over victims. In the last 2 years since the start of operation of the pedestrian crossing-grade separation, there has been a single victim compared to the six recorded in the previous 3 years. However, there are still risky behaviours by pedestrians crossing the road below the pedestrian crossing-grade separation passing through a pedestrian fence that has not continuity providing to the pedestrian an opportunity to cross by it.

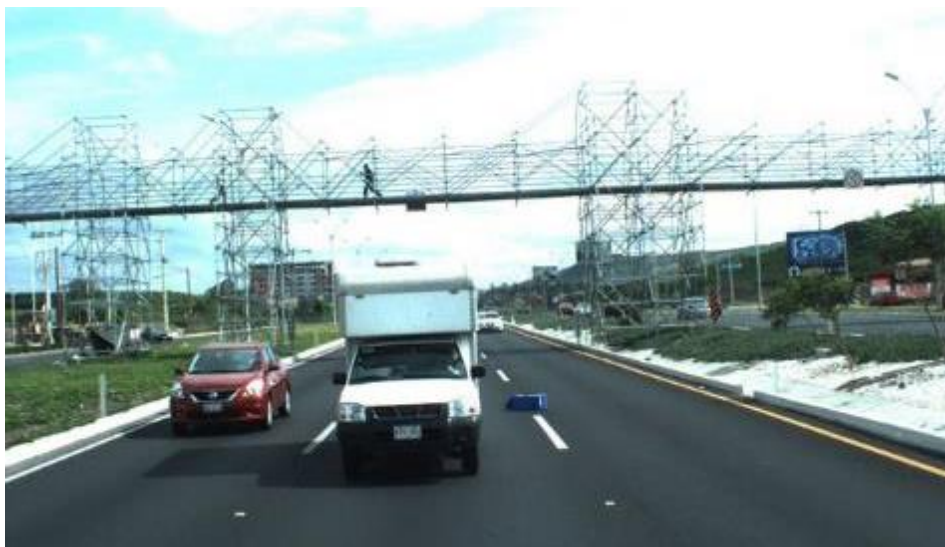
*Figure 6.91 - Detail of pedestrians using the provisional Pedestrian Crossing-Grade Separation*

Pedestrian Crossing-Grade Separation. During the Road Safety Inspection carried out on the highway section, a provisional pedestrian crossing-grade separation was found that connected both sides of the highway, at kilometer 12 + 100, in whose adjacent areas there are two commercial malls, one on each side of the highway, where important work and entertainment centers are located. The proposed improvement measure was the construction of a final pedestrian crossing-grade separation, which meets the objectives of providing vulnerable users an infrastructure for safe circulation in the area.

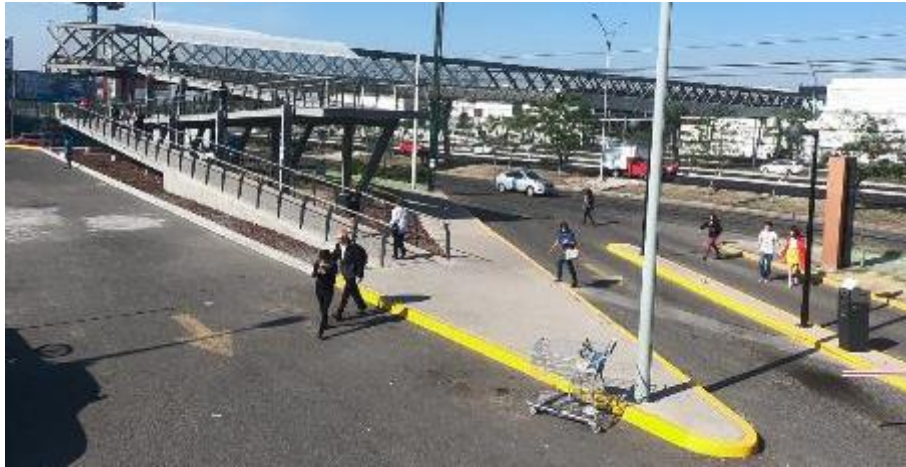
*Figure 6.92 - Panoramic view of the permanent Pedestrian Crossing-Grade Separation, seen from the east side*

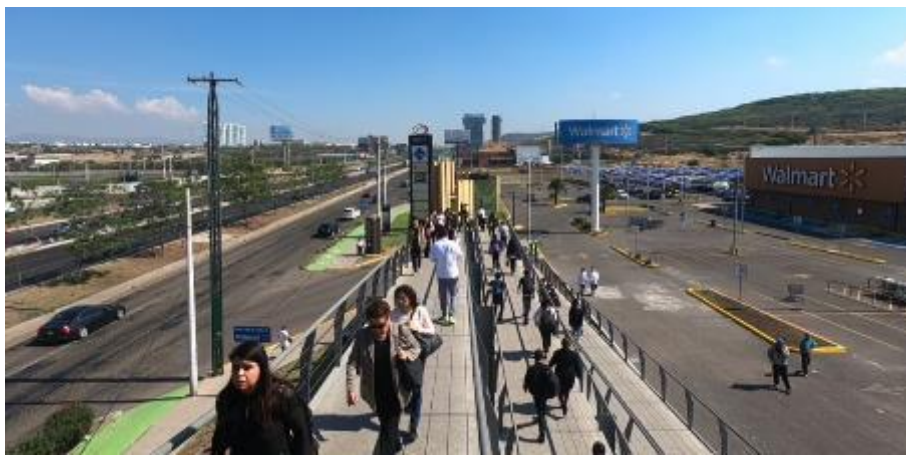
*Figure 6.93 - Access ramp to the Pedestrian Crossing-Grade Separation, east side seen from the north view*

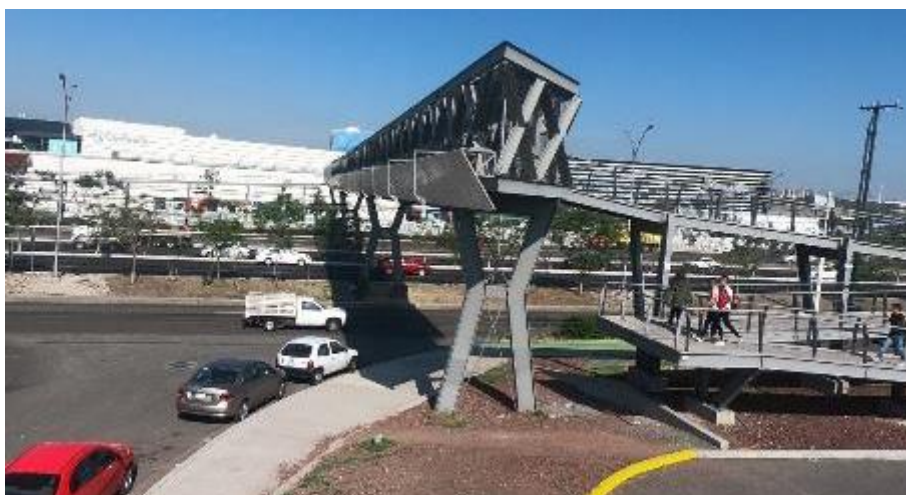
*Figure 6.94 - Side view of the Pedestrian Crossing-Grade Separation, seen from the east side*

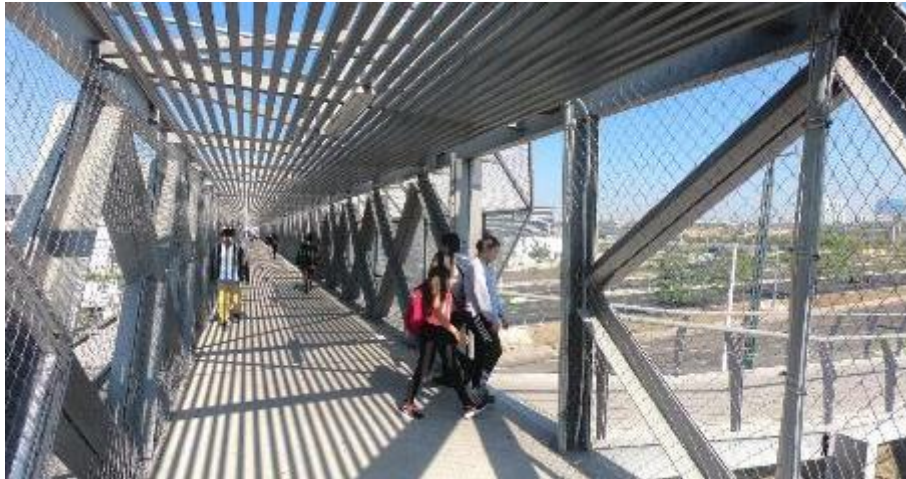
*Figure 6.95 - Interior view of the Pedestrian Crossing-Grade Separation*

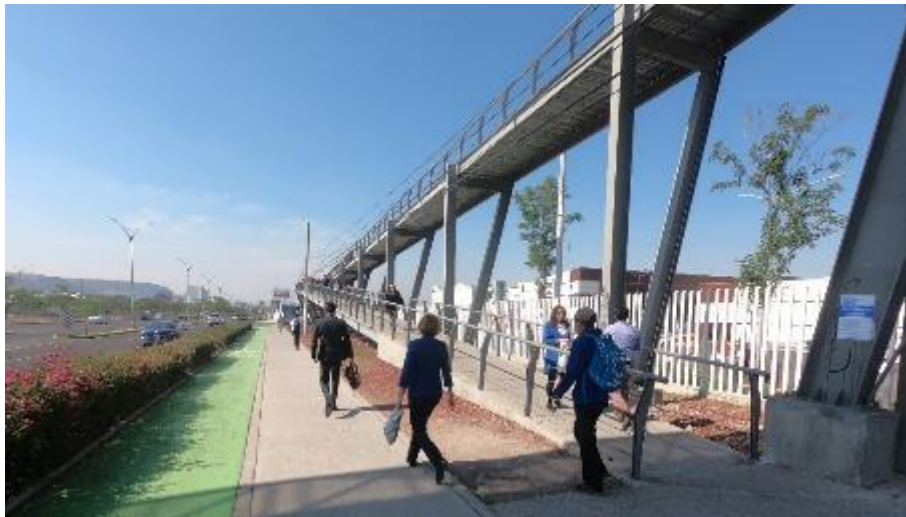
*Figure 6.96 - Access ramp to the Pedestrian Crossing-Grade Separation, west side seen from the south view*

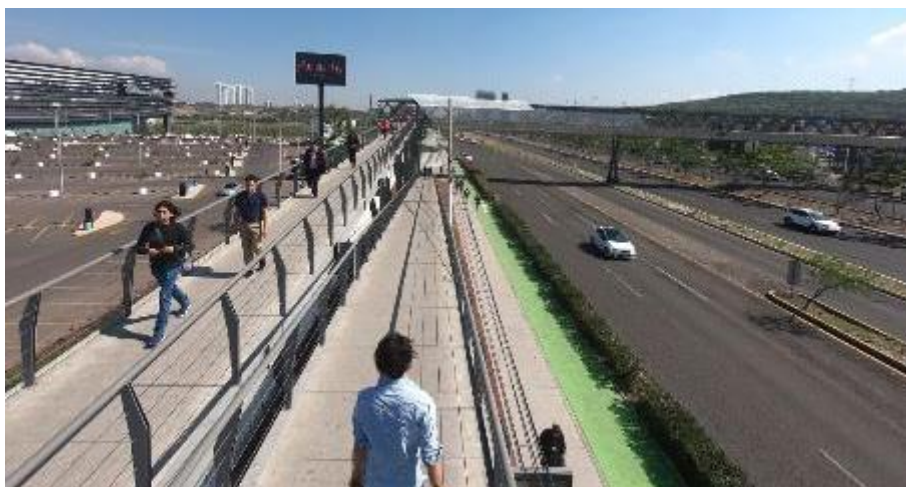
*Figure 6.97 - Access ramp to the Pedestrian Crossing-Grade Separation, west side seen from the north view*

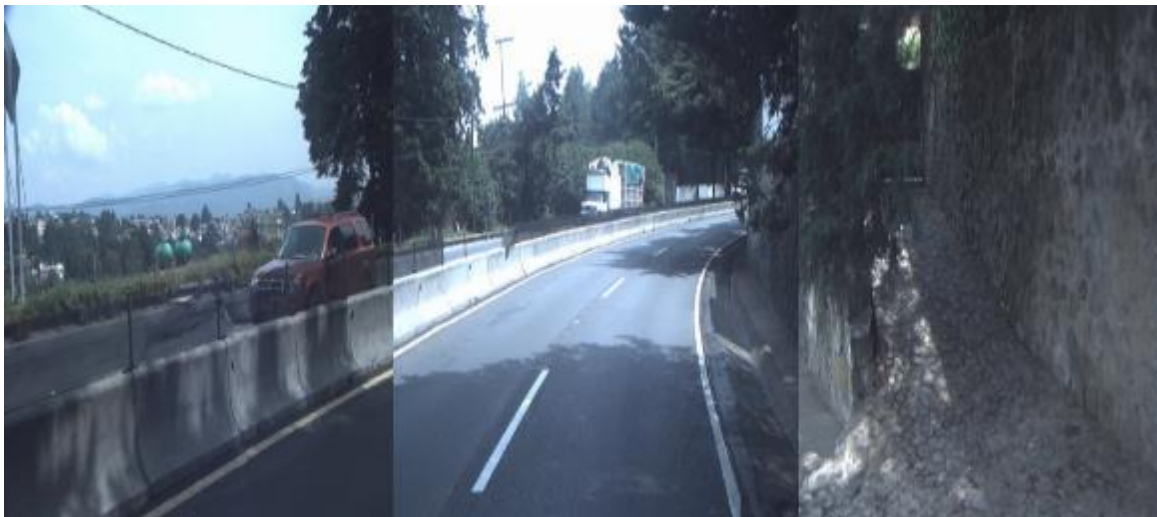
Figure 6.102 - Visibility problems.

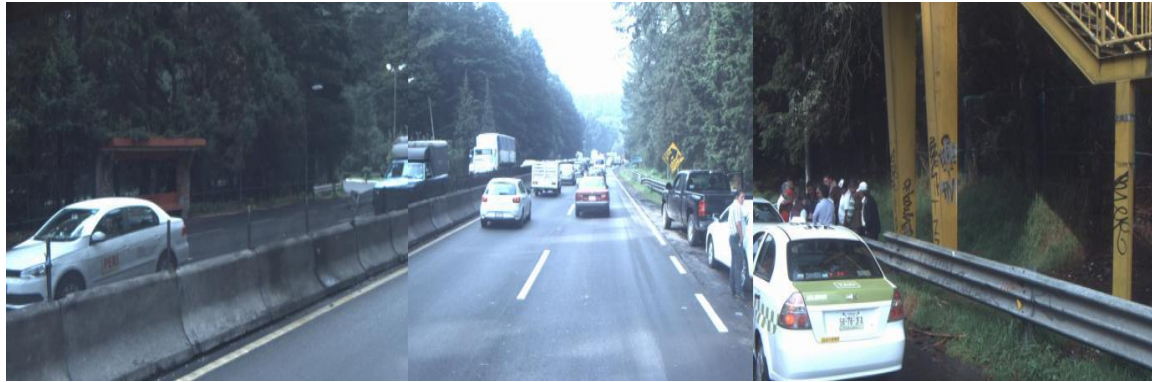
Figure 6.104 - Safety problems at public transport stops.

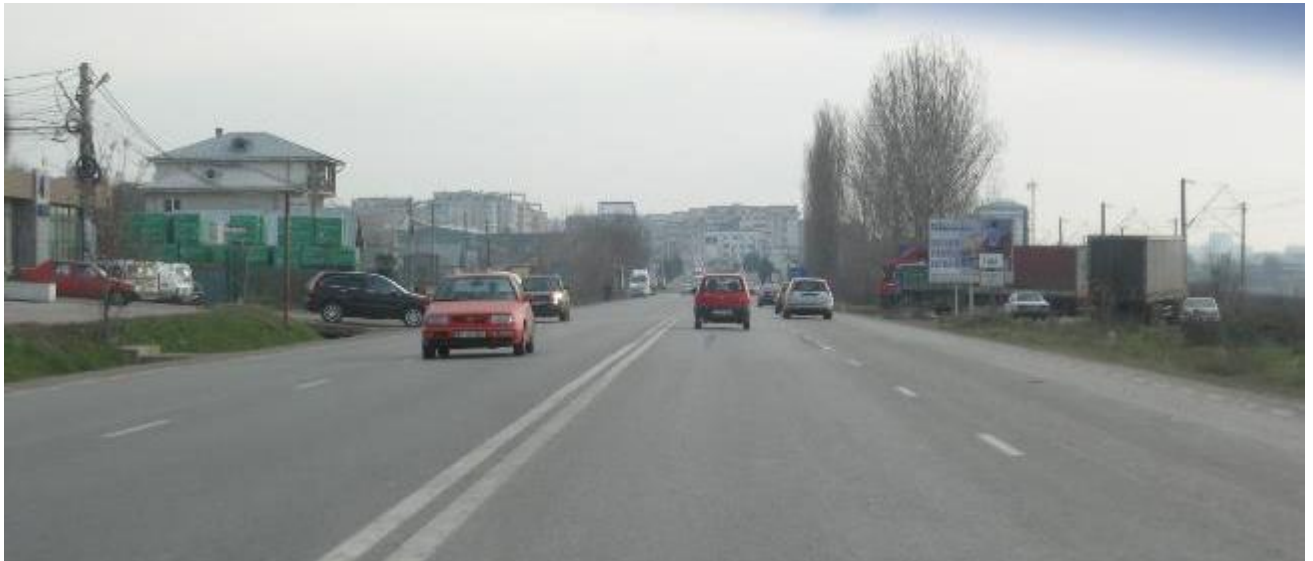
*Figure 6.106 – Before the first intervention: lanes without newjersey separation*

commune. The solutions that were adopted were the separation of circular traffic across the town by placing New Jersey concrete safety fencing with  $H = 1.00$  m, width at the base being 64 cm.

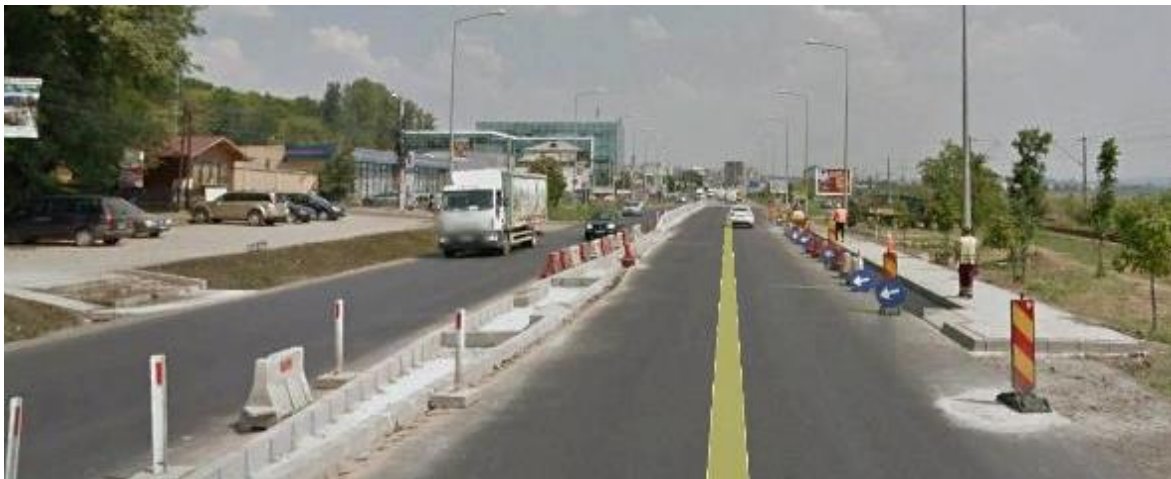
*Figure 6.110 – During the intervention: construction site section 1, Iasi oriented view, details of the pedestrian refuge island*

- The central island is raised - because of the high traffic of freight cars, it was chosen the protection solution for pedestrians waiting on the island at a higher level than the national road
- Overall design length = 65.00 m
- Length of space on the island available to pedestrians = 9.00 m
- The width of the central island = 2.00 m
- Width of space available for crossing pedestrians = 4.00 m
- Crossing is done by changing the direction of travel - in "S"
- Space available for pedestrians on the island is bounded by pedestrian fence
- Signals for pedestrian crossing have been designed with intermittent yellow light, both on the right-hand side of the road and those installed on the central island.
- The traffic speed in the pedestrian crossing area was limited to 30 km/h.

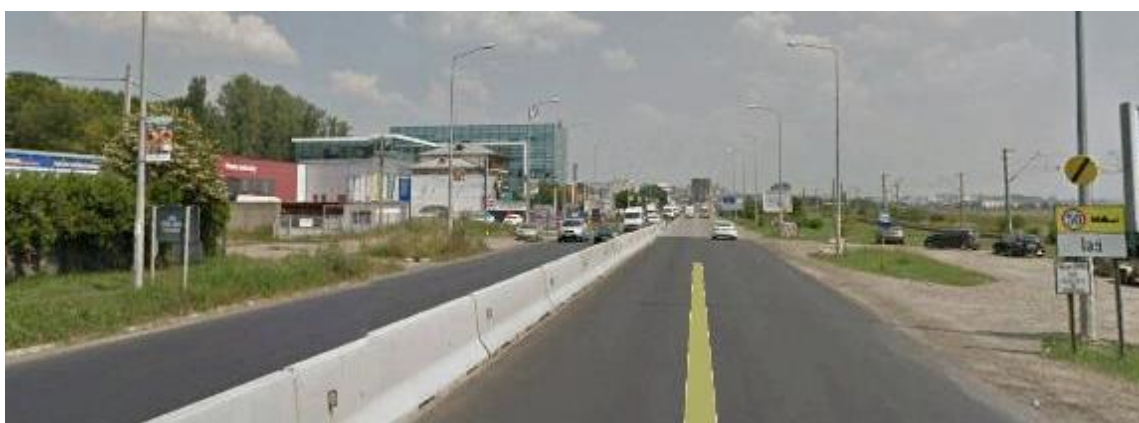
*Figure 6.111 – During the intervention: construction site section 2, Iasi oriented view*

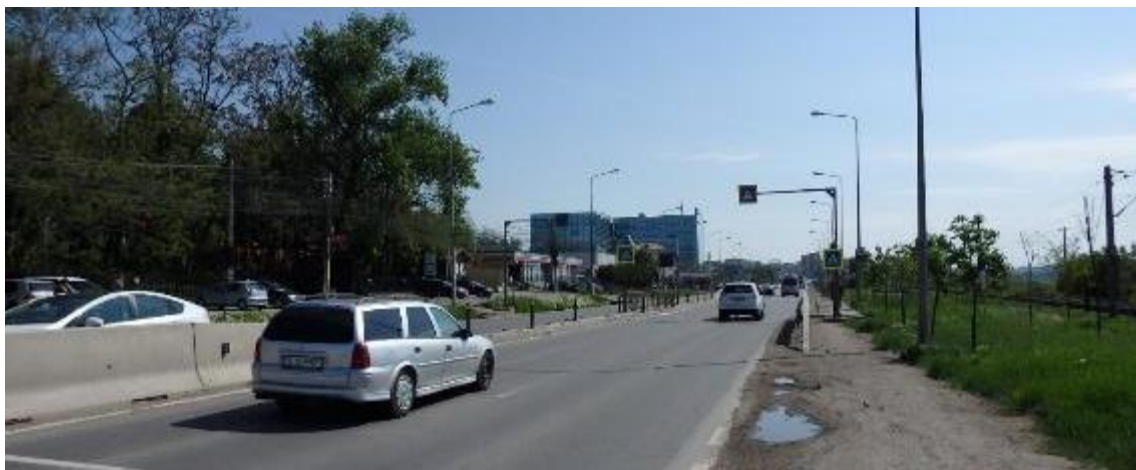
*Figure 6.116 – After the intervention: road section 1, Iasi oriented view*

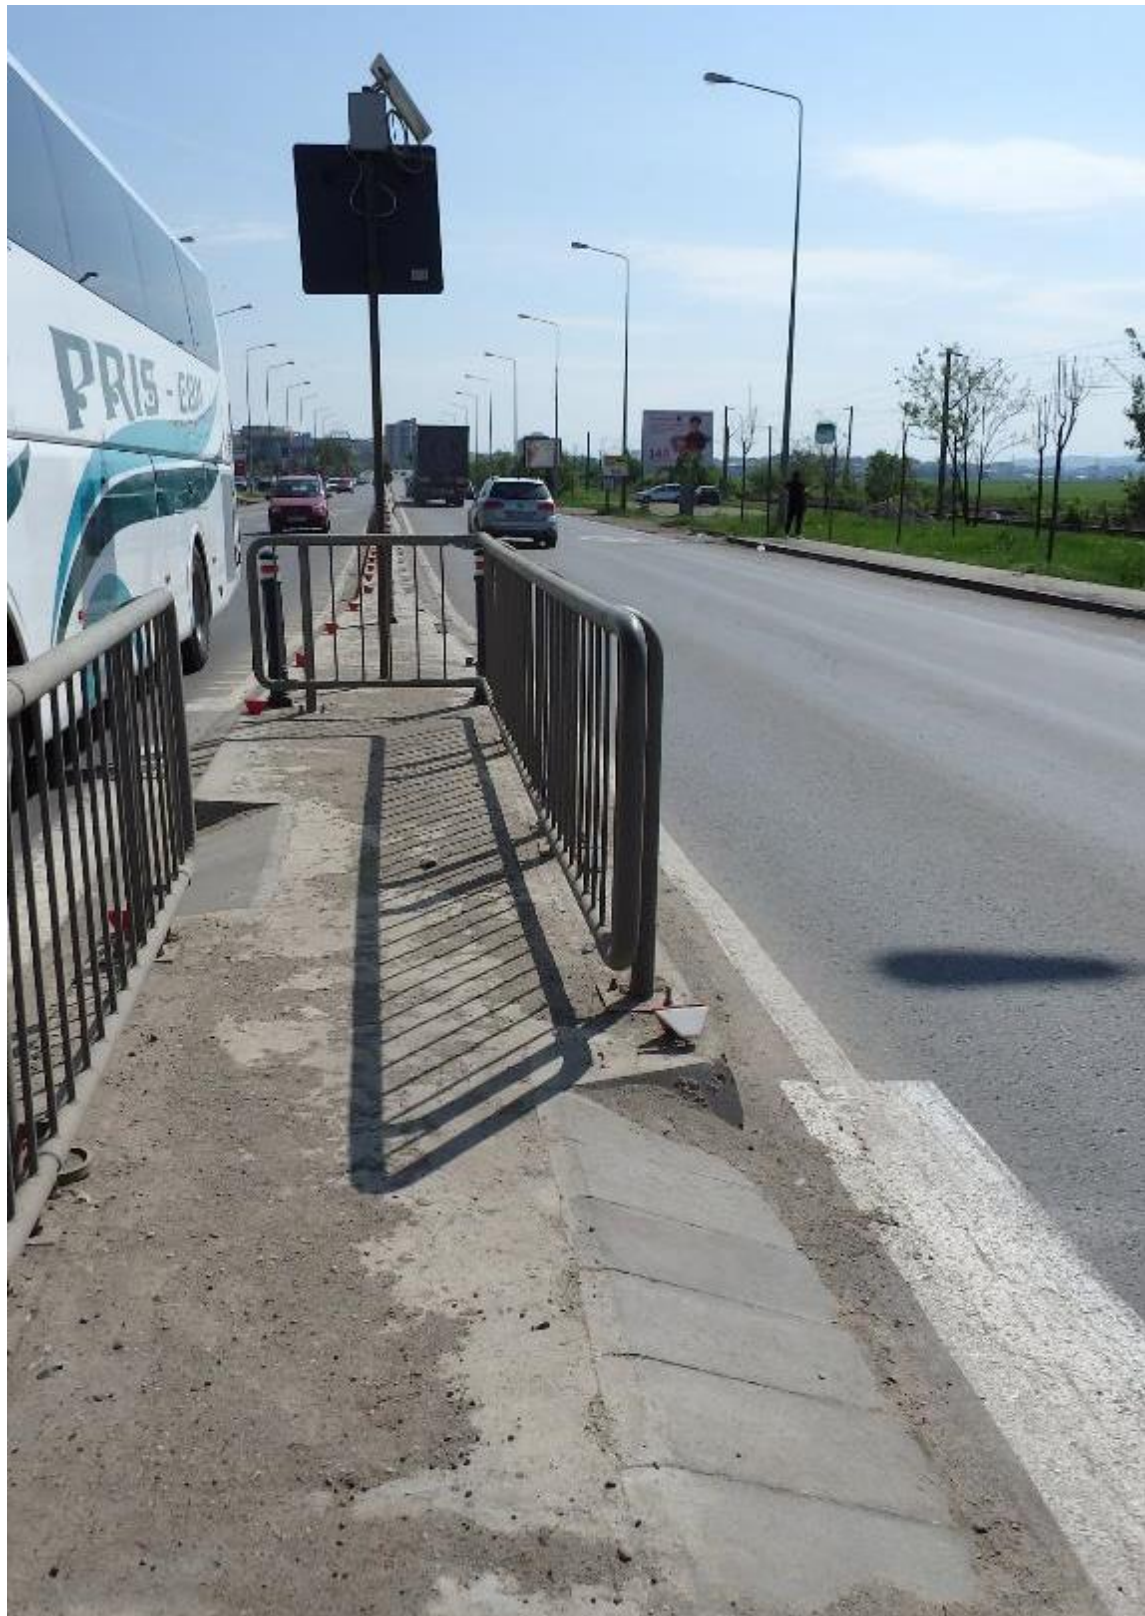
*Figure 6.117 – After the intervention: road section 1, lasi oriented view, details of the pedestrian refuge island*

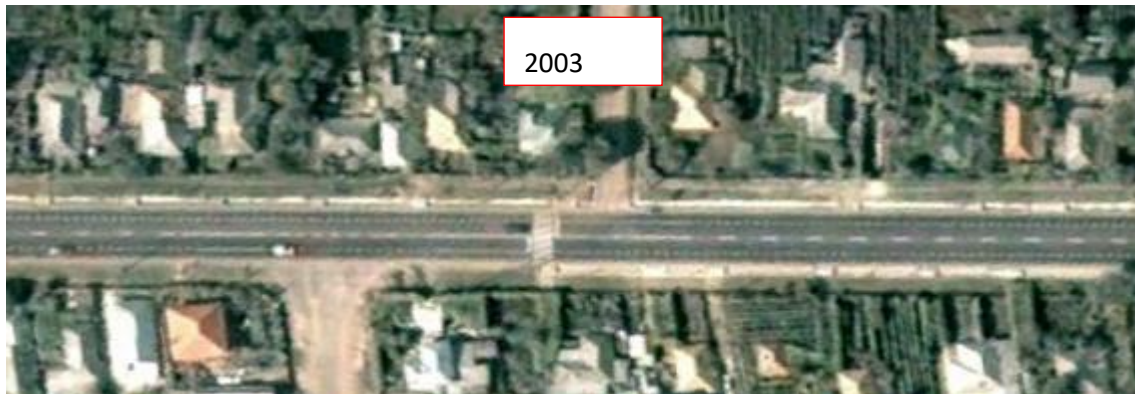
*Figure 6.119 - Design detail for a pedestrian crossing in the rehabilitation works on DN 28*

B. Arranging the pedestrian crossing by separating the walking directions with a forbidden space, prior to the location of the passage and directing traffic on the circulating lane, in the crossing area, as the traffic also takes place on the reinforced platforms, as well as the application of warning strips of cross- high-volume road markings.

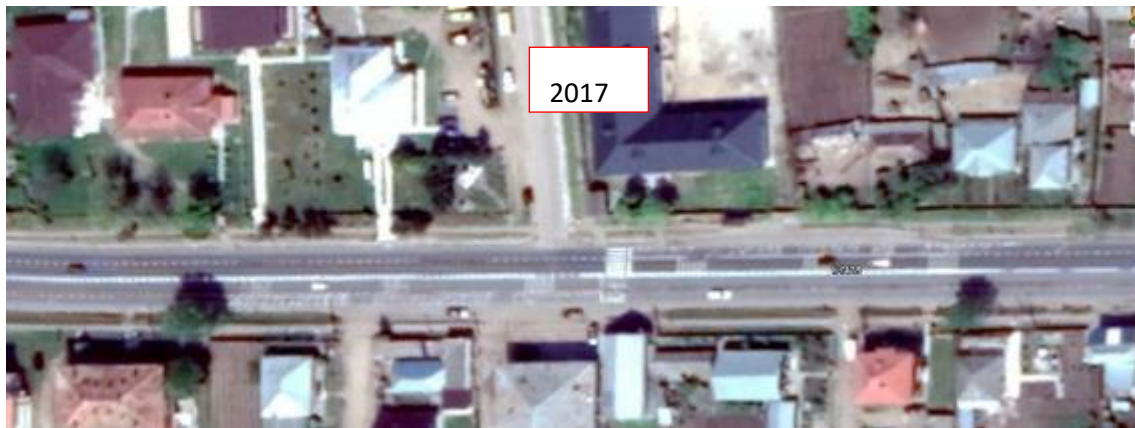
*Figure 6.120 - Redesigning the pedestrian crossing in Bălțați locality*

For economic and legal reasons, version B was adopted, and, depending on the financial possibilities, the realization of a pedestrian bridge was also considered.

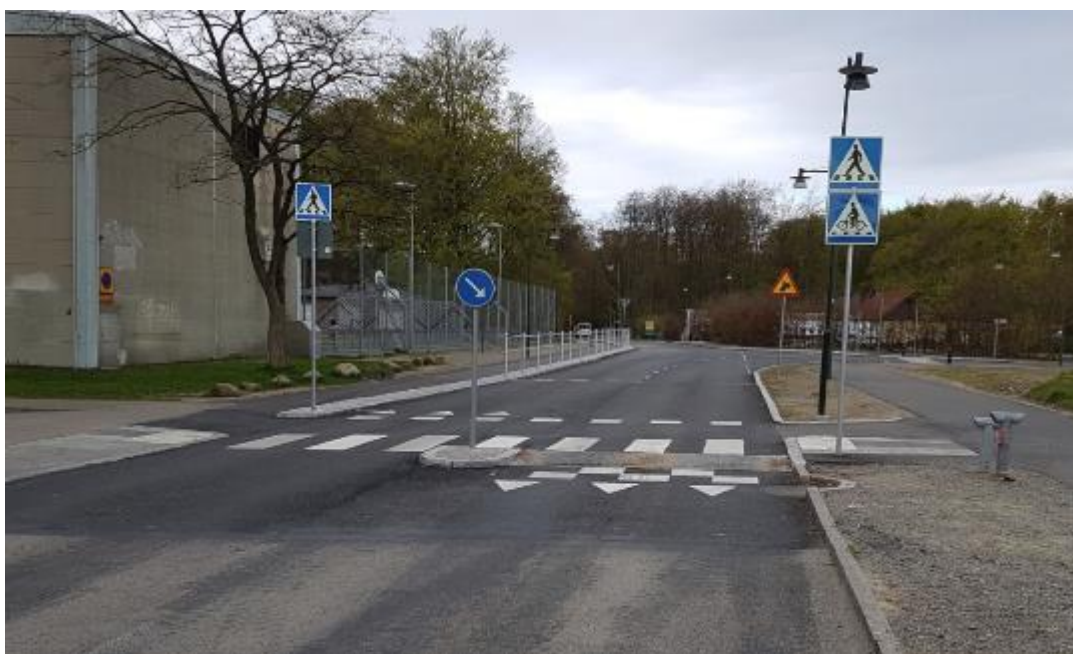
Figure 6.135 - Realization of a bicycle crossing with pedestrians crossing and speed reduction (speed humps). Source: City of Helsingborg

In summary, bicycle crossings provide a high level of accessibility for cyclists where the design is made according to the regulations and with speed calming to 30 km / h. The effects are probably best if multiple bicycle crossings are done simultaneously, in continuous stretches of priority bicycle-stretches. A recommendation from the project is also that a strategy for information - both locally and nationally - should be presented. People has poor knowledge of what a bicycle crossing is. This is confirmed in road-side interviews.

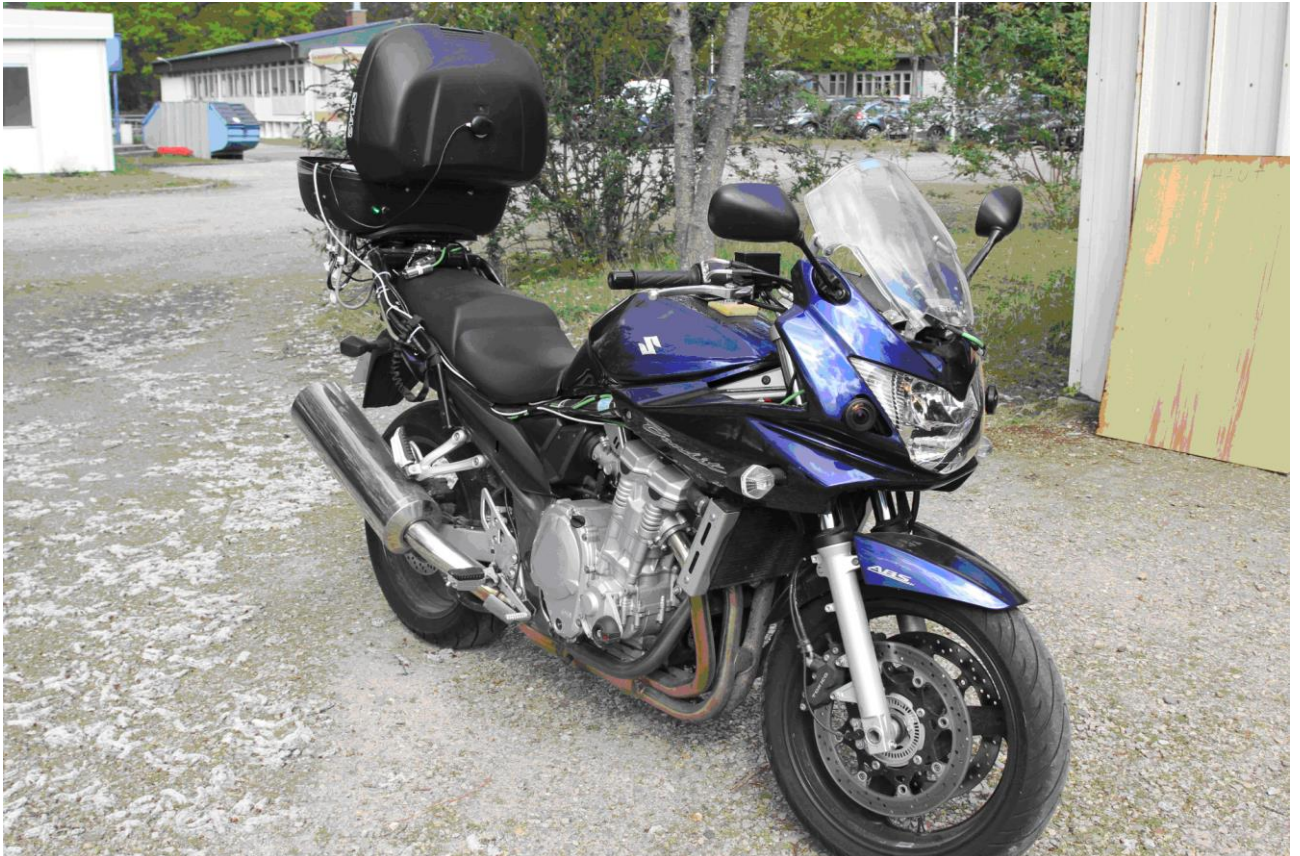
- to gain a deeper understanding of the environment surrounding the motorcycle (cameras);
- to learn about PTW dynamics (Inertial Measurement Unit, or IMU);
- to measure trajectory and speed on a continuous basis (GPS);
- to monitor handlebar controls (data acquisition board).

*Figure 6.136 - The instrumented motorcycle (called MACC)*

The instrumented motorcycle (called MACC) is able to deliver the following informations:

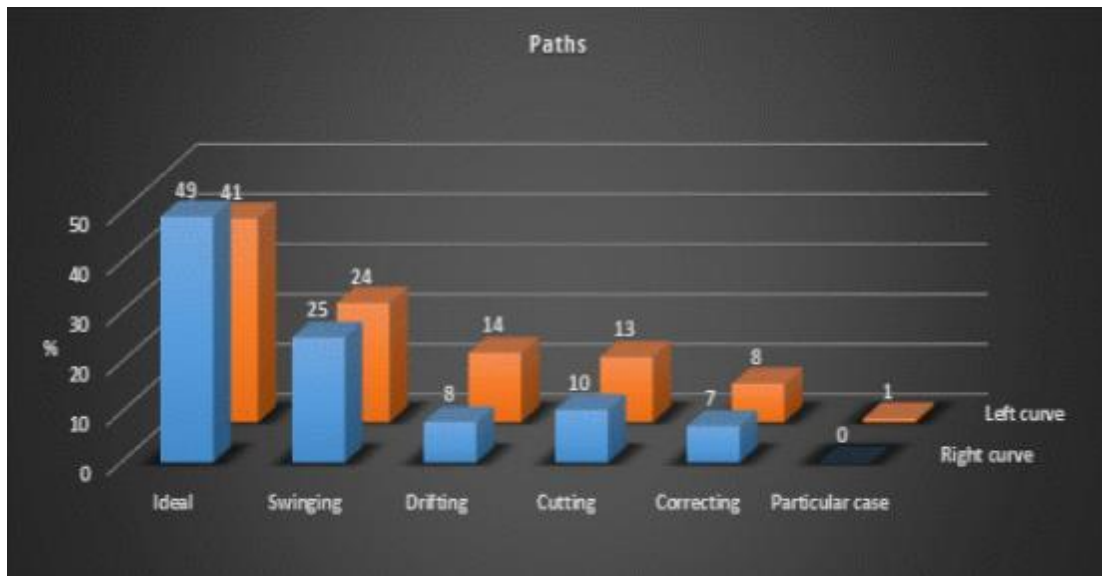
Graph 6.5 - PTW Trajectories according Spacek typology

In terms of trajectories, the study compared bend types and categories and found that the formulae used to determine bend categories (based previously on the car database only) were consistent with results for PTWs and, therefore, that the formula can also apply to PTWs. However, this hypothesis will need to be tested with a statistical study. According to Spacek trajectory typology, the study showed the “ideal trajectory” is the most common with “swinging trajectory”.

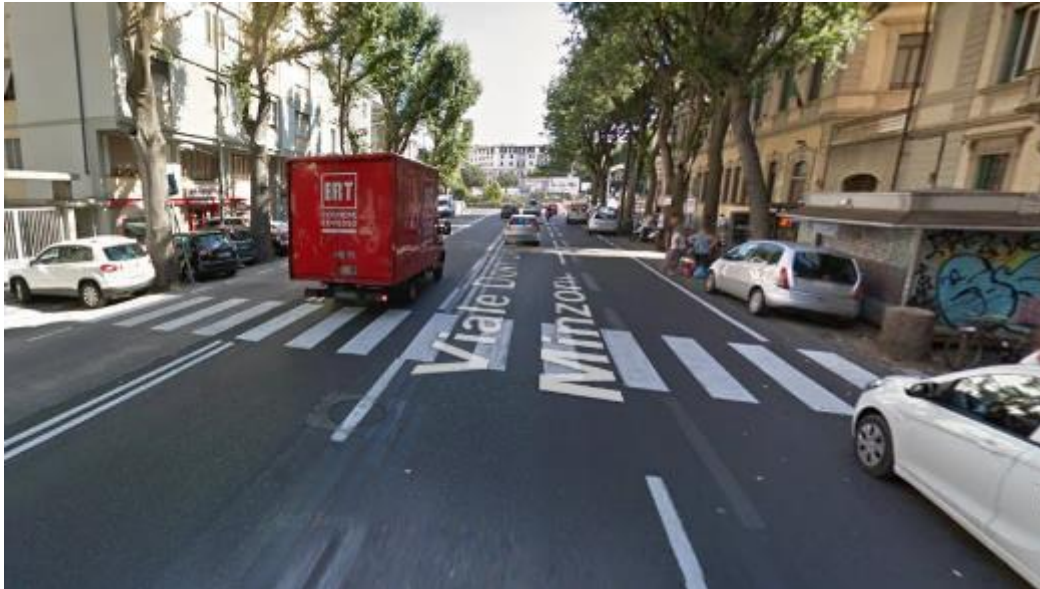
Figure 6.137 – Pedestrian crossing before the intervention [2]

It should also be noted that the crossing didn't have any traffic lights and this is at the expense of pedestrian safety. Furthermore, often pedestrians found themselves hidden behind parked cars (it is difficult to control unauthorized stops, especially if they are carried out for short periods of time) or tried to cross when the traffic flow is blocked, exposing themselves to the risk of accidents involving two wheelers that are surpassing.

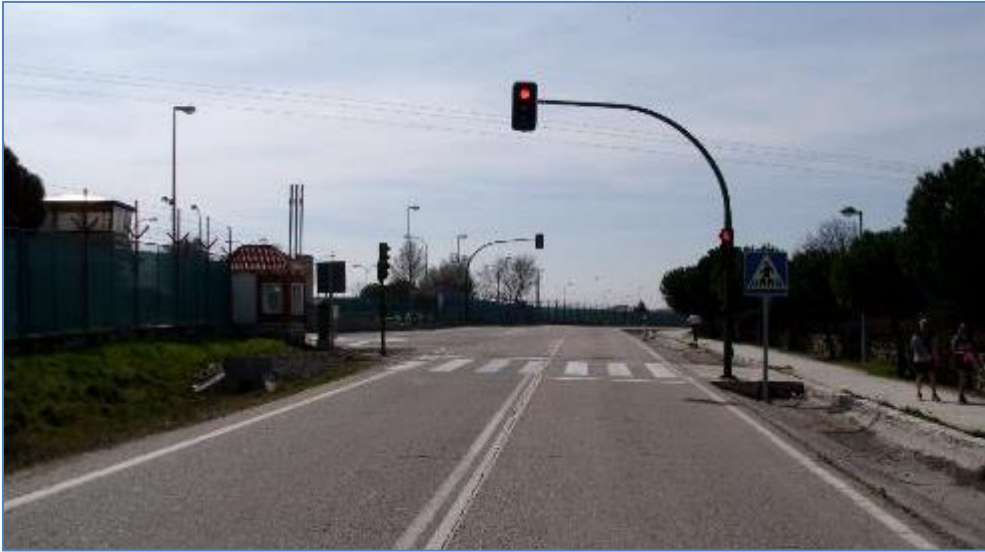
*Figure 6.142 - Pedestrian crossing with traffic lights in an area near a town*

However, various studies of High Accident Concentration Sections identified in the State Road Network have shown cases in which numerous collisions with pedestrians were recorded, despite the provision of adequate signing or the existence of traffic lights.

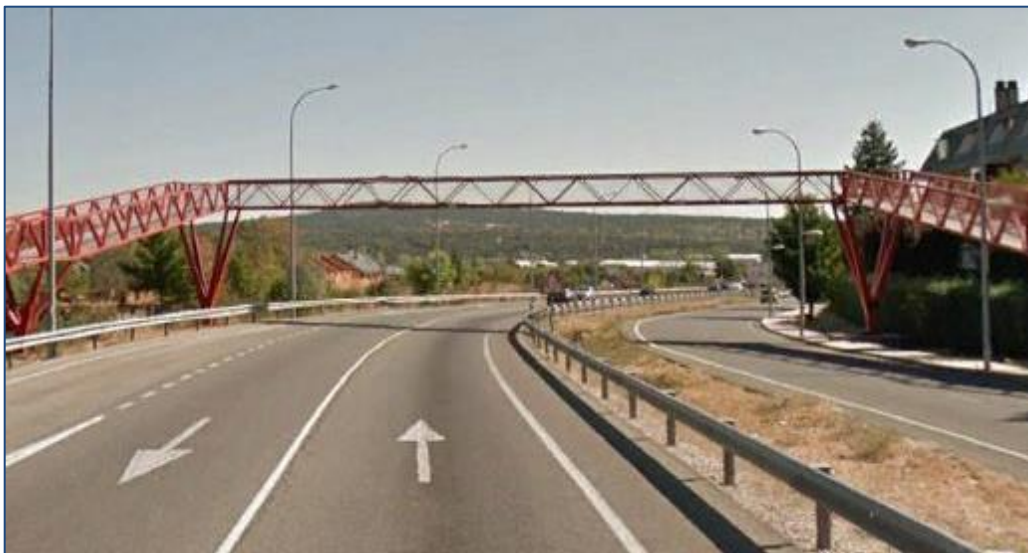
*Figure 6.143 - Example of pedestrian bridge in a population alternative*

- The construction of pedestrian crossings at different levels should be considered as a joint treatment of pedestrian traffic in the road area affected. This involves a joint study for the layout of sidewalks and refuges. And where appropriate, they should be analyzed together with the arrangement of the elements that generate pedestrian traffic in the area, such as bus stops, parking areas, etc.

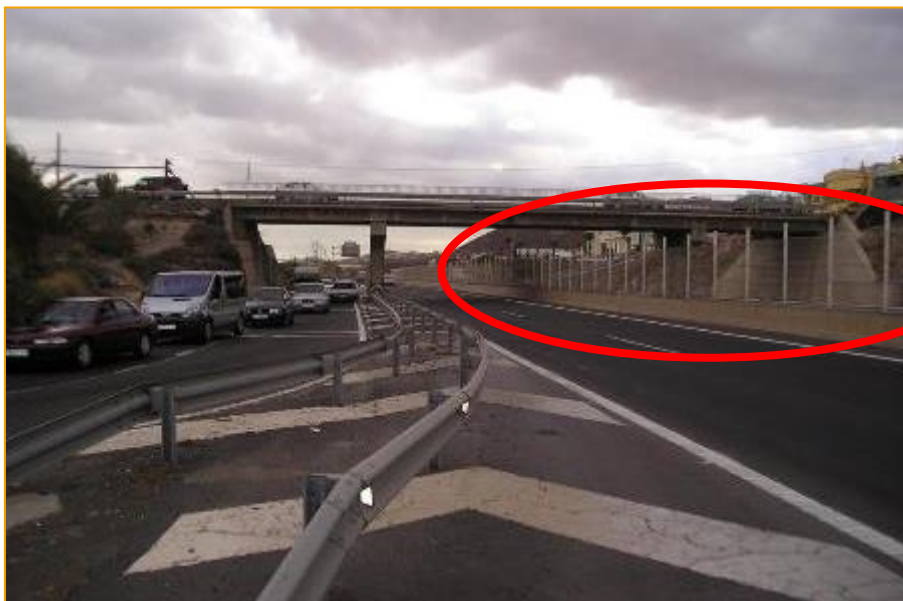
*Figure 6.144 - Example of fence over New Jersey barrier, to avoid pedestrian crossing in an area with overpass*

Pedestrians tend to make their way as short as possible, so in many cases the only effective way to make them use passes at different levels is to physically prevent them. The provision of pedestrian parapets on sidewalks or fences on the roadsides and road medians are the most appropriate measures to force the use of overpasses and underpasses.

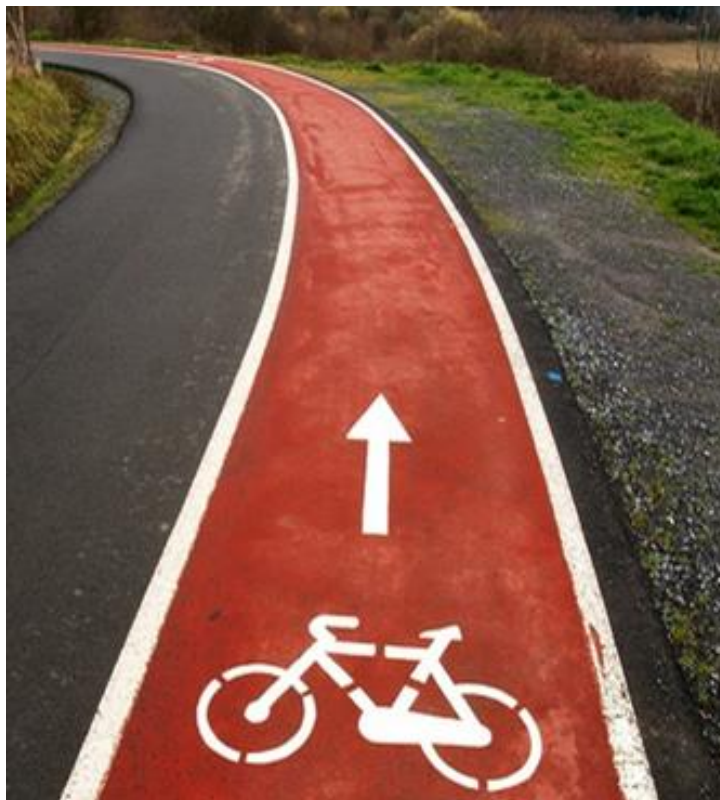
*Figure 6.151 - Example of differentiated coloured pavement and specific road marking in a bicycle path*

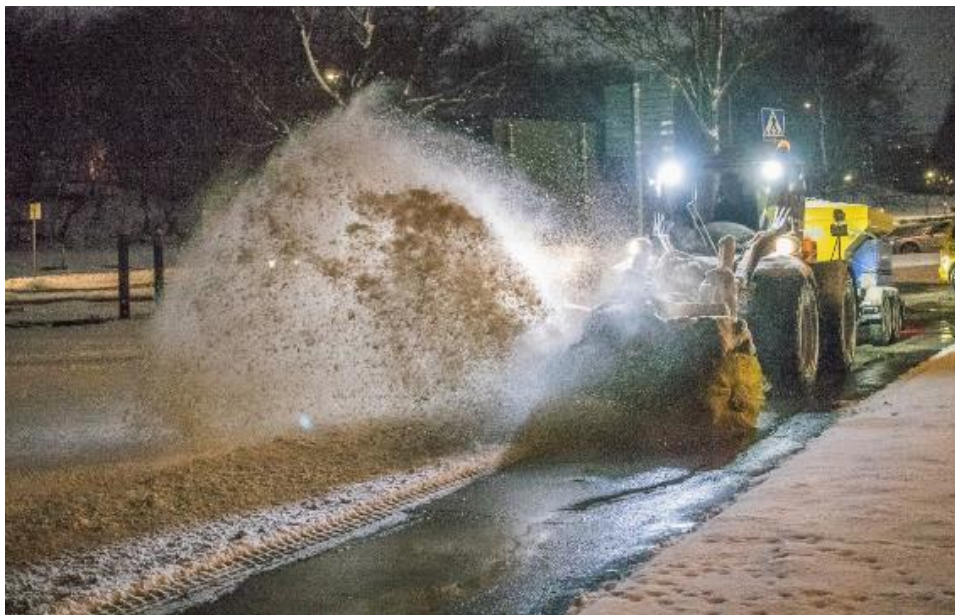
Figure 6.152 - A sweep sweep-salting measure on a bicycle path in Stockholm

Using salt for skid control of bicycle paths could be one way to maintain a high degree of safe mobility for cyclists during winter. In recent years, a method using a front-mounted power broom for snow clearance and salt for de-icing (commonly called “sweep-salting”) has become popular for winter maintenance of bicycle paths in Sweden (). Linköping was the first municipality in Sweden to test the method, already in 1999, within a PhD-project conducted at VTI (Bergström, 2002). The promising results from the tests in the PhD-project encouraged Linköping to increase the use of the method, and they have been applying it increasingly ever since on selected bicycle routes in the municipality. In 2013 the city of Stockholm decided to improve their winter maintenance service level on bicycle paths, in order to promote cycling during winter. Therefore, Stockholm decided to try the “sweep-salting” method and evaluate its potential to improve the service level on bicycle routes for commuting (Niska & Blomqvist, 2016a; 2016b, 2018; Niska, Blomqvist & Järllskog, 2016; 2017). As Stockholm found interest in the method, so did several other municipalities and now (2018), at least 25 other Swedish municipalities have started to practice the method.

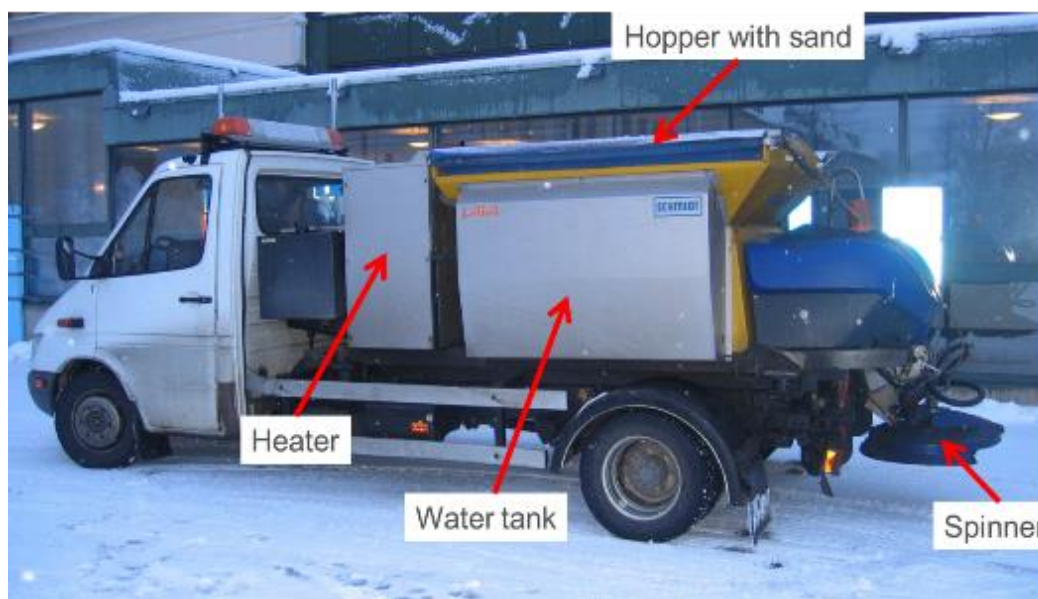
Figure 6.153 - The equipment used for spreading warm wetted sand on walkways and bike paths in Umeå municipality, in Sweden.

Considering the safety of cyclists and pedestrians the winter maintenance service level needs to be improved and there is a need for skid control measures that are effective and, at the same time, reduce the amount of grit spread during the wintertime. Warm wetted sand, a method where the sanding material is mixed with hot water while spreading and where the sand adheres to a cold surface through a process of melting and freezing, could be the solution. In this study, the applicability of using warm wetted sand on walkways and bike paths has been evaluated in Umeå municipality during the winters of 2010/11 and 2011/12. The evaluations comprised measurements of friction, road condition observation and interviews with operators as well as cyclists and pedestrians.

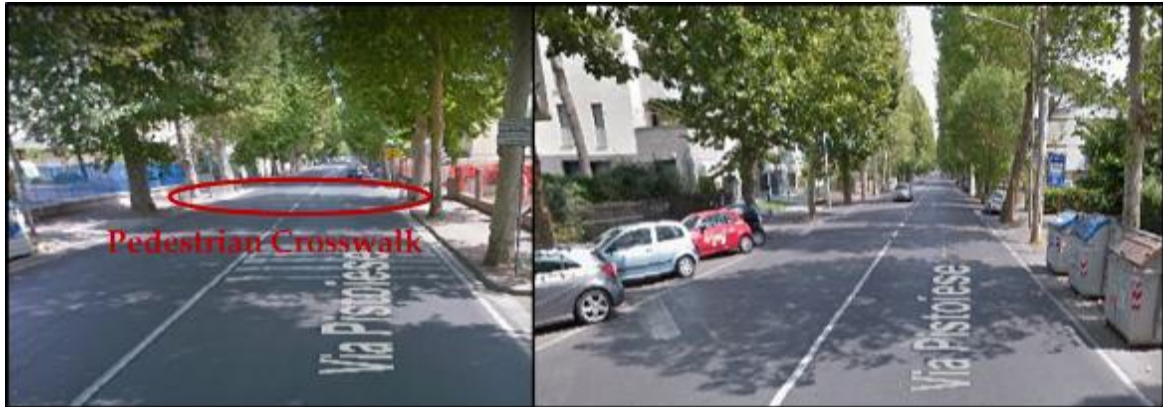
Figure 6.157 - Details of the road before the interventions: on the left, crosswalk with low visibility; on the right, the evidence of wide lanes and long straight. In both cases the trees contribute to move the focal point to the horizon [6].

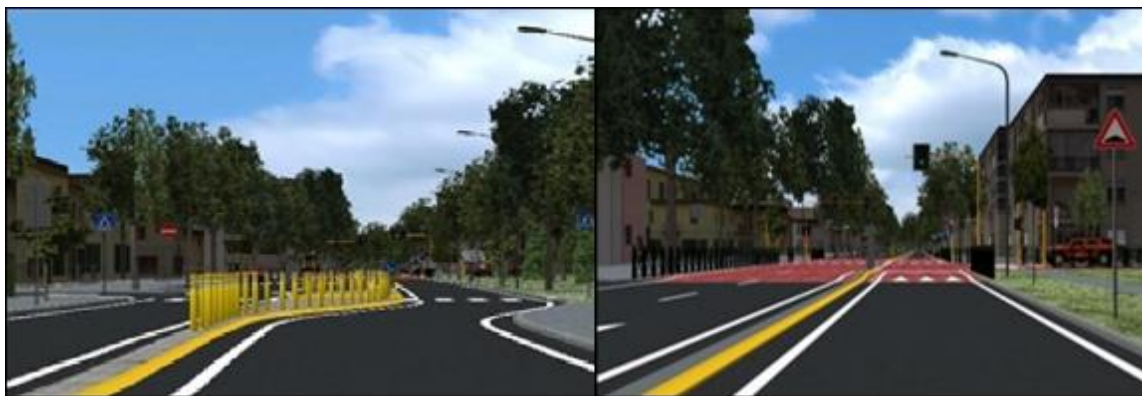
Figure 6.159 - Details of the designed countermeasures: on the left, yellow bollards in a change of the cross section, on the right, a raised coloured intersection. Both the countermeasures capture drivers attention alerting them of a critical point and moving the focal point closer.

- the construction of raised platforms in correspondence of the intersections and at the pedestrian crossings (Figure 6.159);
- the insertion of optical cues to move closer the drivers’ vanishing point, consisting in coloured portions of the roadway in correspondence of the raised intersections and crosswalks and in yellow bollards along the edge of the

roadway at the points where the carriageway in one direction changes its organization from two to one lane (Figure 6.159, Figure 6.161 and Figure 6.162);
