# CATALOGUE OF CASE STUDIES

*Road safety improvements relevant to Vulnerable Road Users, Human Factors and Low- and Middle-Income Countries*

**TECHNICAL COMMITTEE C.2 DESIGN AND OPERATION OF SAFER ROAD INFRASTRUCTURE**

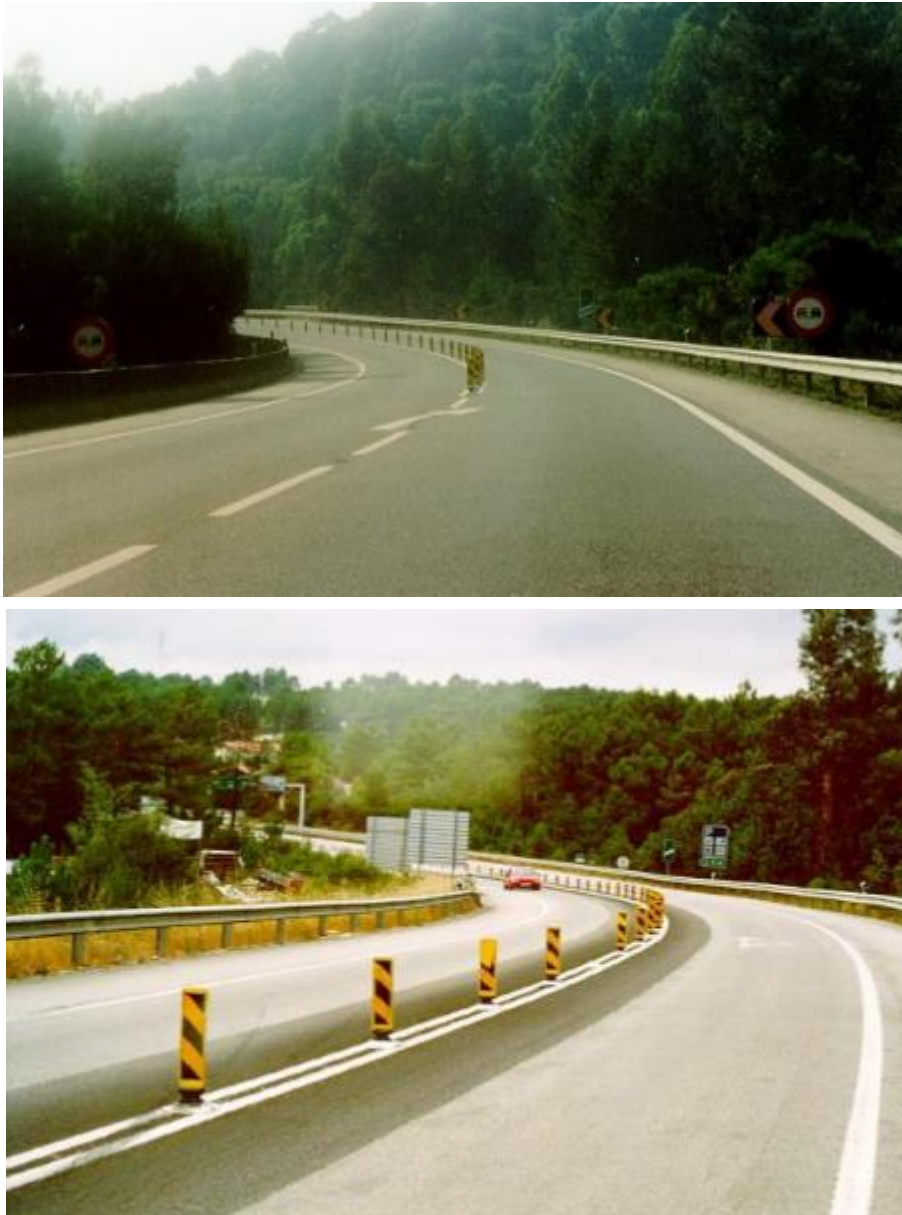
*Figure 6.166 – Visual extension of the median to the beginning of the curve in two interchanges*

The first subset of measures [3] was aimed at improving the operation and safety at the interchanges, which were mostly located at or near horizontal curves, and physical medians shorter than the corresponding curve. This resulted in the sudden and unexpected appearance of the median to unfamiliar drivers. The corresponding late detection of the median triggered head-on collisions on approach zones to these interchanges.

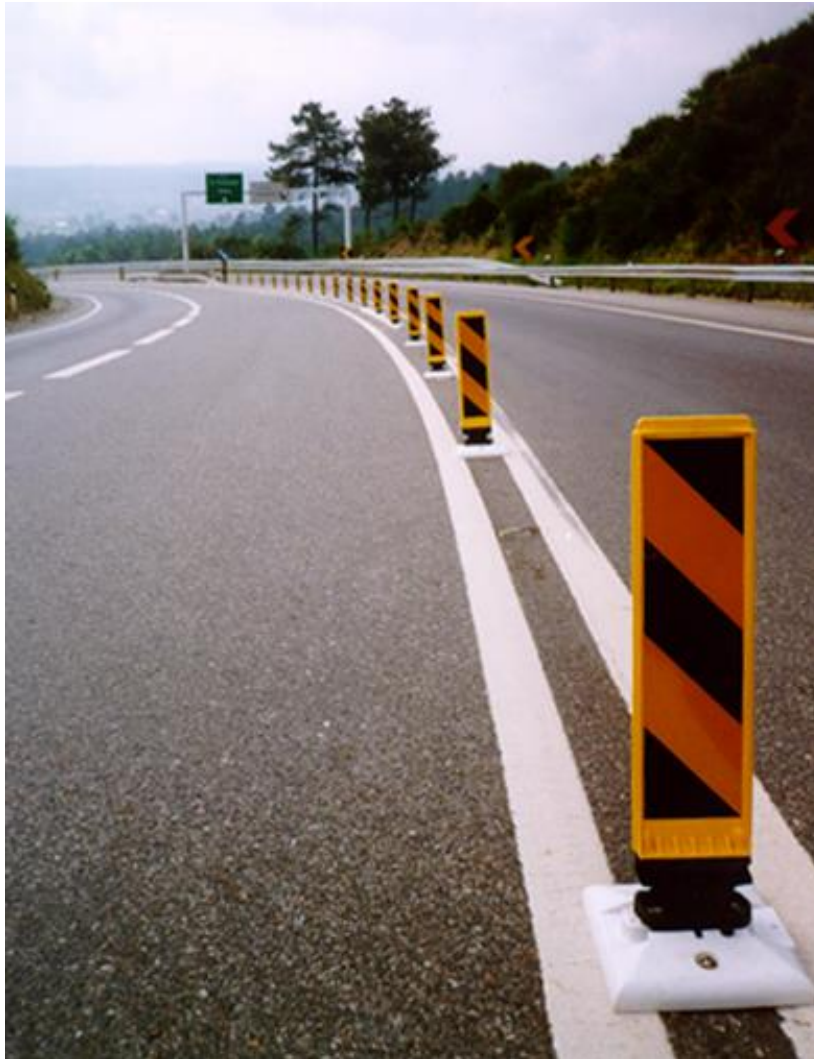
The position marker posts (see Figure 6.167) consisted of an individual base, in white colour, a rubber shock absorber and a vertical plastic blade, with yellow and black stripes (Portuguese permanent signing chromatic criteria). This blade was 15 cm large (equal to the distance between the two longitudinal continuous lines) and 50 cm long and the yellow colour obtained with level 2 retroreflective sheets. The base was fixed to the pavement with expansive screws and two component glue.

Figure 6.167 – Type O7 plastic position marker posts at the road axis

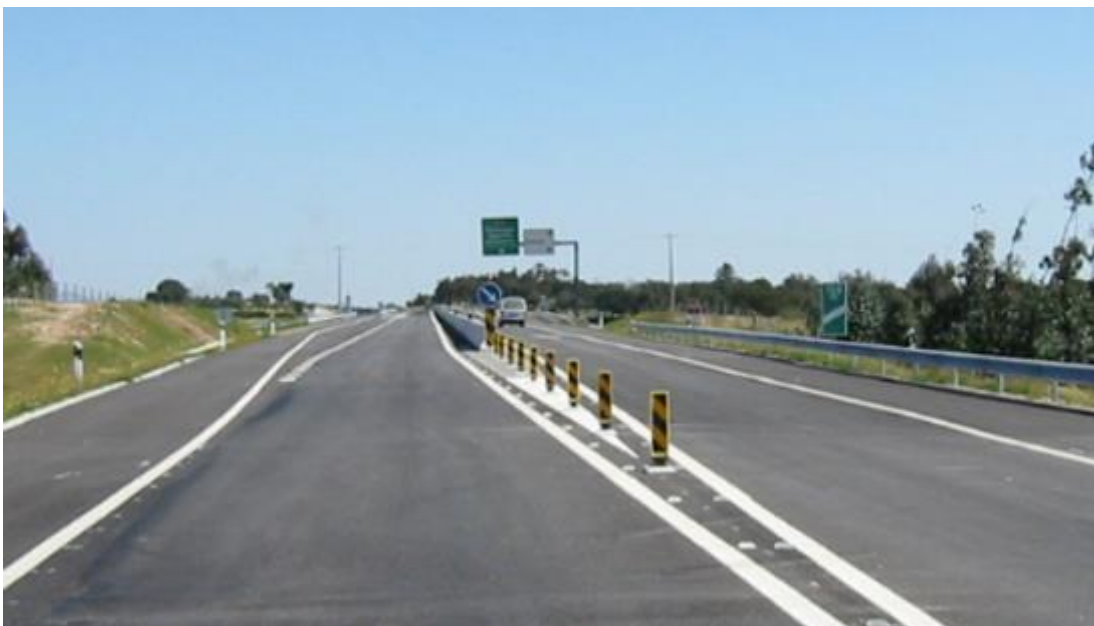
*Figure 6.169 – Inadequate use of plastic position marker posts at the road axis (before a New Jersey or DBA barrier from which the traffic is not protected due to the absence of an appropriate terminal)*

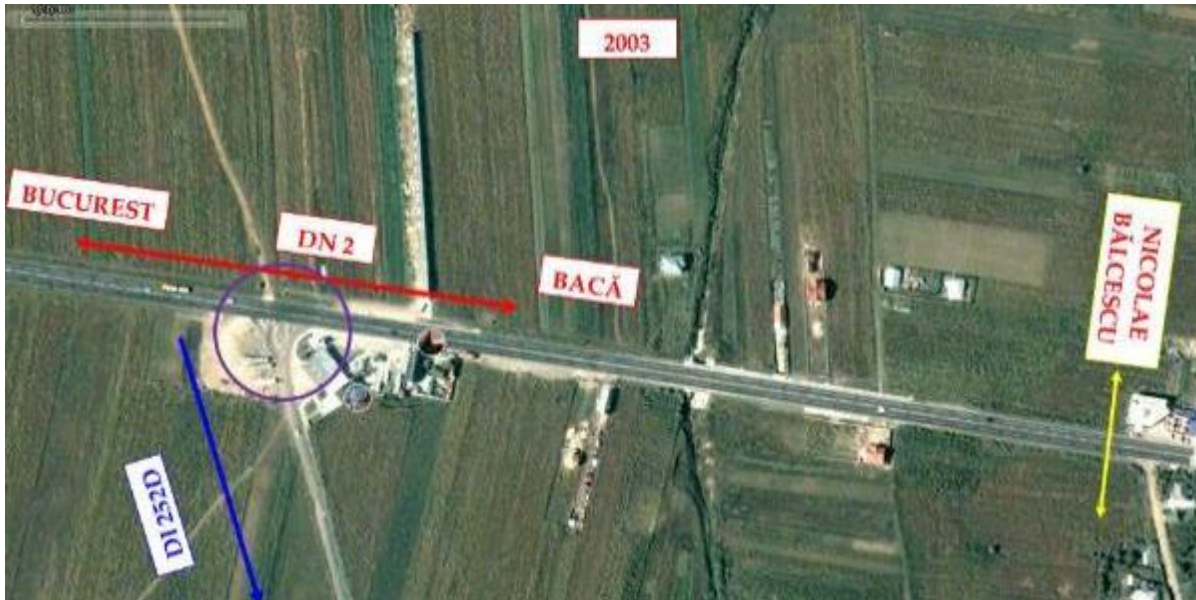
Figure 6.170 – General view of the site before the intervention

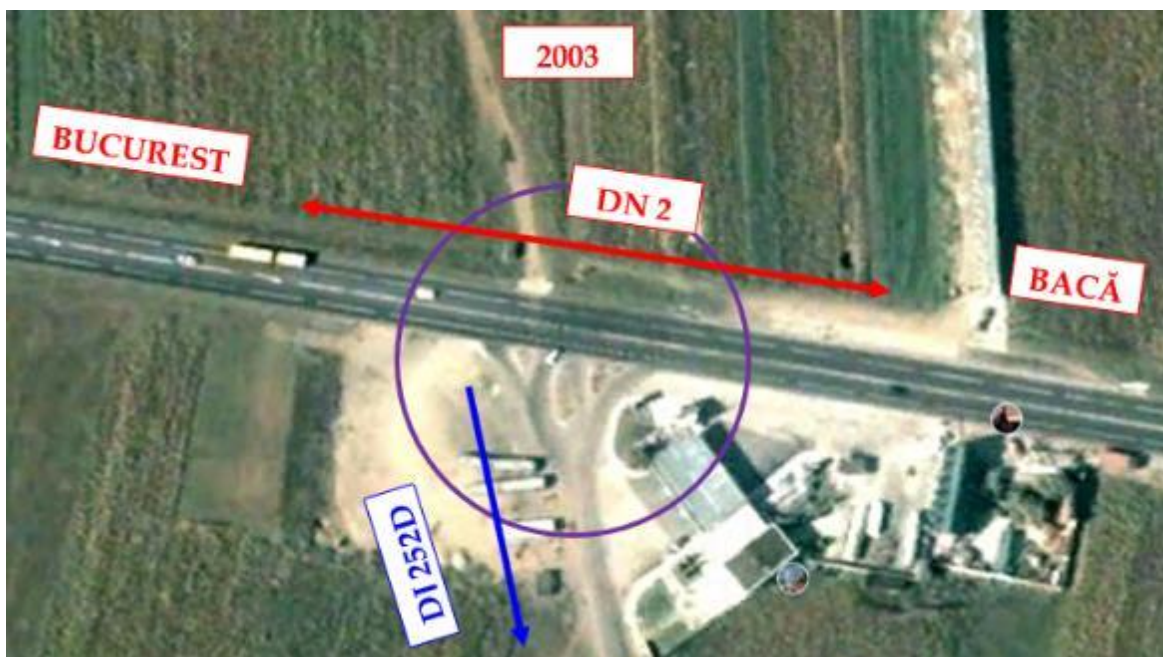
Figure 6.171 – Detailed view of the site before the intervention, zoomed

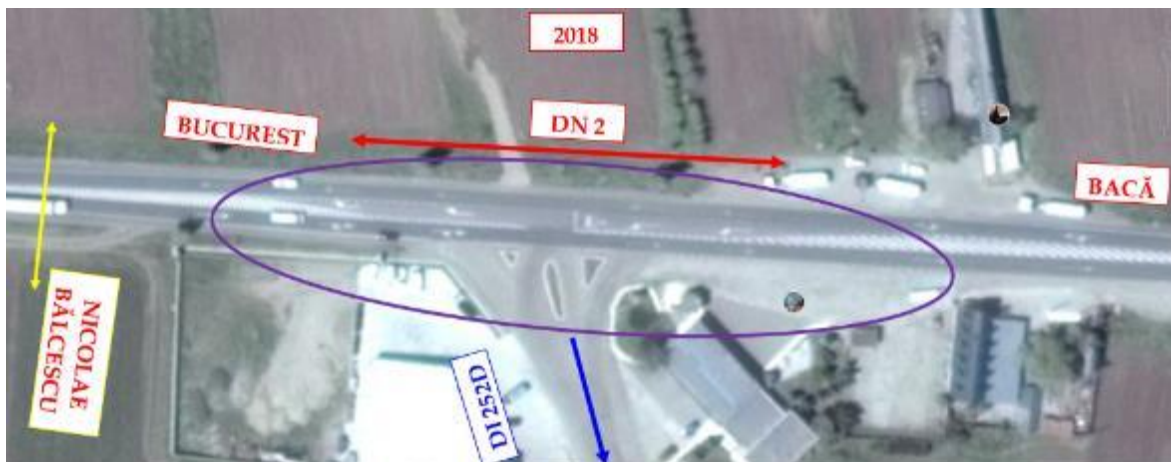
Figure 6.173 – Detailed view of the site after the intervention

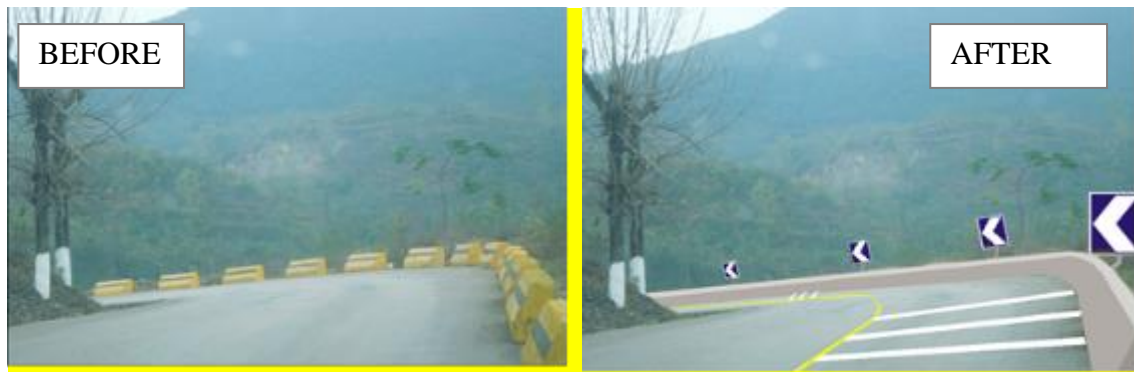
Figure 6.180 - The above two figures are comparison of before and after the implementation of security countermeasures

3 Through the risk assessment model to calculate the risk value of the section before and after the implementation of safety measures, it was found that after the project was implemented, the risk value of the section decreased significantly, and the risk level changed from the most dangerous 5 levels to medium 3 levels.

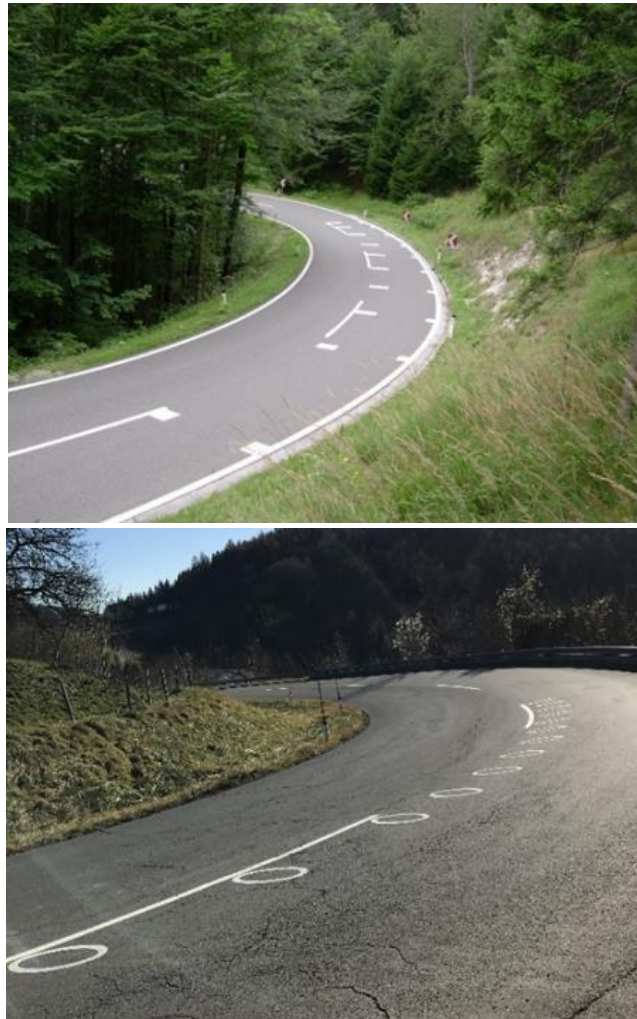
Figure 6.182 - a) “bar” (or “psychological brake”) layout, b) elliptic design

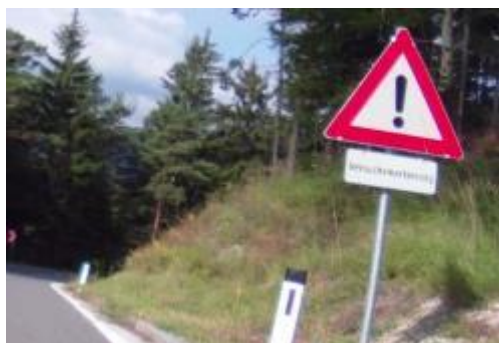
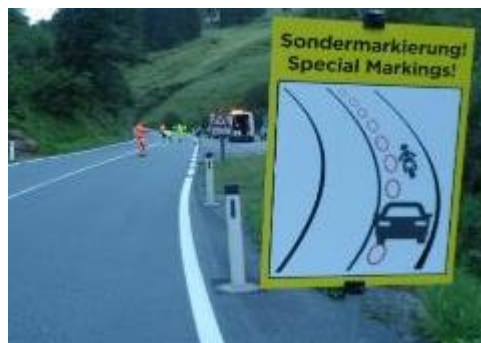
Figure 6.185 - a) simple warning sign, b) informative sign

For safety reasons, some of the road administrators insisted on the use of warning signs.

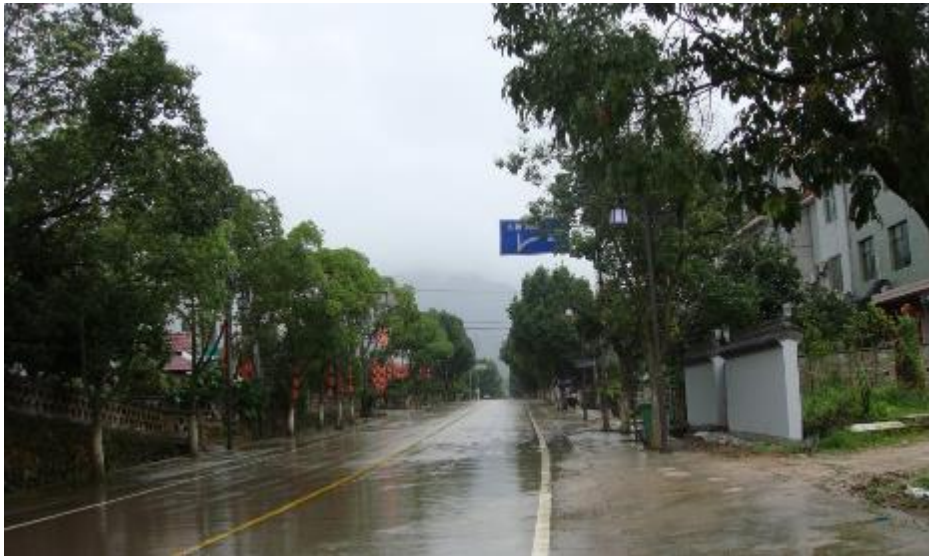
It is a two-lane highway with lots of non-motor vehicles and pedestrians connecting the village of Sanren and Haochuan. The speed of vehicles is fast. According to the previous data, from 2014 to 2016, there was at least one fatal accident between car or light truck and the pedestrian. There was a yellow line in the center of the road, as shown in Figure 6.198.

*Figure 6.198 – The yellow center line before implementation*

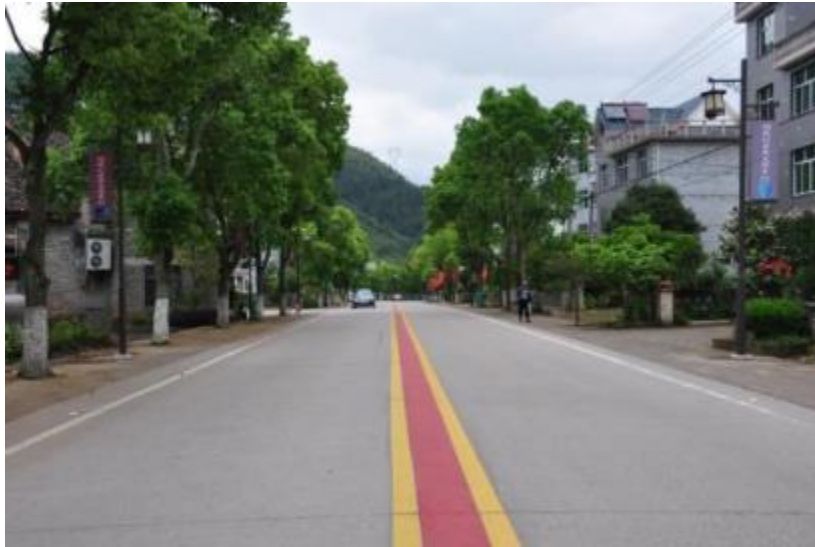
- Road marking are used to paved roadways to provide guidance and information to drivers and pedestrians. In this case, the road center marking has been formed from a single line to a colour wide solid line, as shown in Figure 6.199. Set up street lights to improve the lighting environment for driving and walking at night. After the laying the colour solid center line, the width of the lane was narrowed from 4 meters to 3.5 meters. The size of the center line is 20x100x20cm, as shown in Figure 6.200. The driver will slow down for a better visual field when driving in narrow lanes.

Figure 6.199 – The new color wide solid line in the middle of the road

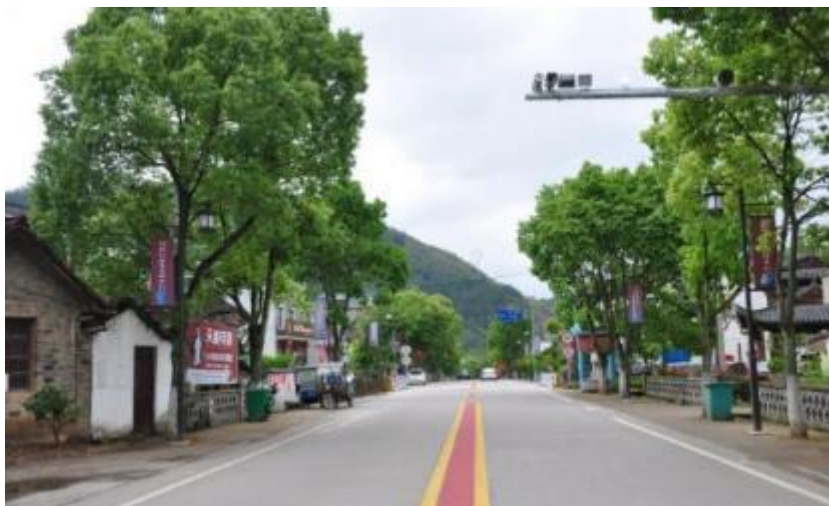
- Set up a snapshot system to monitor the speeding, overtaking and other violating behaviours, as shown in Figure 6.201.

Figure 6.201 - the camera and road monitoring system

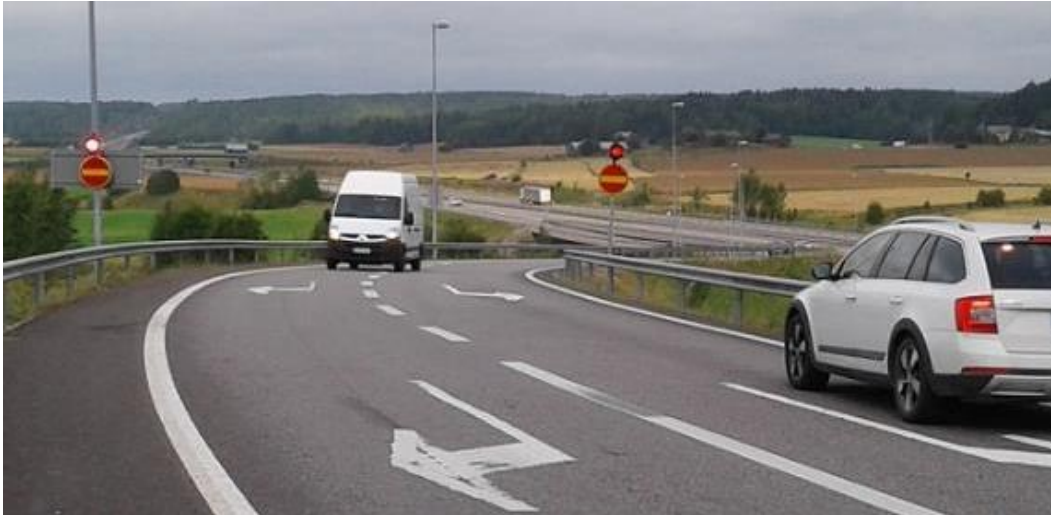
*Figure 6.204 - The most significant system developed in the new project was a warning light that turns red if a driver is about to take a motorway ramp in the wrong direction. Photo: Jaakko Klang*

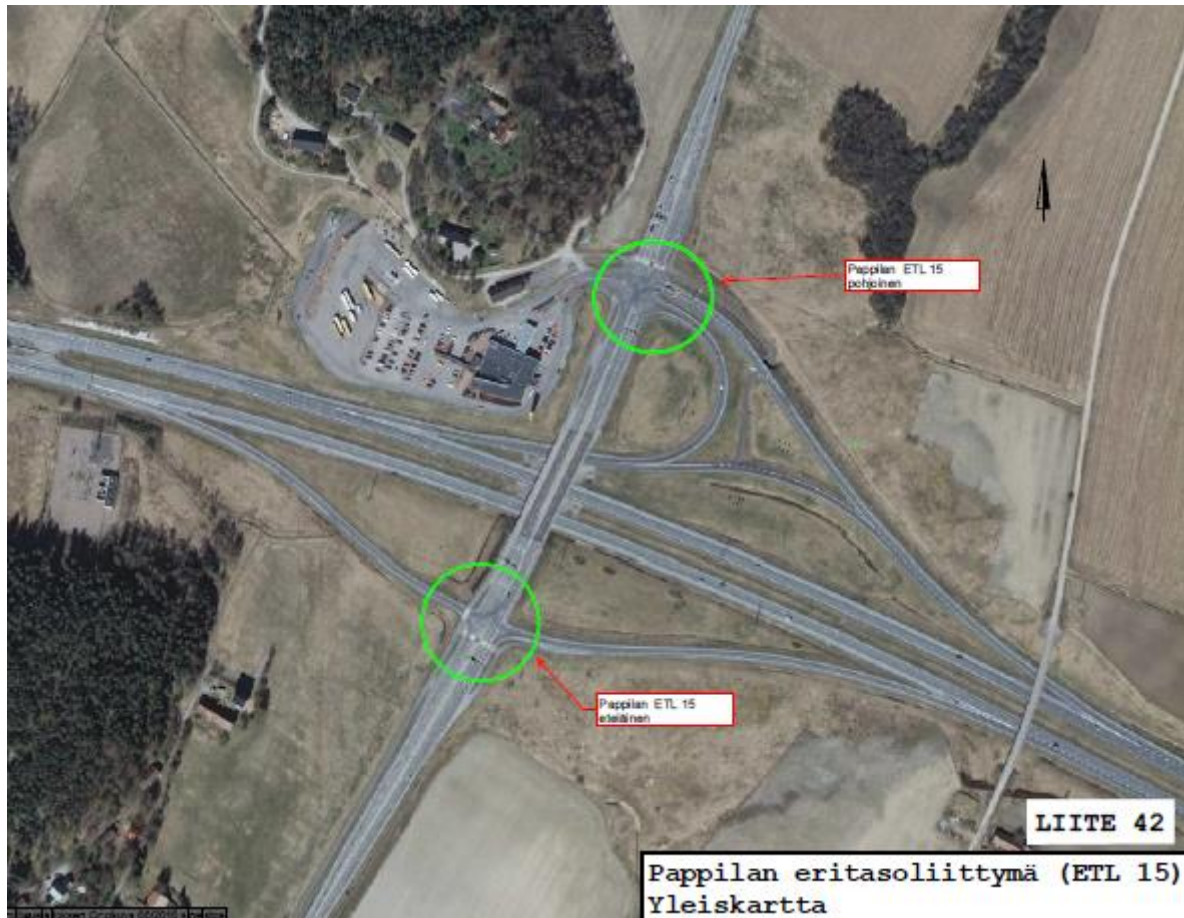
Figure 6.205 - The northern ramp of the Pappila grade-separated interchange. The picture is copied from the construction plan vicinity map: Pappila grade-separated interchange 15, north; Pappila grade-separated interchange 15, south; Pappila grade-separated interchange (ETL 15); Vicinity map

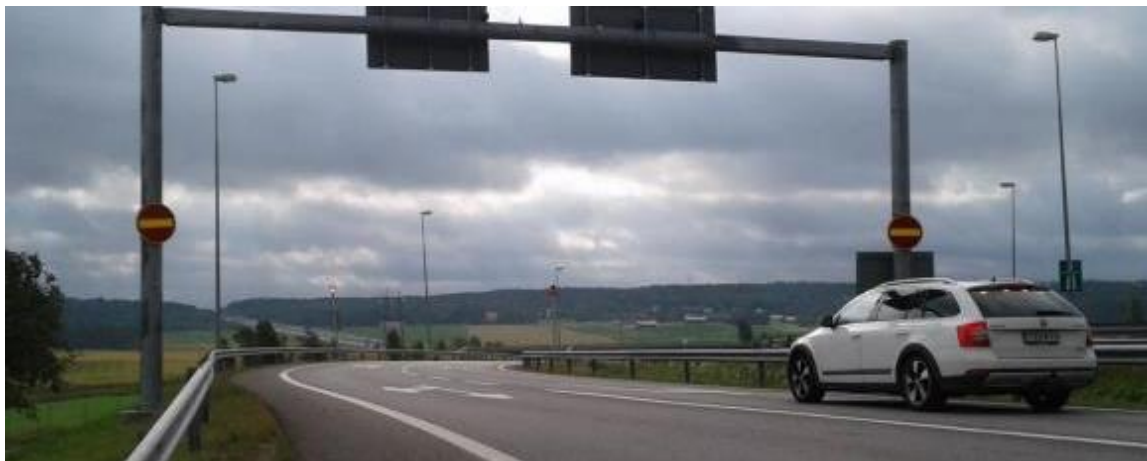
*Figure 6.207 - The most significant system developed in the new project were warning lights that turns red if a driver is about to take a motorway ramp in the wrong direction. Photo: Jaakko Klang*

The warning lights have worked very well. With the exception of a few malfunctions, there have been no cases in which drivers have driven in the wrong direction on an experimental ramp without turning around after seeing the red light. According to several eyewitness reports, two cars started to go in the wrong direction on the Halikko ramp in 2017, but they turned around no later than when the red warning lights flashed. After the construction and installation work was completed, 27 observation visits were made to the location under study, and the equipment worked each time.

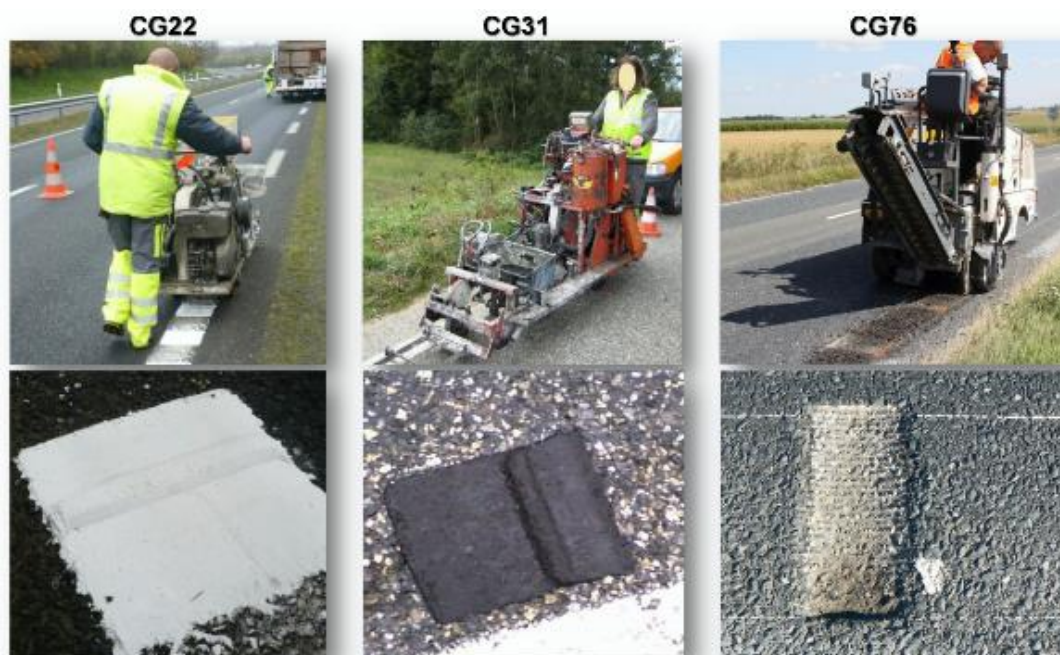
Figure 6.208 - Pictures of implementation of the raised or milled rumble strips for the in situ evaluation. Picture at left: view of the implementation of raised rumble strips for the divided highway in Côte d'Armor (Department 22, France). Pictures at centre: views of the implementation

of raised rumble strips of colour pavement in Haute-Garonne (Department 31, France). Picture at right: views of implementation of milled rumble strips in Seine-Maritime (Department, 76, France).

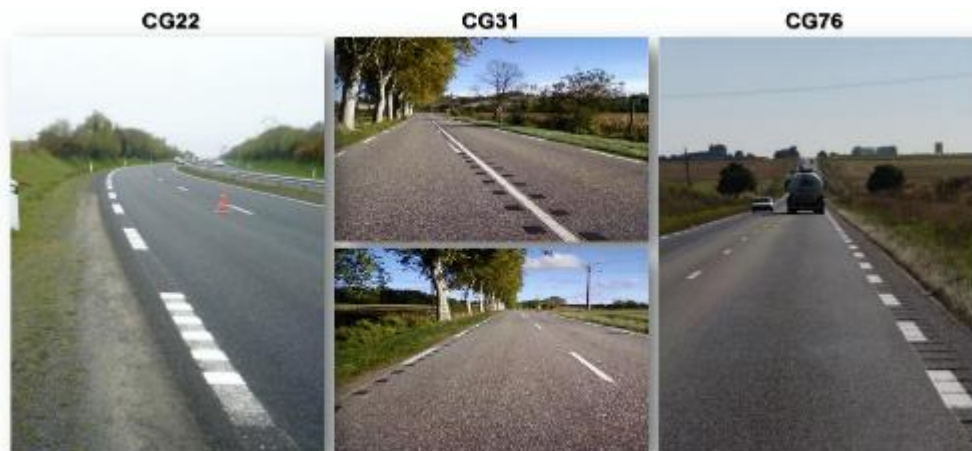
Figure 6.209 - Pictures of implemented raised or milled rumble strips for the in situ evaluation. Picture at left: view of the implemented raised rumble strips on the bend for the divided highway on the dotted road marking of shoulder, in Côte d'Armor (Department 22, France). Pictures at centre: views of the implemented raised rumble strips of colour pavement, at upper, raised rumble strips were implemented from either side of centreline marking on the dotted road marking. At lower, they were along the left side of shoulder markings in Haute-Garonne (Department 31, France). Picture at right: views of the milled rumble strips were shoulder rumble stripEs (i.e., marking is placed over the rumble strips) in Seine-Maritime (Department, 76, France).

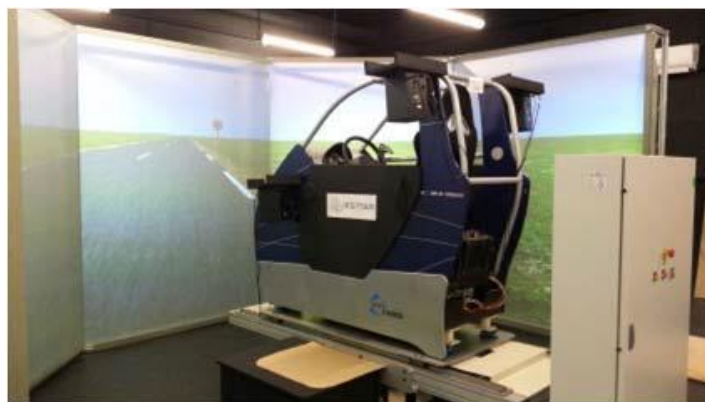
Figure 6.211 - View of the fixed-base driving simulator (copyright Ifsttar, 2012)

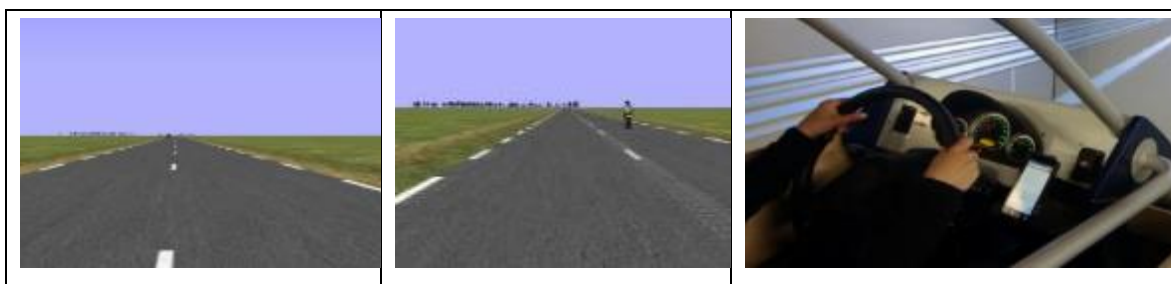
Figure 6.212 - Views of the three driving situations. At left, the reference situation without traffic. At centre, the overtaking of two powered wheels. At right, SMS writing: word “juin” (copyright Ifsttar, 2012)

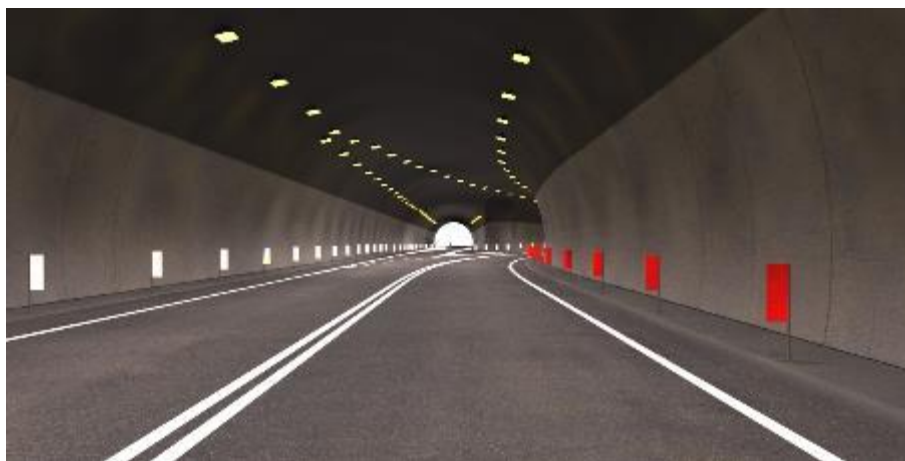
*Figure 6.213 - Reconstruction of the tunnel internal view without visual obstacles at the entrance of the secondary road*

The entrance to the tunnel that serves the secondary road is visible to those who proceed on the main road in northbound direction and is almost perfectly aligned with the straight that the drivers travels before the right bend. The external light defines the entrance even better, making it a focus point for drivers attention (Figure 6.213). This causes an operational problem: drivers who are proceeding northbound are led to believe that the tunnel, and therefore the road, proceed straight, while the main road provides a curve to the right. It is an optical illusion. The consequences of an incorrect perception of the track are mainly of two types: possible speeding, as the road appears straight to the user and this leads him to accelerate, or wrong manoeuvres such as sudden changes of direction, as soon as the presence of the bend becomes clear, with possible loss of control of the vehicle.

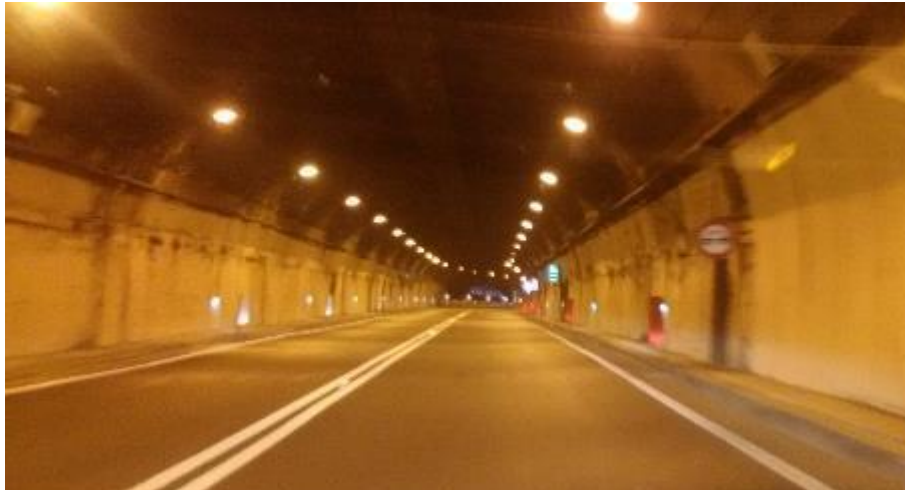
*Figure 6.214 - Tunnel internal view with visual obstacles at the entrance and interection of the secondary road*

Currently the secondary road has been closed to traffic (Figure 6.214), but the goal is to open it again to the traffic, without let this having a negative impact on road safety.

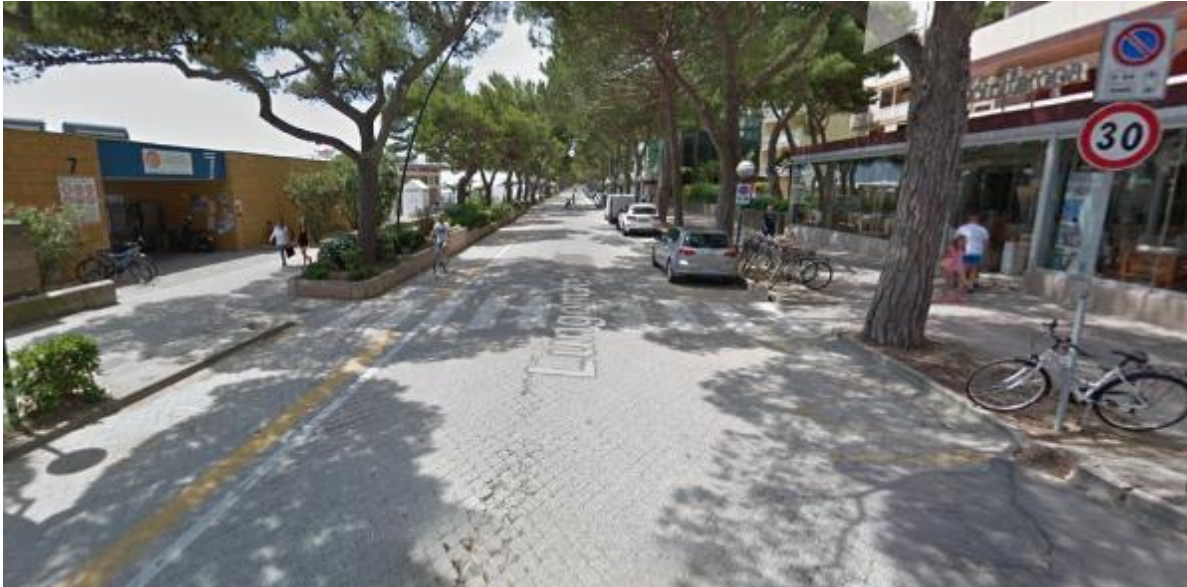
*Figure 6.218 – Road view before the intervention [4]*

Considering the problem from a Human Factors principles point of view [1], there are many factors which seems to be the causes of such behaviour. First of all, the conformation of the road itself, that was a quite monotonous straight with two lines of trees, one on each side of the road, that bring the focal point of the drivers to the horizon: this has the double effect of induce the driver to give less attention to critical driving challenges closer to him (i.e. pedestrian crossing) and to speed up because of the sense of a larger space available. Trees, together with parked cars, can also hide

pedestrians waiting to cross the road or cars coming from the other roads. Furthermore, the standard zebra crossing seemed to be not enough visible from the required distance. Finally, the road section was composed by the cycle path, the travel lane and parking lots lane, with a travel lane of about 4.5 m wide. Such a width can cause speeding [2].

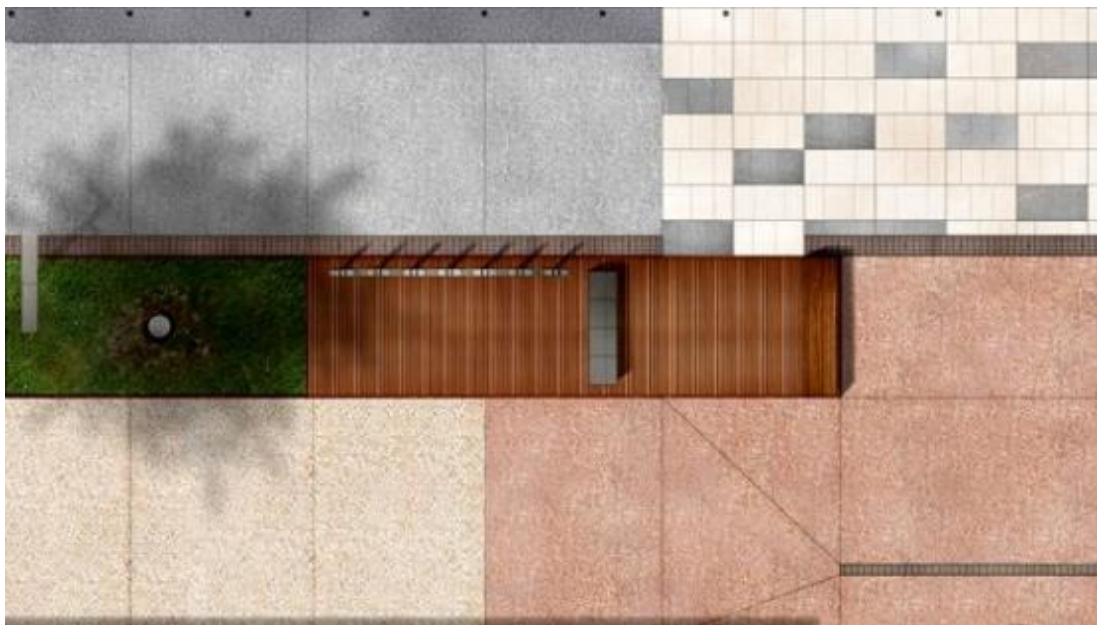
*Figure 6.222 – Detail of the junction between the cycle path and raised pedestrian crossing (square) [5]*

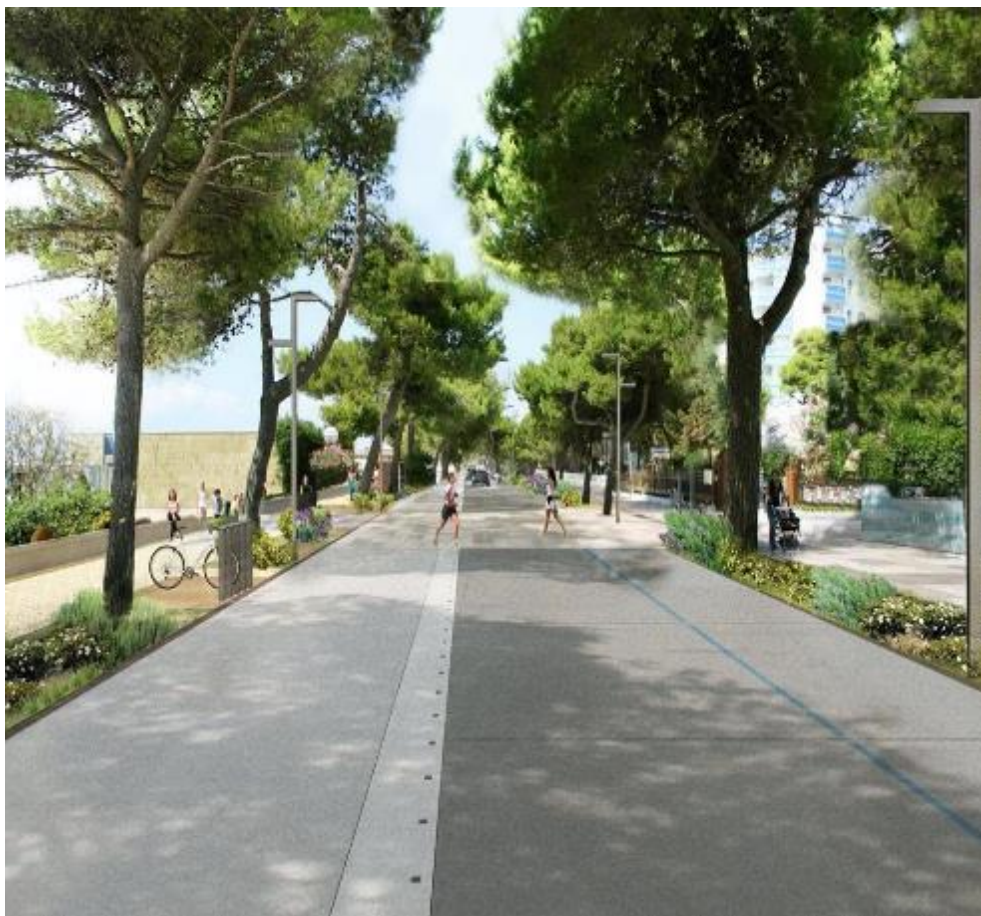
*Figure 6.223 – Reconstruction of the road environment view [5]*

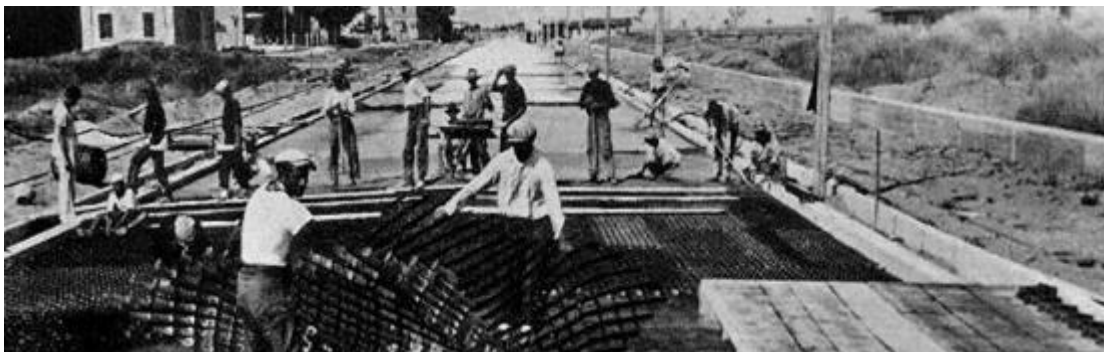
*Figure 6.224 – Construction of original road paving*

A portion (about half of the whole street) of the road paving, originally made with a particular technique that included the insertion of a rhomboidal metal mesh into the concrete casting, was redesigned and executed in order to reproduce the same surface.

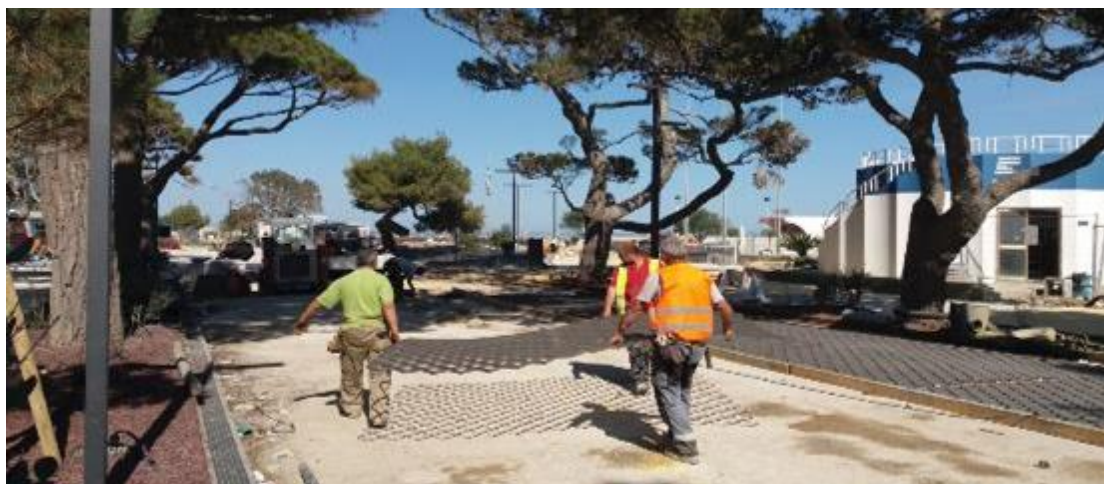
*Figure 6.225 – Reconstruction of road paving*

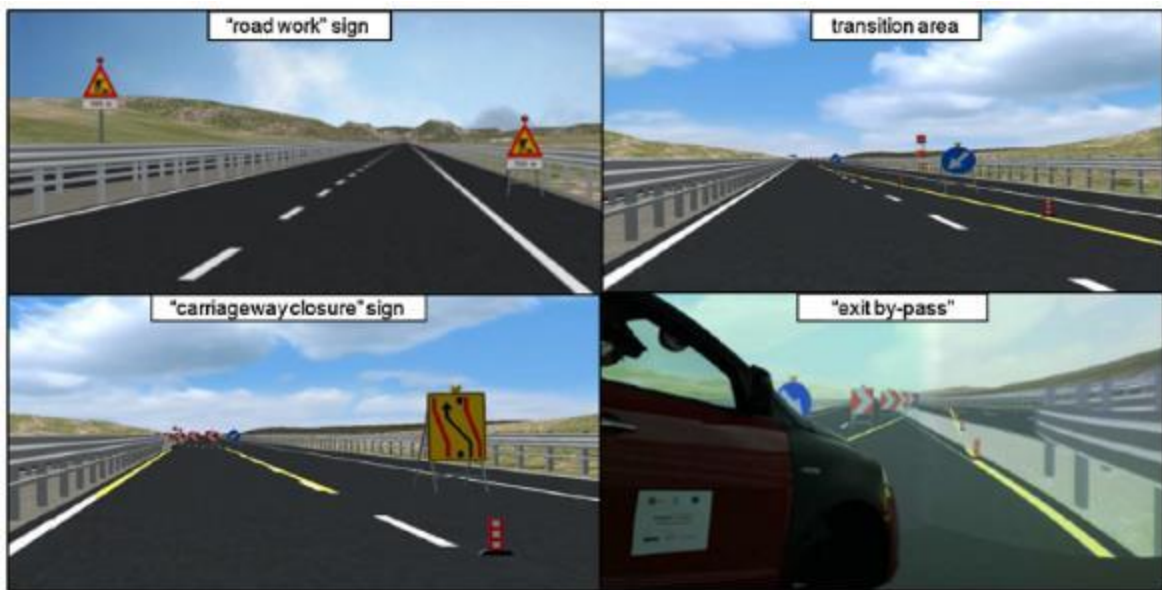
Figure 6.228 - Images of the main parts of the crossover.

The study considered a work zone in a dual carriageway motorway with two lanes in each direction. An entire carriageway has been considered closed and this requires the opening of a gap to divert the traffic of the obstructed carriageway on the adjacent one. Such a work zone has an organization that includes a first part (part 1) in which the user is alerted to the presence of the work zone, a second part (part 2) in which the traffic is diverted to the innermost lane, a third part (part 3) where

the traffic is diverted to the other carriageway and a fourth final part (part 4) in which the traffic is guided back in the carriageway interested by the intervention (Figure 6.228).

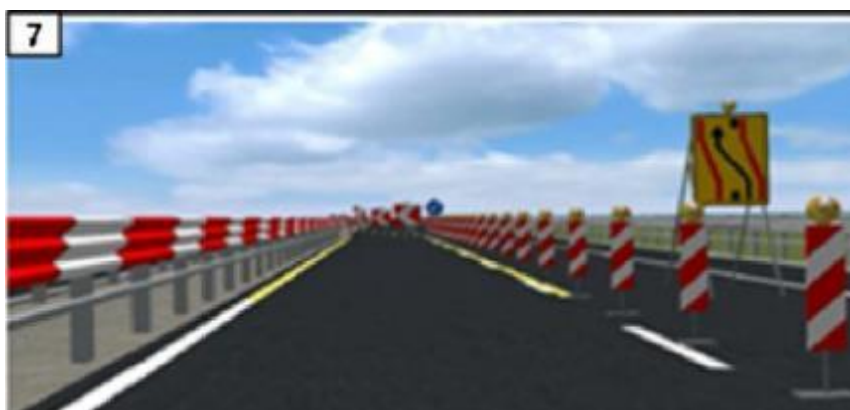
Figure 6.230 - Configuration "7"

The configuration that led to the best results is the "7" configuration: the one in which the median barrier was colored with white and red alternating stripes, similarly to the delineators placed on the outer edge of the lane, as shown in Figure 6.230.

The colour of the traffic barrier, combined with the taller and denser vertical delineators, produced the greatest speed reductions within the warning zone (part 1) and the transition zone (part 2) with a decrease of the average speed of 6-7 km/h in the segment between site B and site F (Figure 6). In the same configuration a slight variation of the average decelerations and a reduction of the maximum deceleration value ( $-0.66 \text{ m/s}^2$  instead of  $-0.81 \text{ m/s}^2$ ) in the transition area was also observed. Finally, a greater homogenization of the speeds within the work zone area is observed

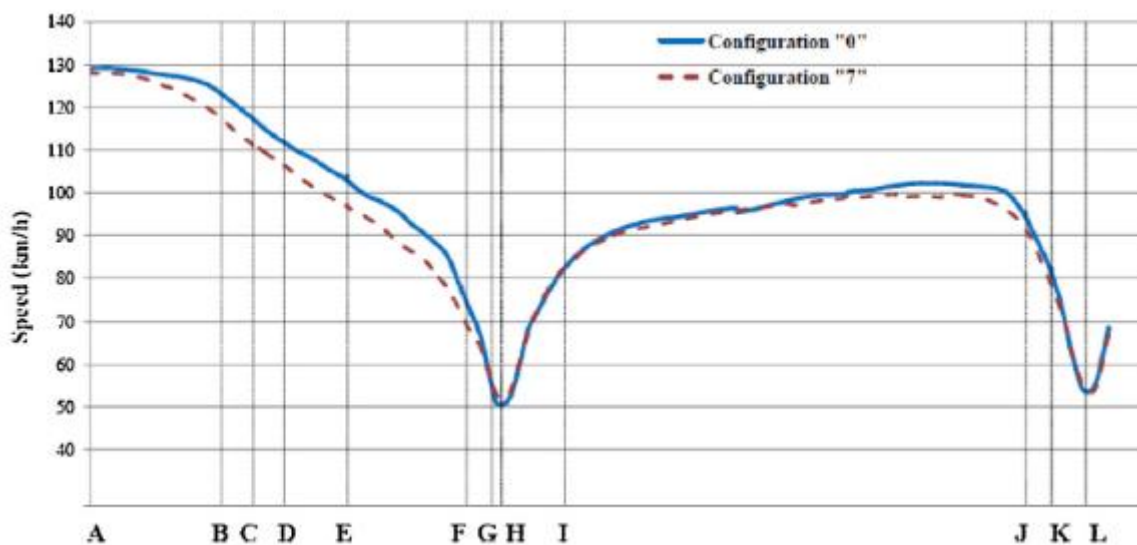
Figure 6.231 – Comparison between average speed of standard configuration “0”, and configuration “7”

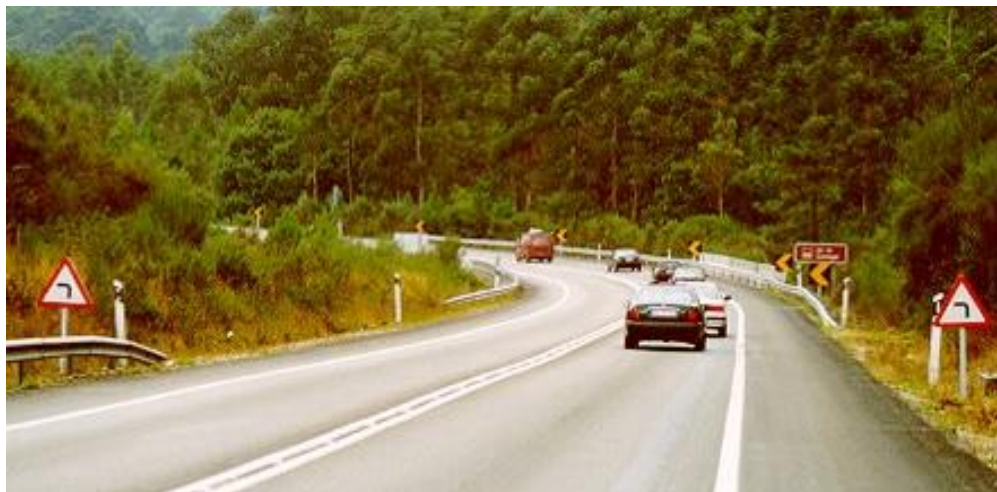
Figure 6.237 - Curve signing with danger warning and chevron alignment signs

- Signing of curves throughout the route section with a unique criteria, similar to the one proposed in Work Package-6 of the SAFESTAR Project, and the application of a rough slurry-seal wearing course at all curves with radii equal or lesser than 300 m – this intervention included 15 curves (see Figure 6.237);

Sharp horizontal curves ( $R \leq 300$  m) were treated with advance warning and chevron signs (see Figure 6.237). Chevrons were located so that the driver could see three chevrons at any moment (before the curve and all along the curve until the change in alignment eliminated the need for the signs – Figure 6.239), to correctly evaluate its curvature and have continuous guidance along the curve.

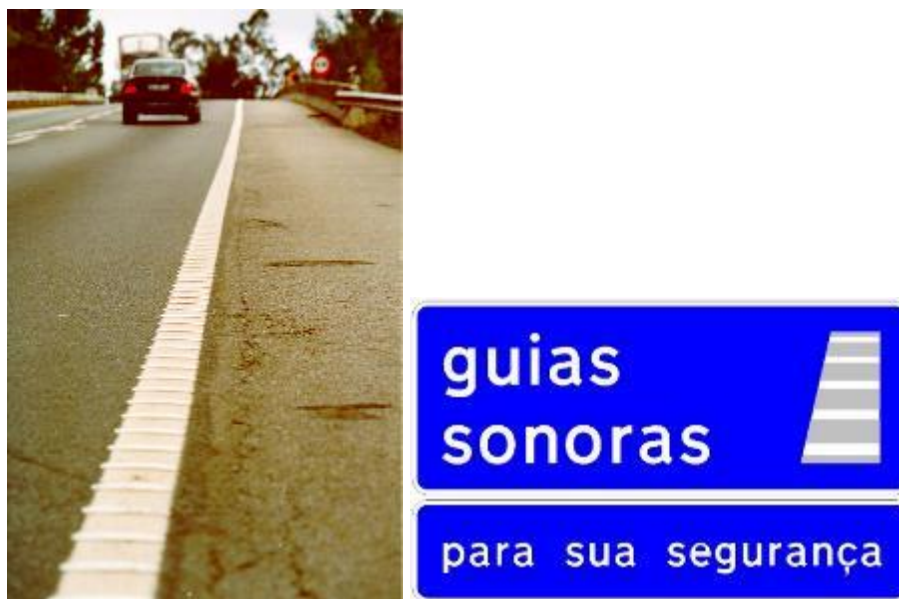
Figure 6.238 - Edge rumble lines and corresponding information sign

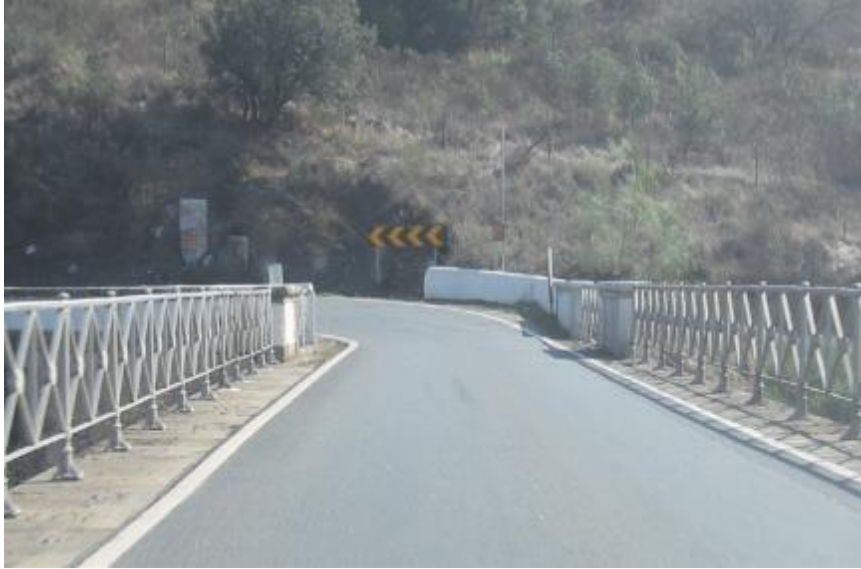
*Figure 6.243 - Example of an existing Class D curve*

Figure 6.243 shows signing of a Class D curve, just after an old bridge in a national road in Alentejo. The application of LCEM resulted in better curve negotiation performance (for both light and heavy vehicles) and in a considerable reduction in the number of vehicles running on the inside shoulder. Before-after studies allowed to observe more uniform distribution of the trajectory transversal positions (namely in curves) with these LCEM [8].
