# CATALOGUE OF CASE STUDIES

*Road safety improvements relevant to Vulnerable Road Users, Human Factors and Low- and Middle-Income Countries*

**TECHNICAL COMMITTEE C.2 DESIGN AND OPERATION OF SAFER ROAD INFRASTRUCTURE**

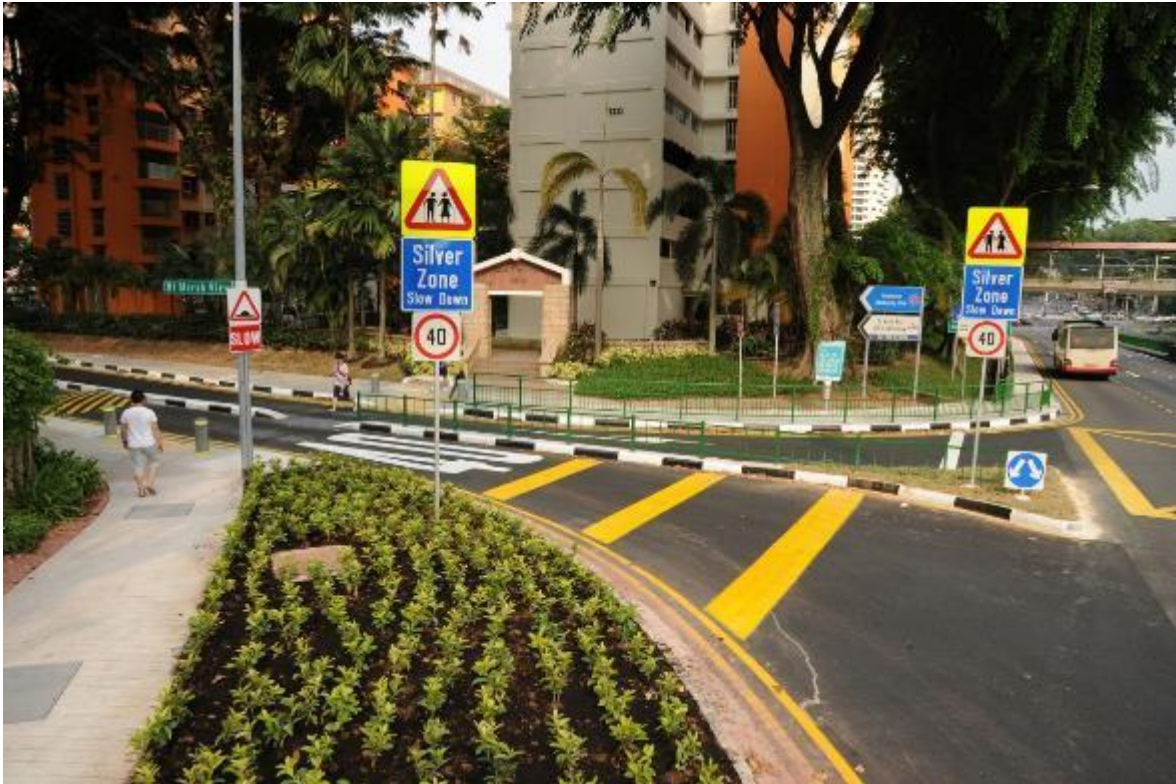
- Silver Zone gateway treatment with signage and road markings to inform motorists that they are entering into a special zone and to look out for pedestrians. Yellow color is used to catch driver attention and the gateway layout inform drivers that they are entering an area that differ from the rest of the road.

*Figure 6.244 – Silver Zone gateway*

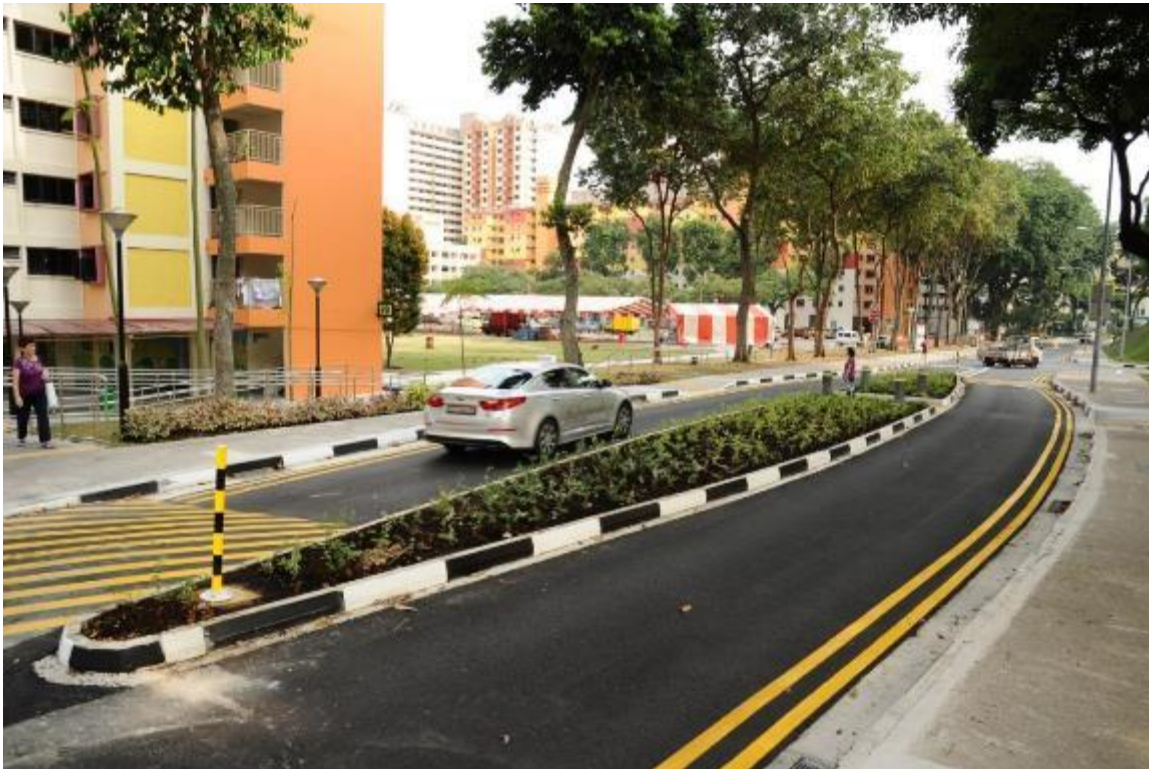
*Figure 6.245 – Example of implemented Eye-land*

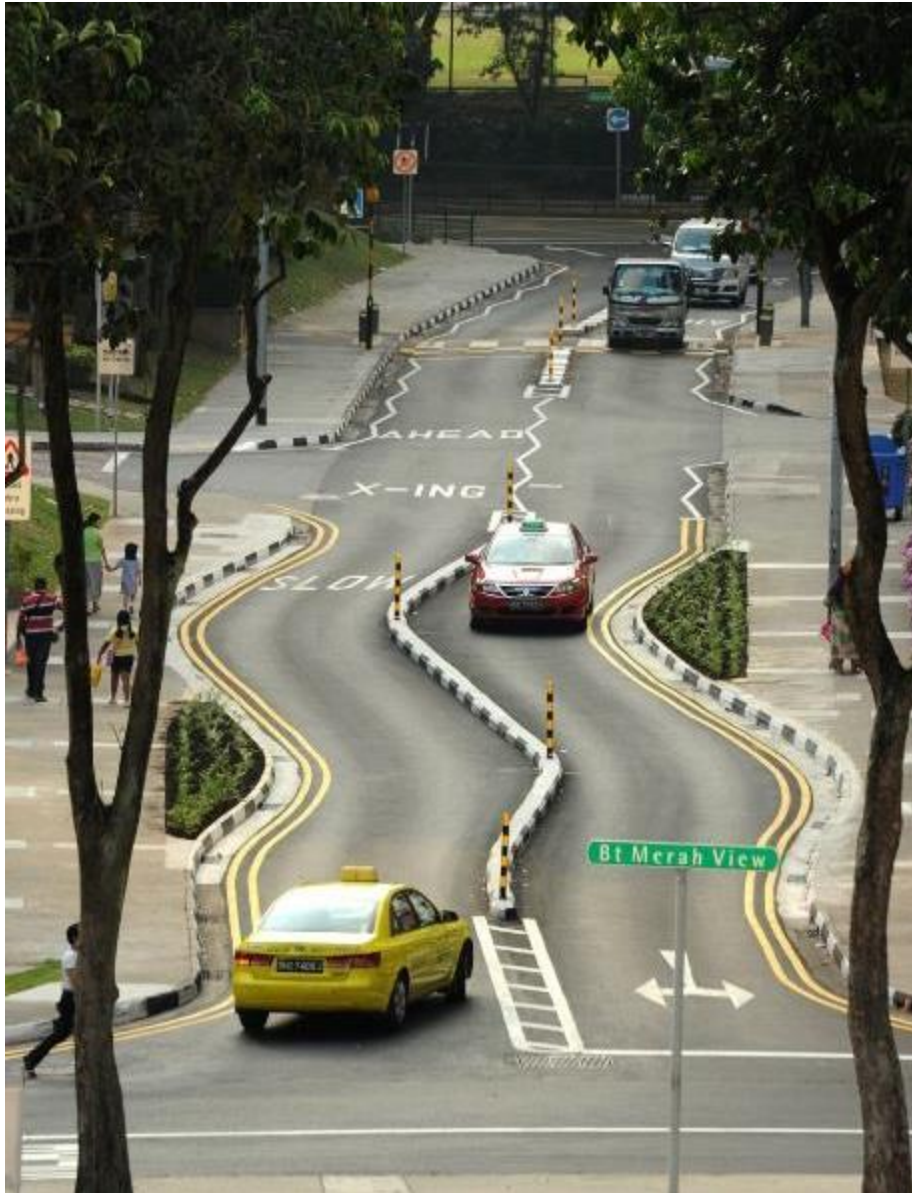
*Figure 6.246 – Example of Chicanes*

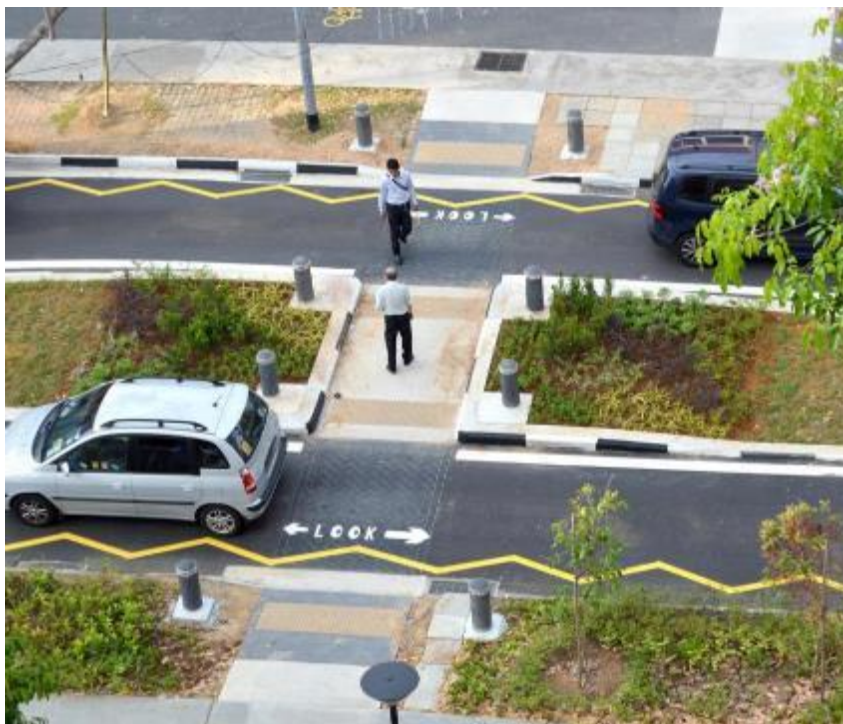
Figure 6.247 – Examples of Narrowed Lanes

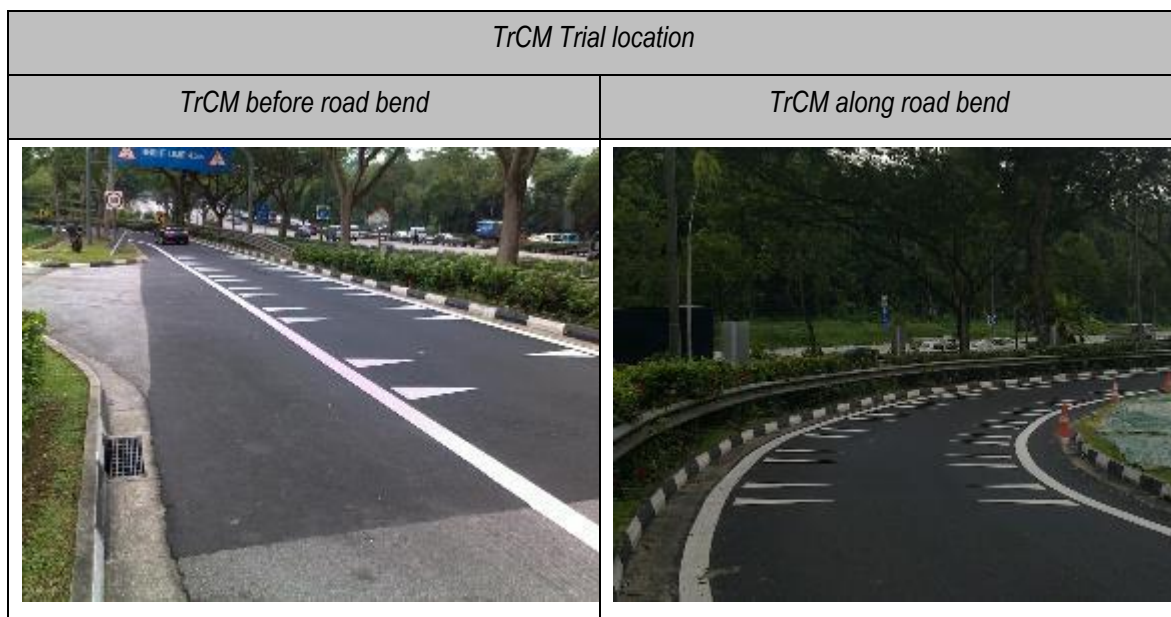
*Figure 6.248 - Before and along bend scenerio for a TrCM trial location*

This project entails utilising low cost measure (road markings) to create a visual narrowing effect to curb speeding at locations especially where physical traffic calming measures are deemed unsuitable. This is a psychological measure to overcome problems such as noise disturbance, damage to vehicles and discomfort to occupants while still retaining the capability of reducing vehicle speeds. TrCM encompass two parallel sets of jagged triangles pointing towards the road carriageway to visually narrow the road. The triangles also provide a “gripping” and funnelling visual effect when motorists approach the markings to encourage them to reduce their speed. These features serves to heighten motorists’ awareness on the need to be more alert and reduce their speed down. TrCM was first introduced as a trial at 3 locations in May 2008. It was subsequently expanded to a total of 11 locations.

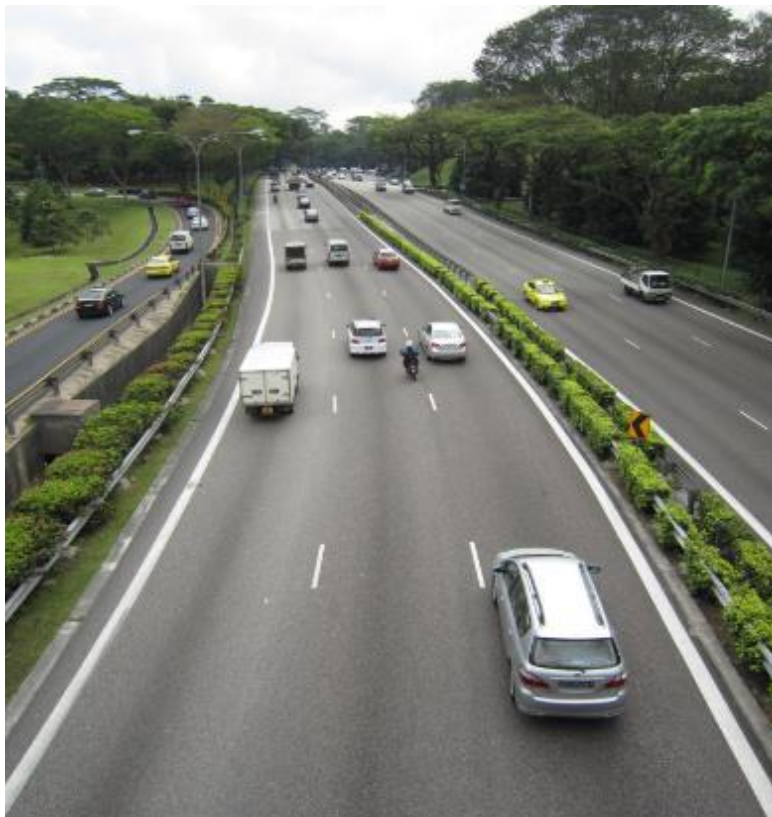
Figure 6.249 - Before the intervention

The Broader Alignment Lane Markings are a series of thicker lane markings painted along stretches of bends to encourage motorists to reduce their speeds and keep aligned to their respective lanes. They are usually implemented along expressways and major arterial roads where there is evidence of speeding, accidents or infrastructural damage and where physical traffic calming measures are not appropriate. The markings are more than twice the width and spaced closer apart compared to the normal lane markings. After the successful pilot in Mar 2012, BALM has been extended to 15 more locations.

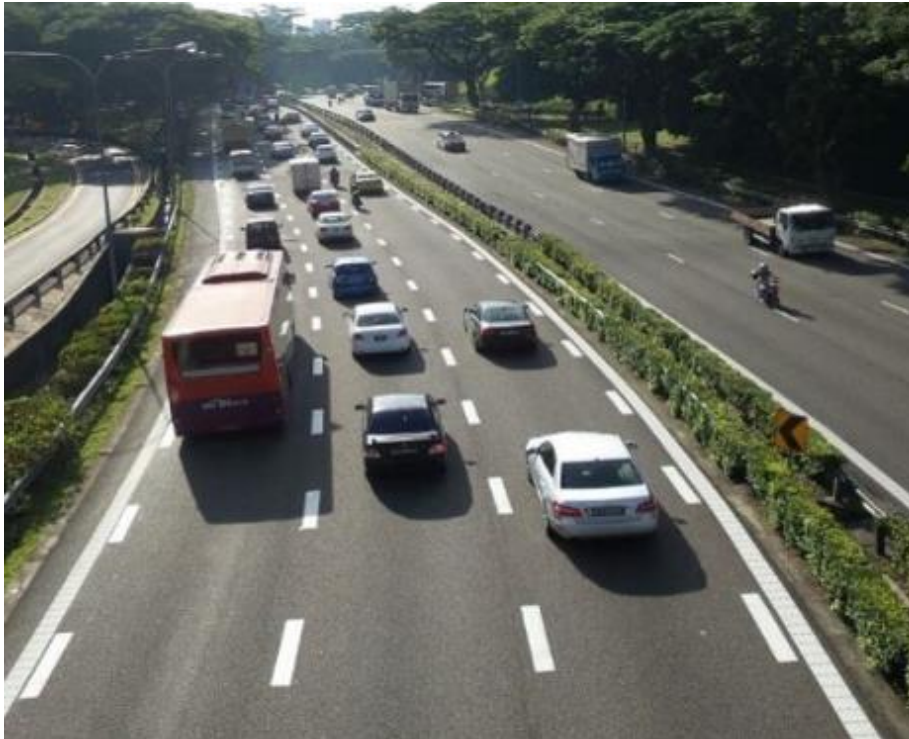
*Figure 6.250 – After the intervention*

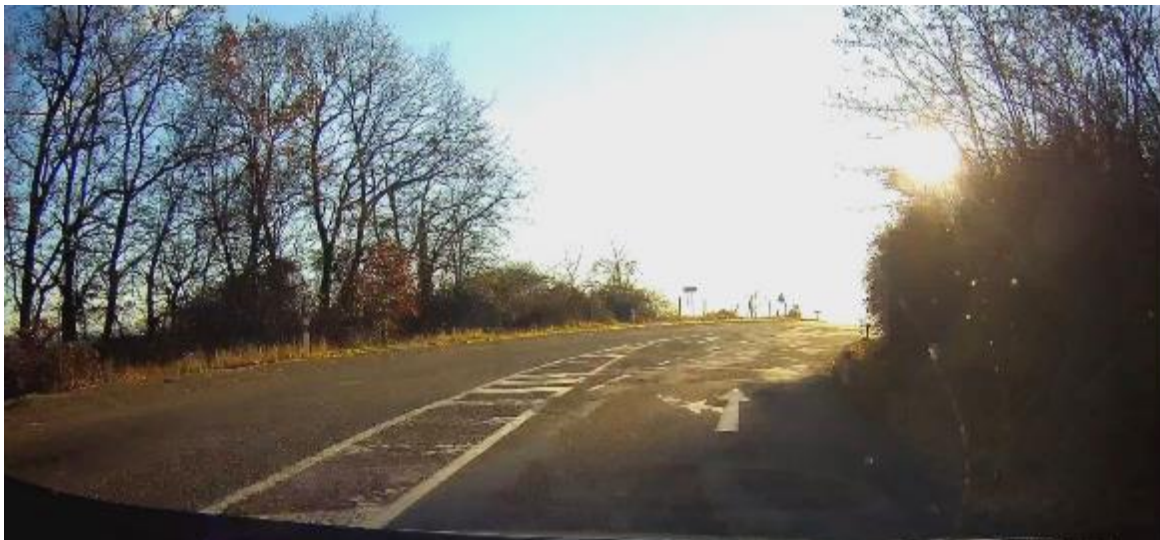
Figure 6.251 - Combination of the horizontal and vertical alignment and intersection

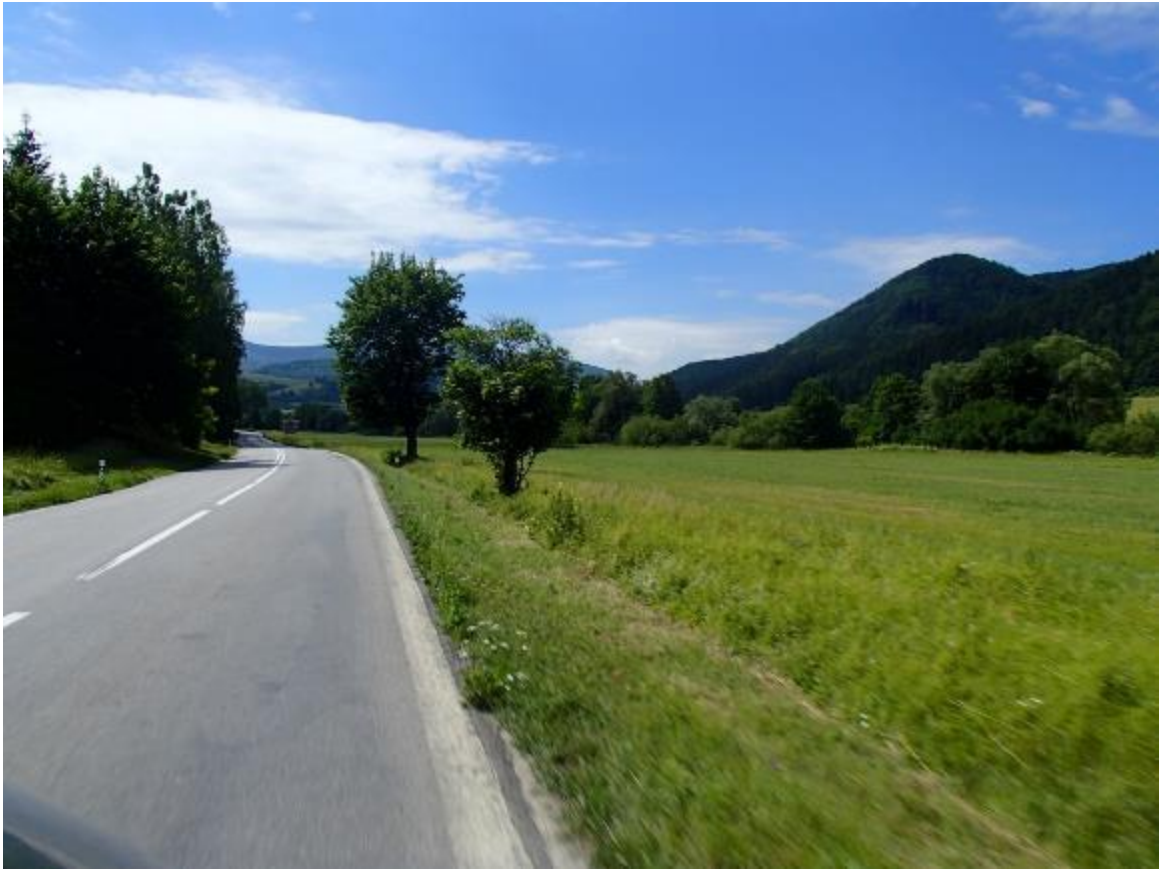
*Figure 6.252 - Combination of the horizontal and vertical alignment*

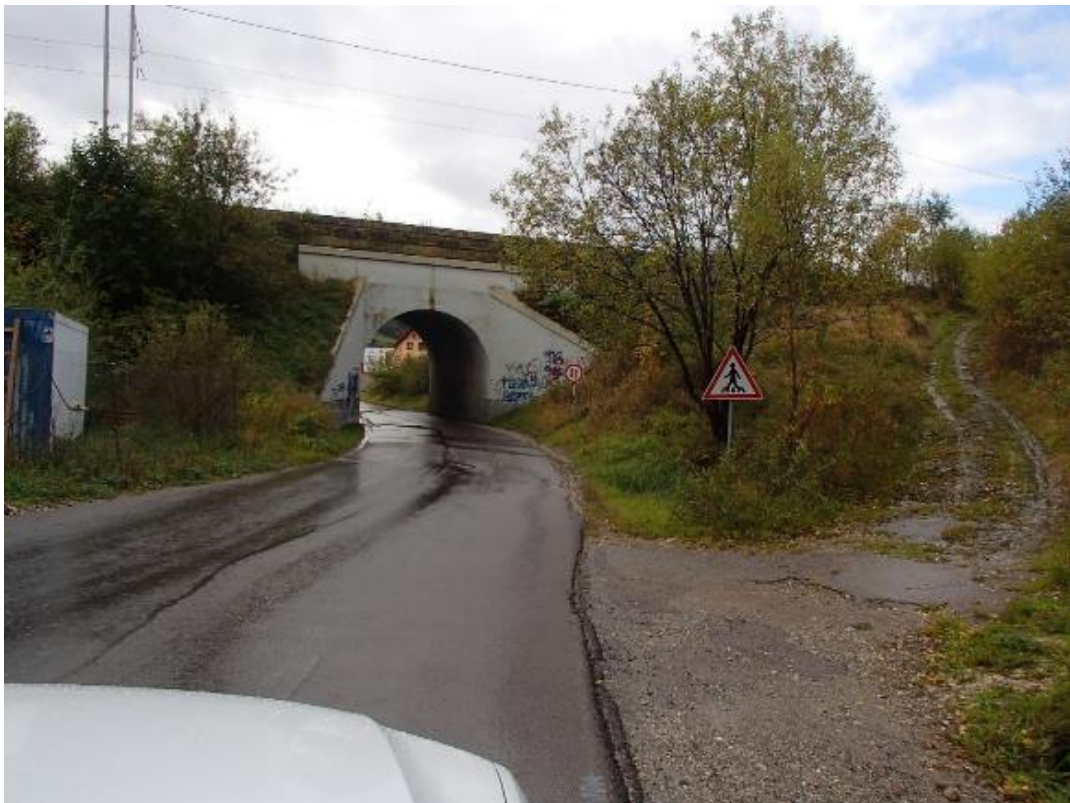
*Figure 6.253 - Width reduction by a barrier*

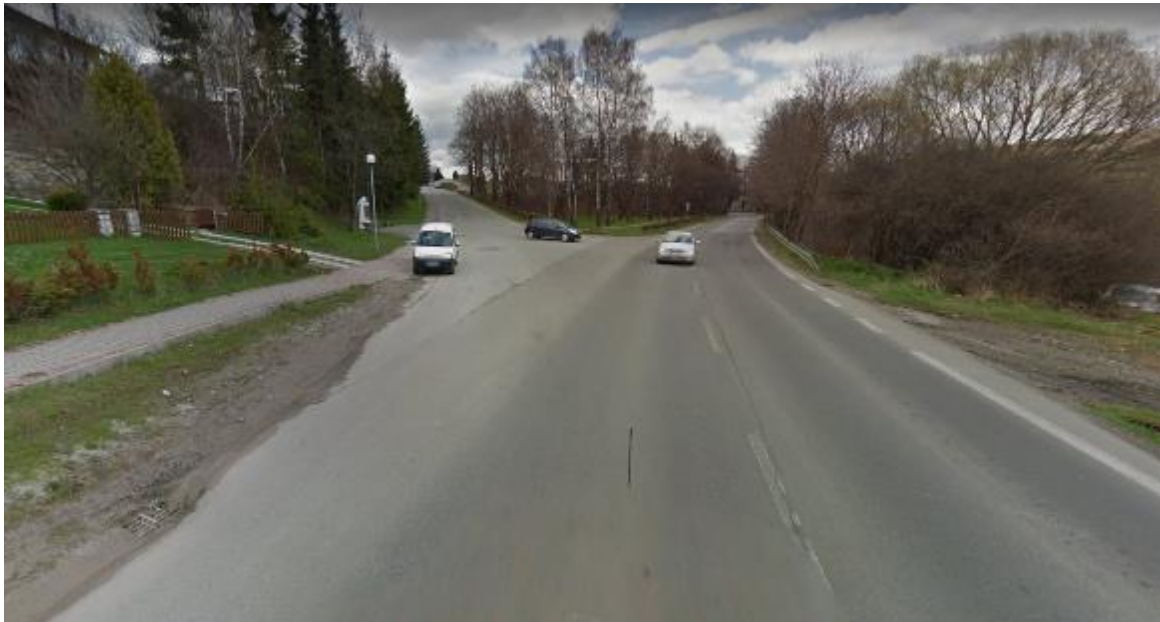
Figure 6.254 - Combination layout and intersection – before intervention

The case study presents problems of the bad layout with a combination of the intersection problems (crossing angle, sight distance). The previous situation shows Figure 6.254. The changes included a new design of vertical and horizontal layout, rebuilding the intersection from fork to the roundabout (Figure 6.255). The roundabout solved the problems mentioned above and improved the category width and new safety elements were added. The new design took into account also vulnerable road users, especially pedestrian. The project was realised last year and the current situation is shown in Figure 6.256, Figure 6.257.

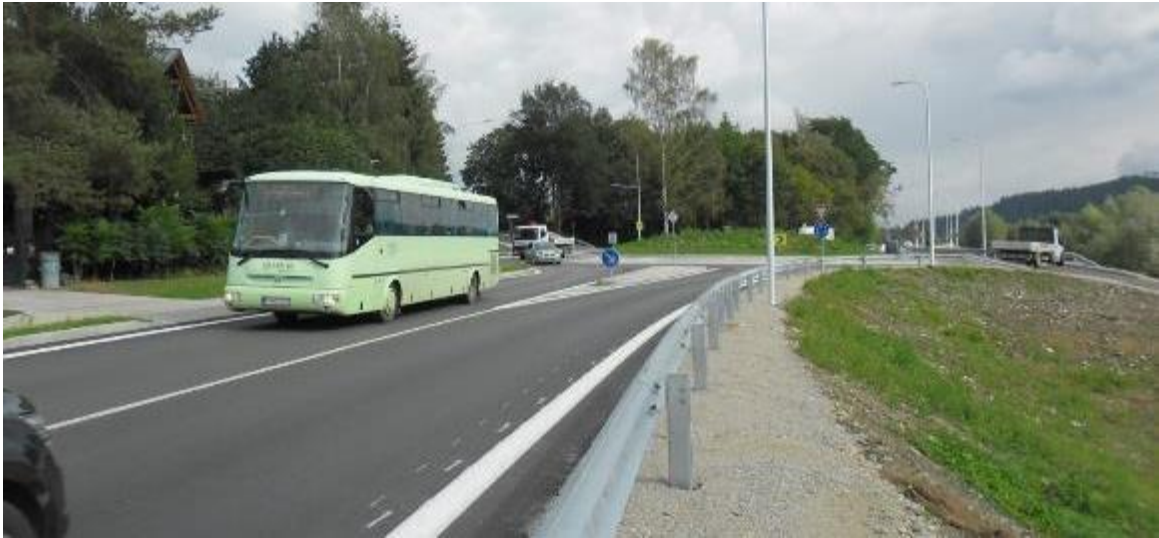
*Figure 6.256 - New layout and roundabout intersection – after intervention*

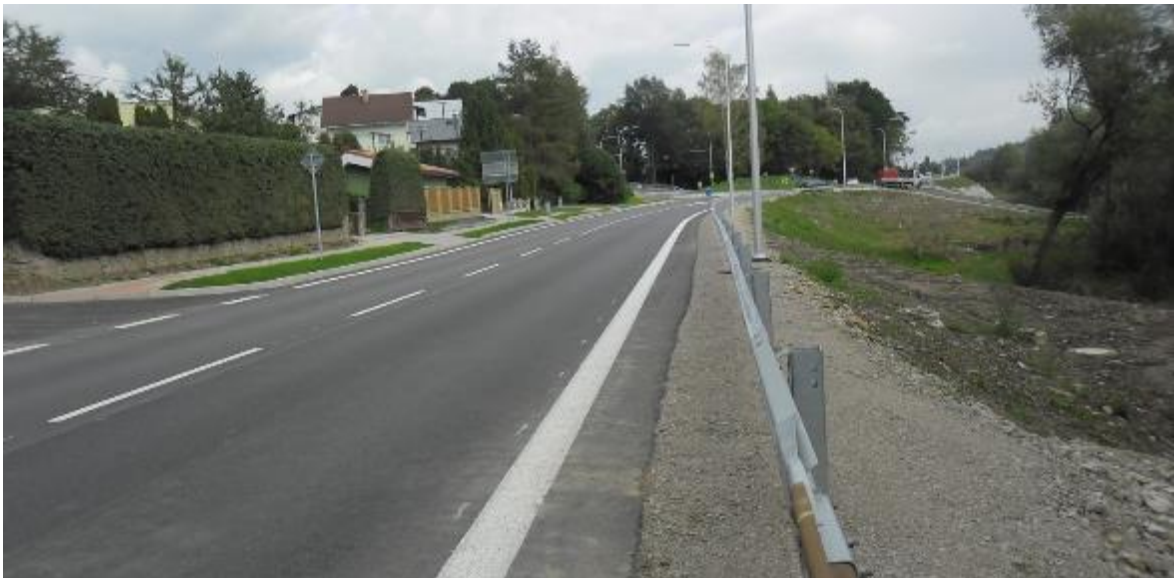
*Figure 6.257 - A new solution of the section – after intervention*

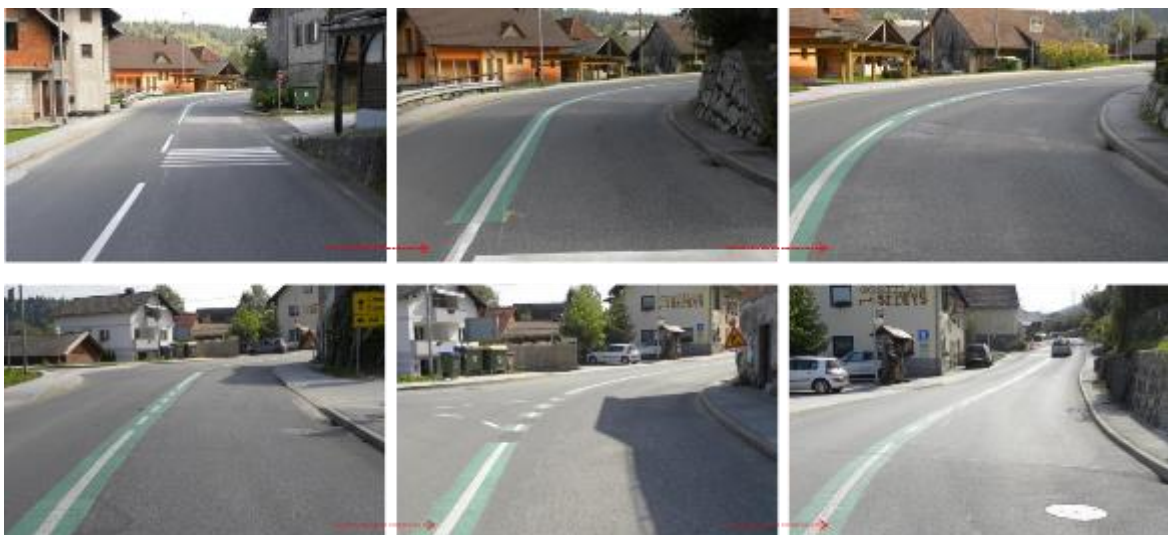
Figure 6.261 – Site after the intervention, Direction A

From each direction, optical traffic calming stripes were set up before the curve and a junction and after that green contrast stripes were implemented for optical narrowing the road. Where individual road junctions (access to the house) are we just cut / brake the middle lane on the green contrast surface, as on the junction with other road we cut / brake the middle lane and the green contrast surface, to make it more conspicuous / obvious that there is an intersection.

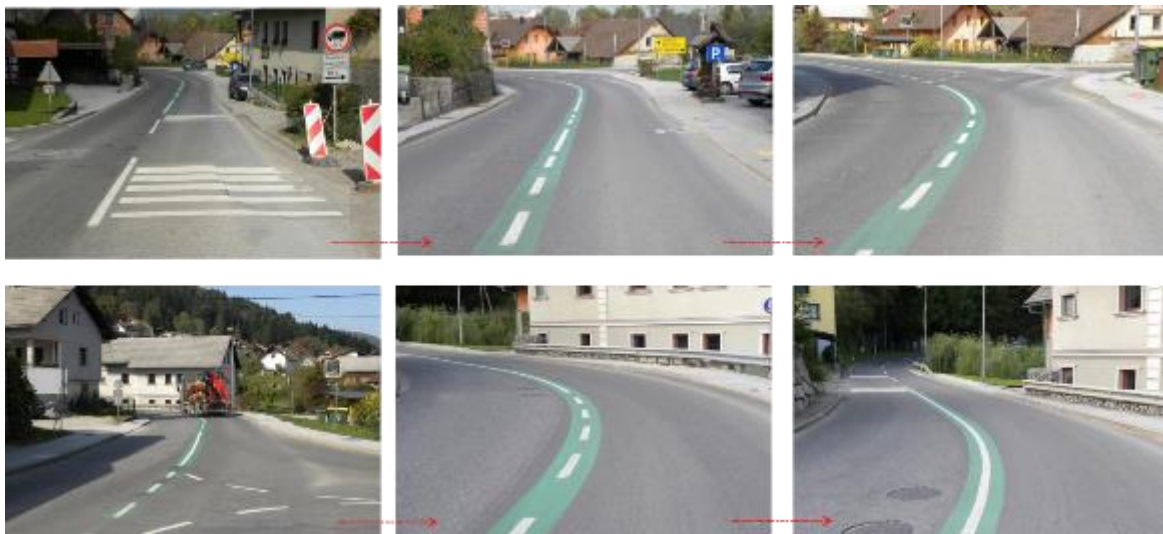
Figure 6.262 – Site after the intervention, Direction B

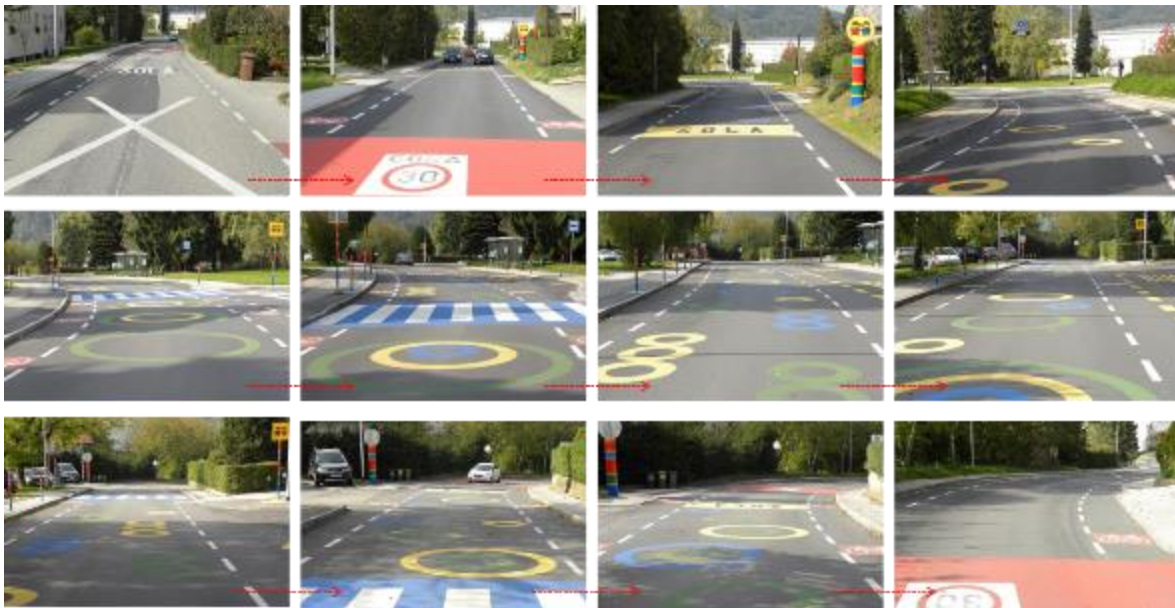
Figure 6.267 – After the intervention, Direction A

In pictures below there is new (after) road design, from both directions, near the School in the zone 30 km/h.

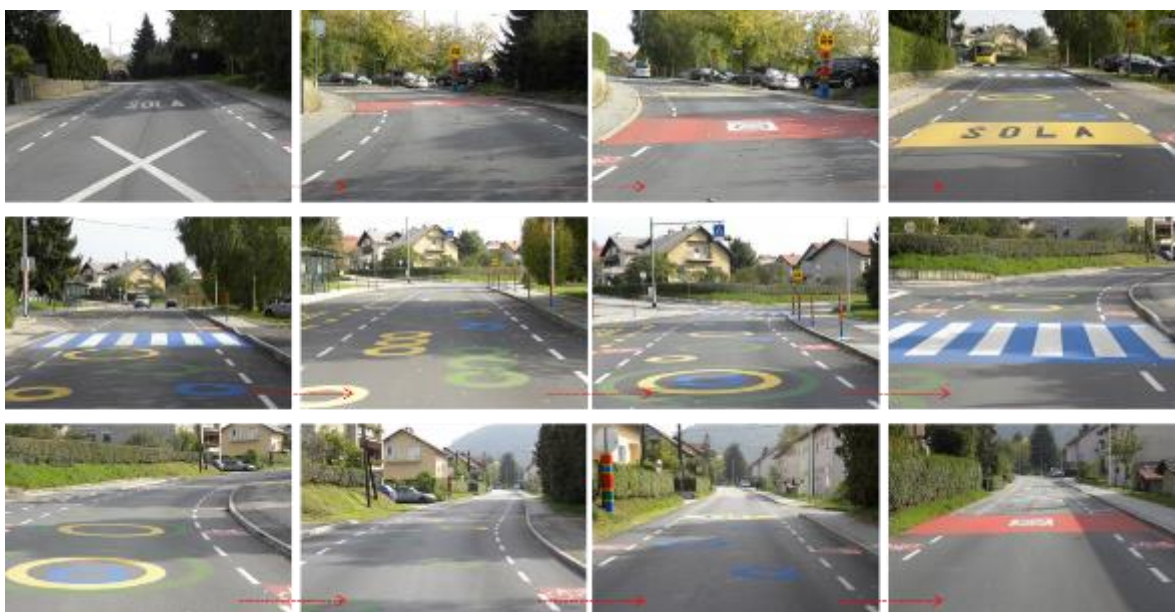
Figure 6.268 – After the intervention, Direction B

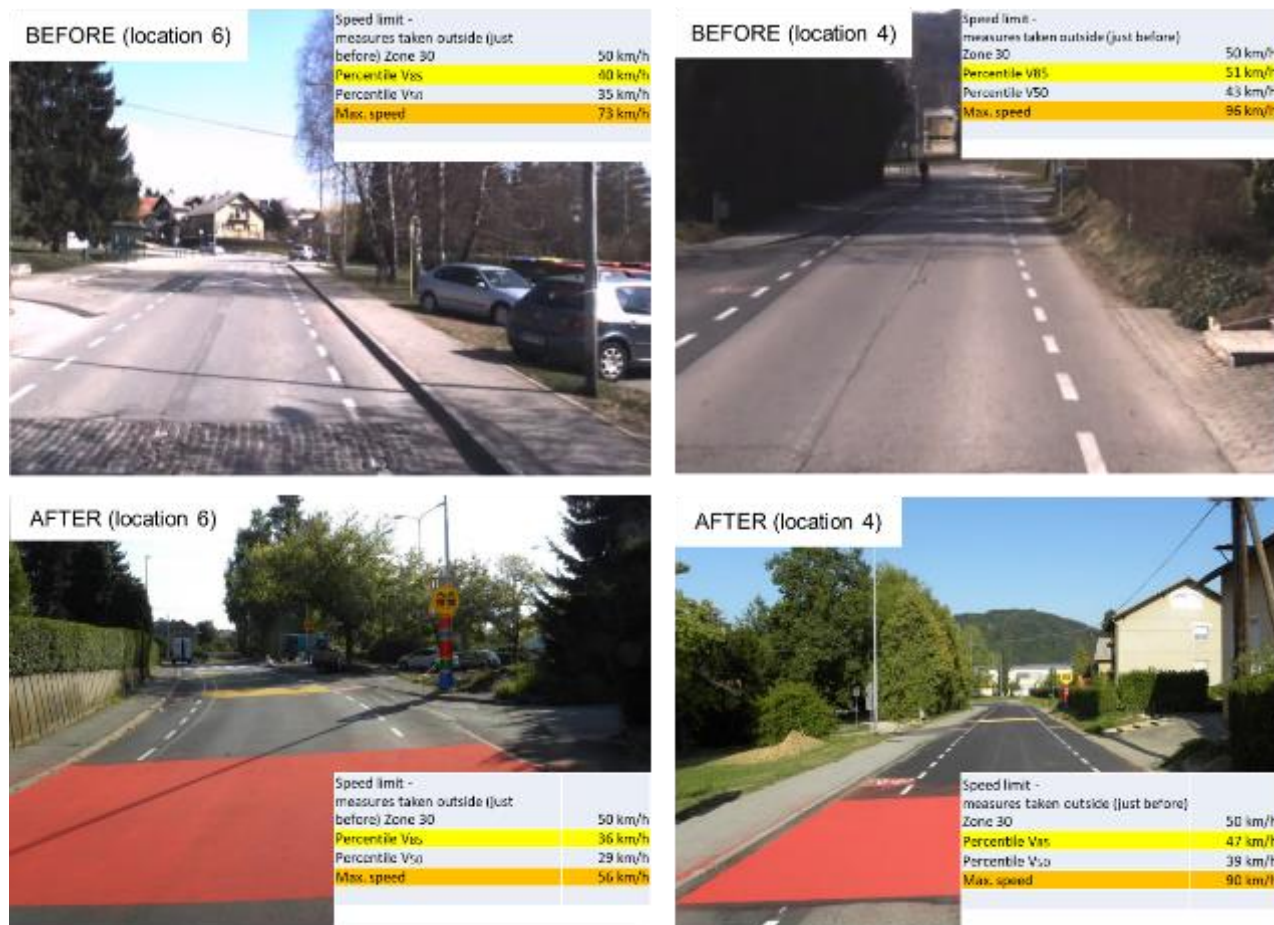
Figure 6.270 – Operating Speed analysis

In addition, we can see in the graphs that speed has reduced, also extremes and has moved to the left in the Gauss curve. 85<sup>th</sup> percentile speed was reduced for 4 km/h and max. speed in location 4 lowered for 6 km/h as in location 6 for 17 km/h.

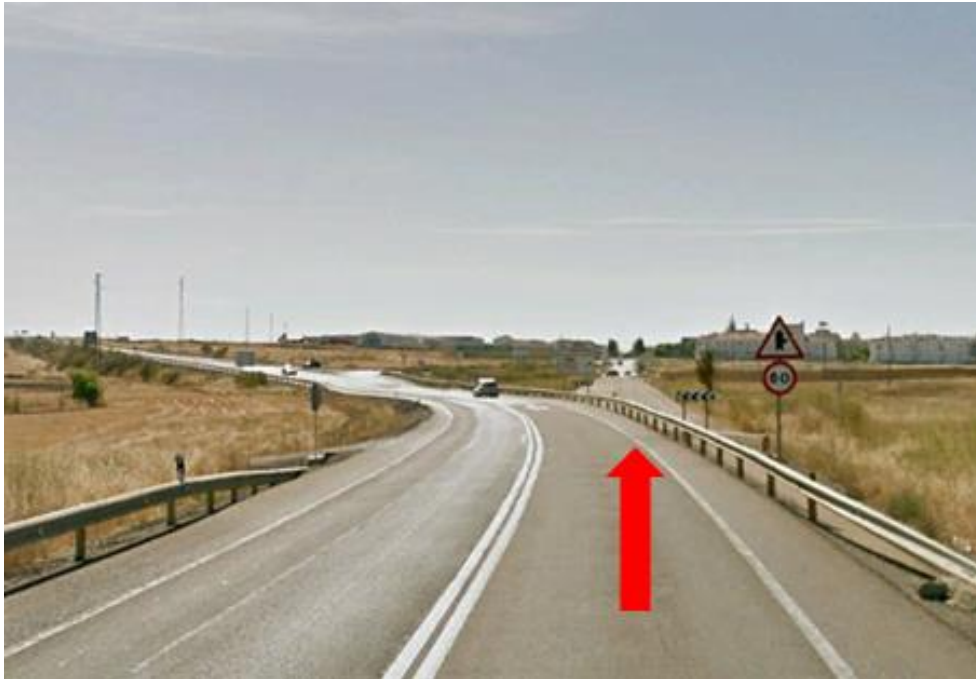
- One of the most common cases comes when apparent perspective transmits continuity driving forward in a case of loss of priority in “Y” junction (junction placed at an acute angle). This often occur when two roads of the junction have a similar range.
- This perspective produces two undesirable effects:
- One for the vehicle driving on the road which do not lose priority because it cannot be aware in last chance that is going to take the wrong way and finding itself forced to carry out a sudden manoeuvre to get back to the correct one. It can generate risky situations.
- The second effect is for the vehicles which are getting closer to the junction through a secondary road. They cannot be aware of the need to stop or to give way, being forced to brake abruptly or even going onto the priority carriageway.

Figure 6.271 - N-432 ordinary road. West junction of Llerena. Secondary road is in extension of the main road

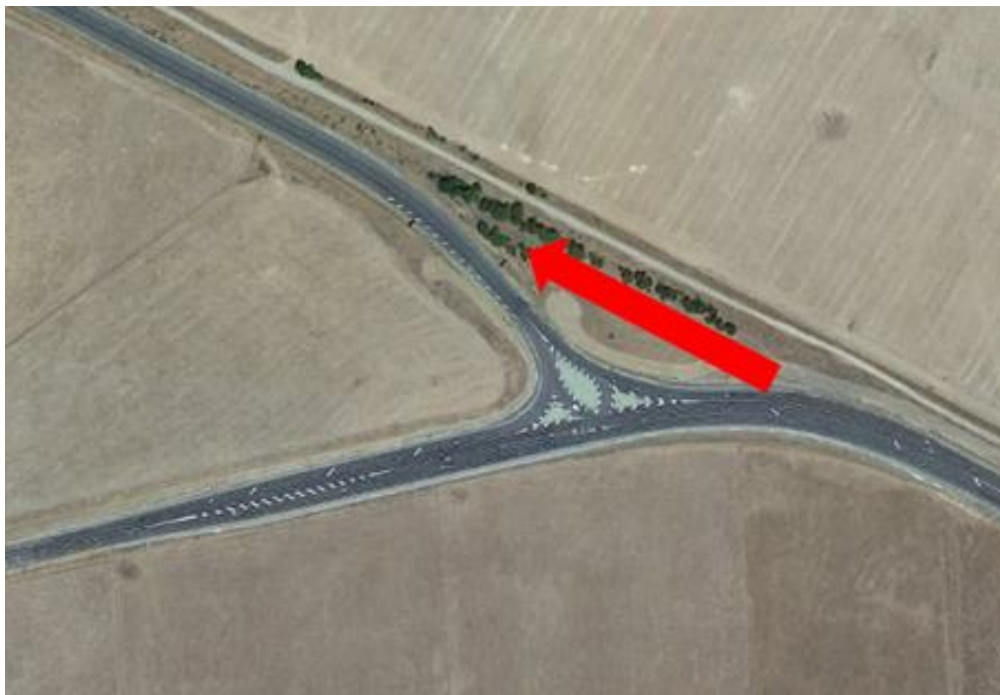
- In these cases, the most effective solution is the conversion of the junction, increasing the angle between the two roads to the maximum possible. It is necessary try to achieve 90°, turning it into a “T” junction because this kind of junction do not generate misleading perspectives and each movement trajectory has a better appreciation.

Figure 6.272 - N-521 ordinary road. Current horizontal alignment of Malpartida junction (Cáceres)

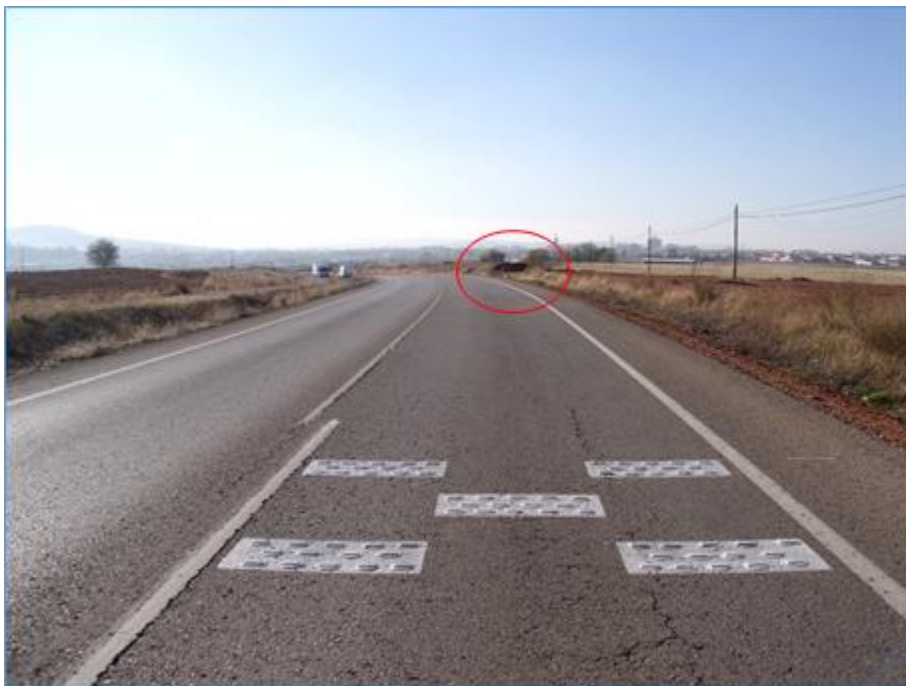
In these cases, solution adopted is the provision of a physical element which make a visual barrier and remove the misleading perspective. Physical elements that are most frequently used are plantations. A vegetable screen provision consists on shrubs arranged in the outside area of the platform (depending on the route elevation may be required to plant trees of a greater height). Other times, waste products from the excavation have been used to form a banked-up bed of lands that cover the view that produces undesirable effects

*Figure 6.273 - Disposition of a mound of land to eliminate continuity prospect*

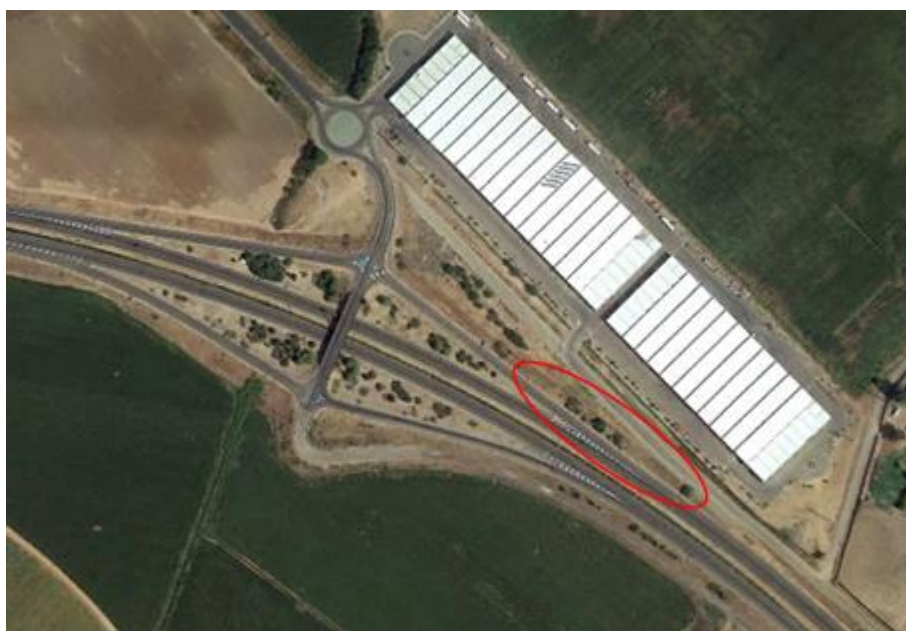
*Figure 6.274 - Tree layout to eliminate front continuity prospect*

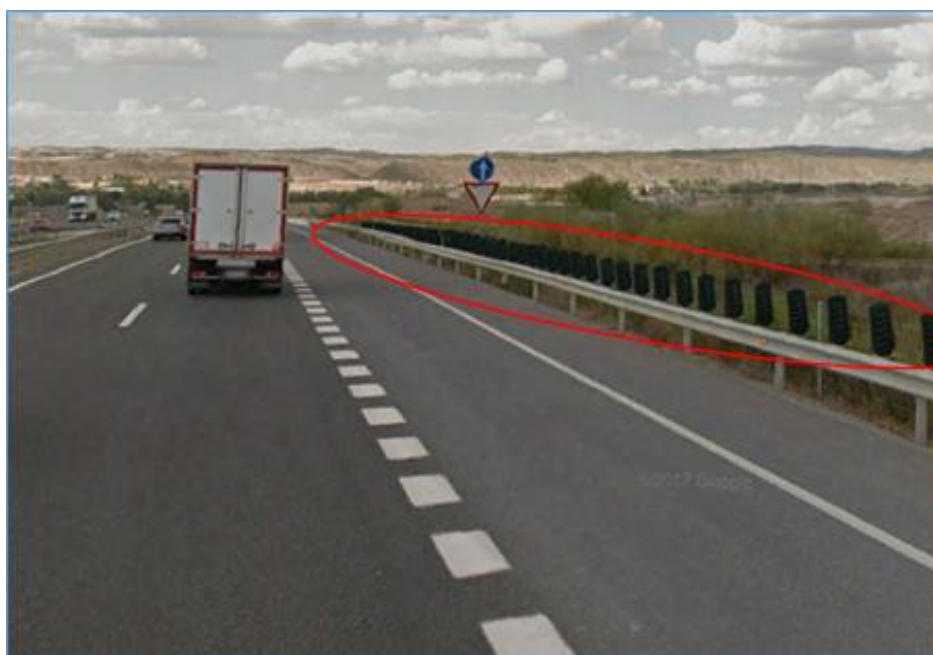
- Another case in which misleading perspectives are produced, occurs at night when two road sections meet in parallel where vehicles headlights circulating in the other way do not permit correctly identify the path to be followed. It can even occur between the two carriageways of a same highway.
- In these cases, it has been widespread the use of antiglare screens. They are components placed over the safety barriers which hide the vision of the road section that is not desired to be seen by the driver. This component, placed at regular intervals, produces the same effect as a diaphragm wall that could be placed on the outer edges of the road. However, it has a lower cost.

Figure 6.276 - Anti-glare screen on metal safety barrier

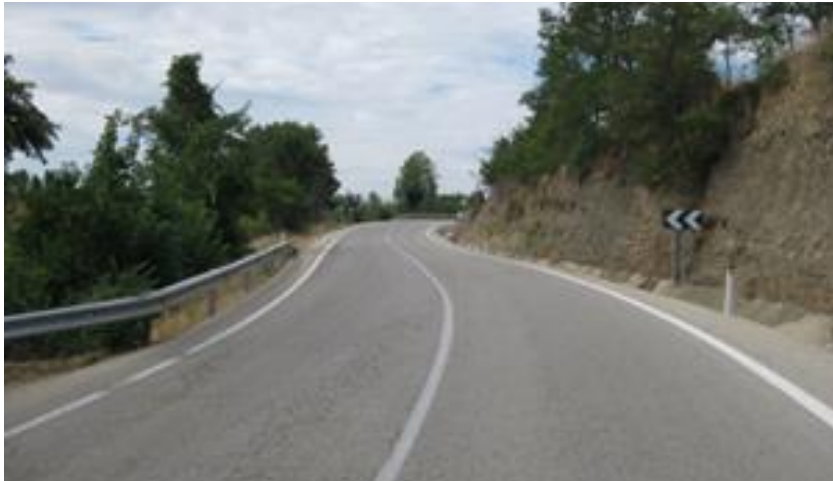
*Figure 6.278 - Example. Junction without sight because cut slope*

Improvement measures for these situations are, on the one hand, site clearing not to be interrupted visual between junction and approaches in the main road. On the other hand, in the case of existence of very vertical cut slopes, the improvement measure consists on laying cut slope. That is, to decrease slope value to avoid it can be an obstacle in junction visual.

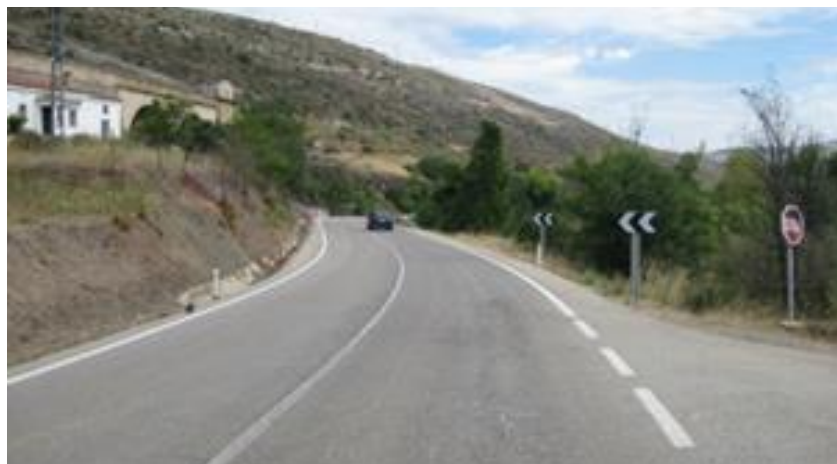
*Figure 6.279 - Example. Lack of sight because vegetation*

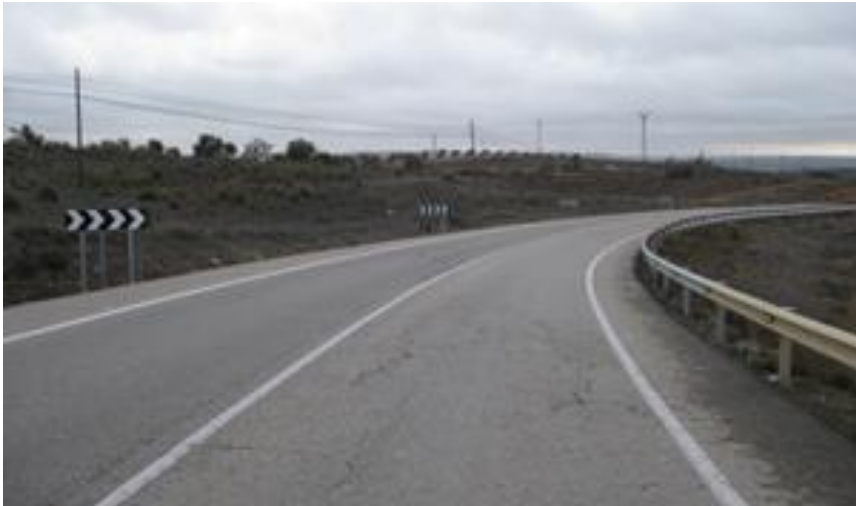
Junctions without enough sight, due to vegetation existence or cut slope disposition, in which some described improvement measures have been carries out (site clearing or laying cu slopes), show an accident rate decrease because reaches accidents have been reduced.

*Figure 6.280 - Example of site clearing to improve sight in curve*
