# CATALOGUE OF CASE STUDIES

*Road safety improvements relevant to Vulnerable Road Users, Human Factors and Low- and Middle-Income Countries*

**TECHNICAL COMMITTEE C.2 DESIGN AND OPERATION OF SAFER ROAD INFRASTRUCTURE**

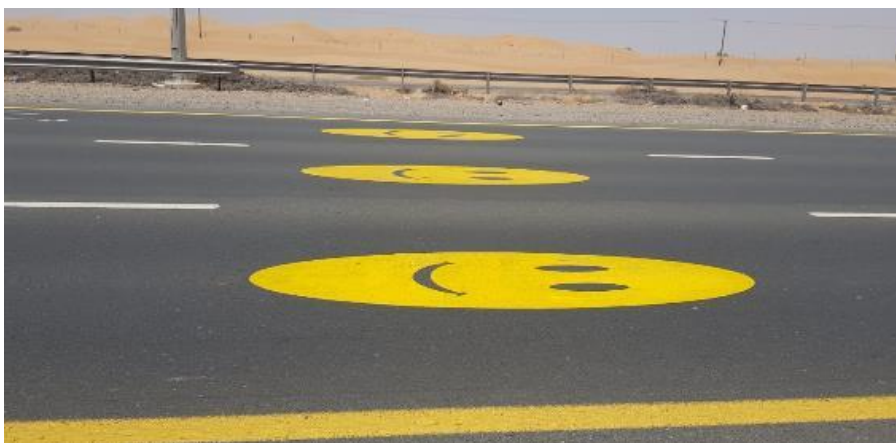
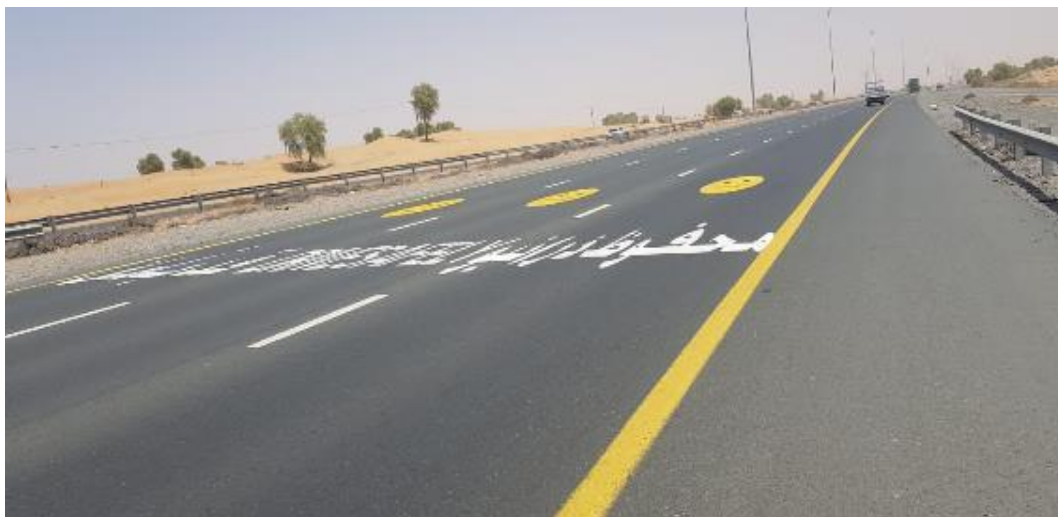
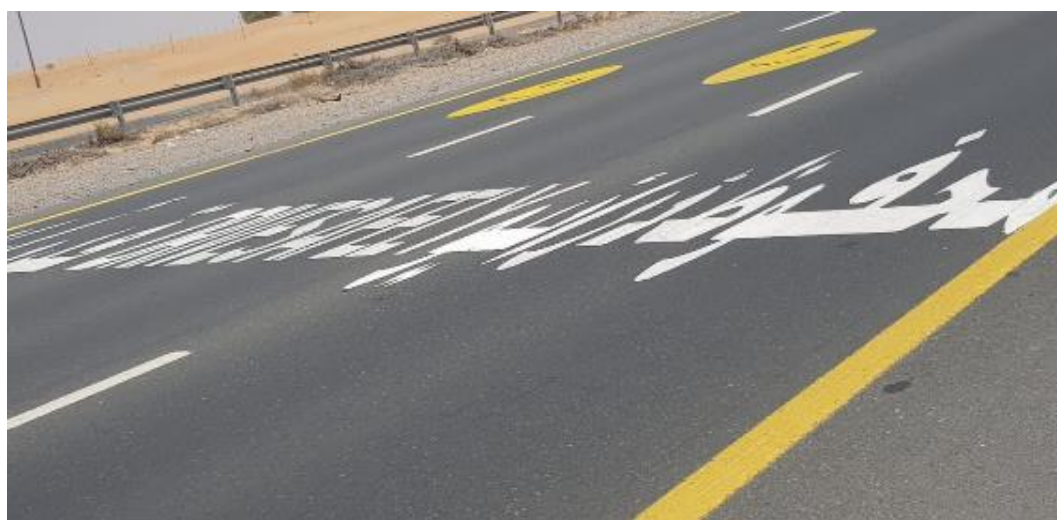
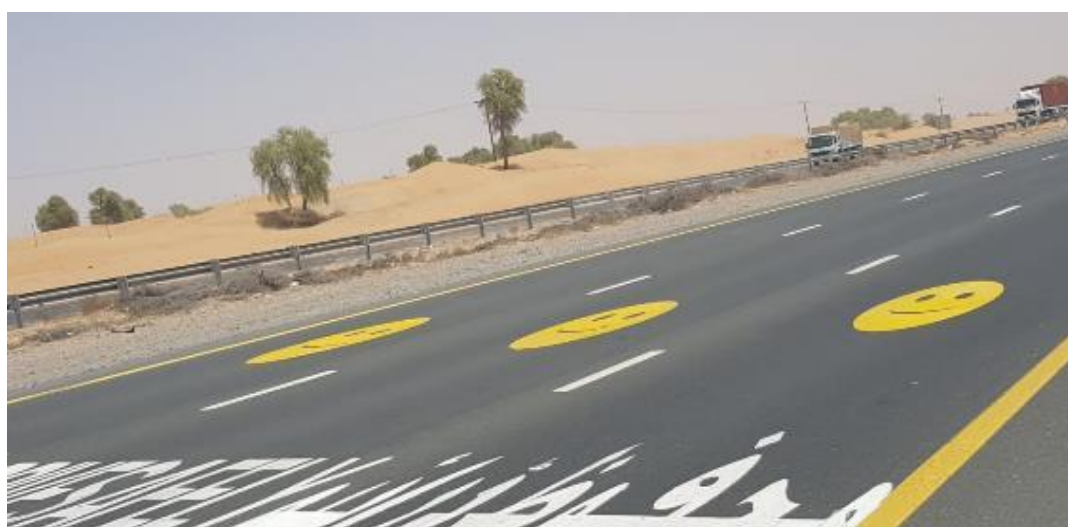
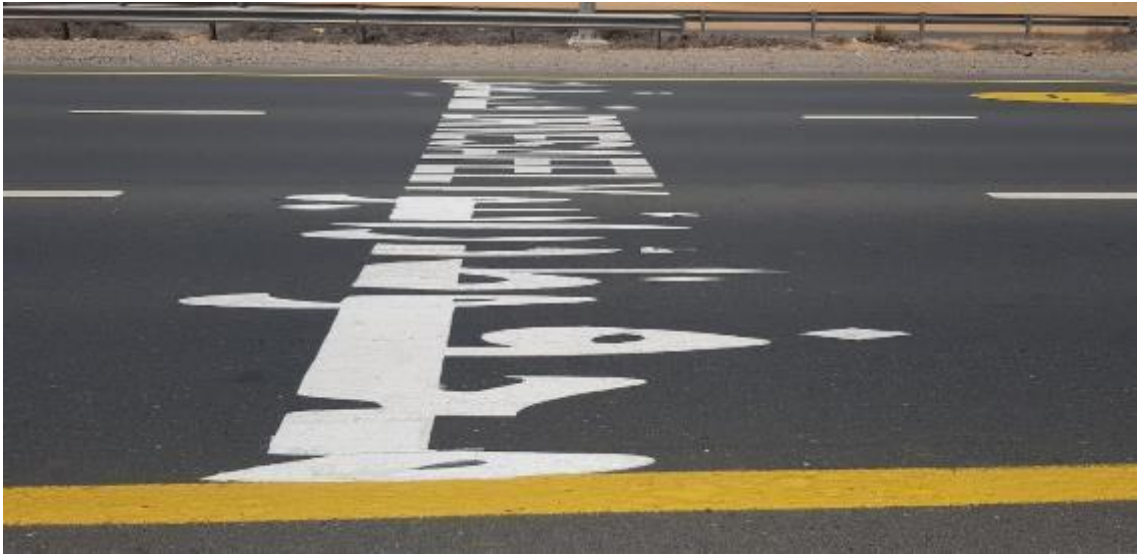
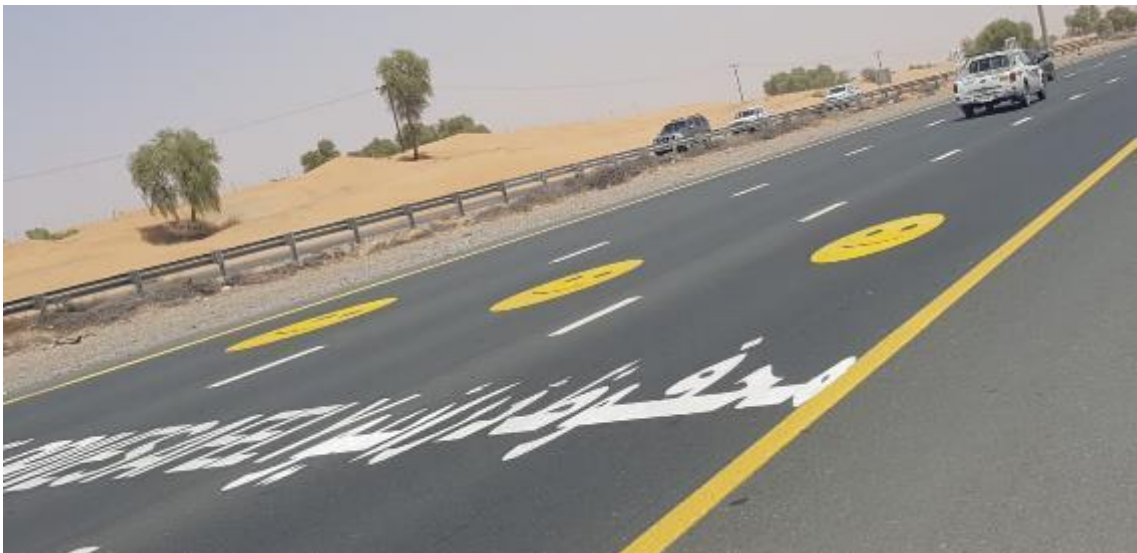
One of them has to do with the painting of a DRIVE SAFELY advise in the carriageway. The selected location to do that is one of the main corridors in the country (Road Sheikh Mohammed Bin Zayed, E311 in the border of the emirates of Ajman and Umm AlQuwain. The message pretends to warn the drivers and drive caring about the rest of the drivers, without speeding and keeping safe distance. Considering that the population is formed by a large amount of nationalities, it was decided to write the message in 3 languages: Arabic, English and Ordu to reach different massive sectors. This action pretends to have a positive psychological effect in the drivers. In this point SMILEY FACES were painted in the middle of the lane with the legend DRIVE SAFELY. The faces have 2.5m in the shortest axel and 4.2m in the longest one (parallel to the cars direction).

Figure 6.281 Multilingual motivational road marking for a safe driving. Sheikh Mohammed Bin Zayed Road (Umm Al Quwain). Detail 1.

This both measures were applied using cold paints in order to try this technology under the local conditions (traffic, weather, temperature, uv effect, etc). The results about this aspect after 2 years since they were applied are totally satisfactory.

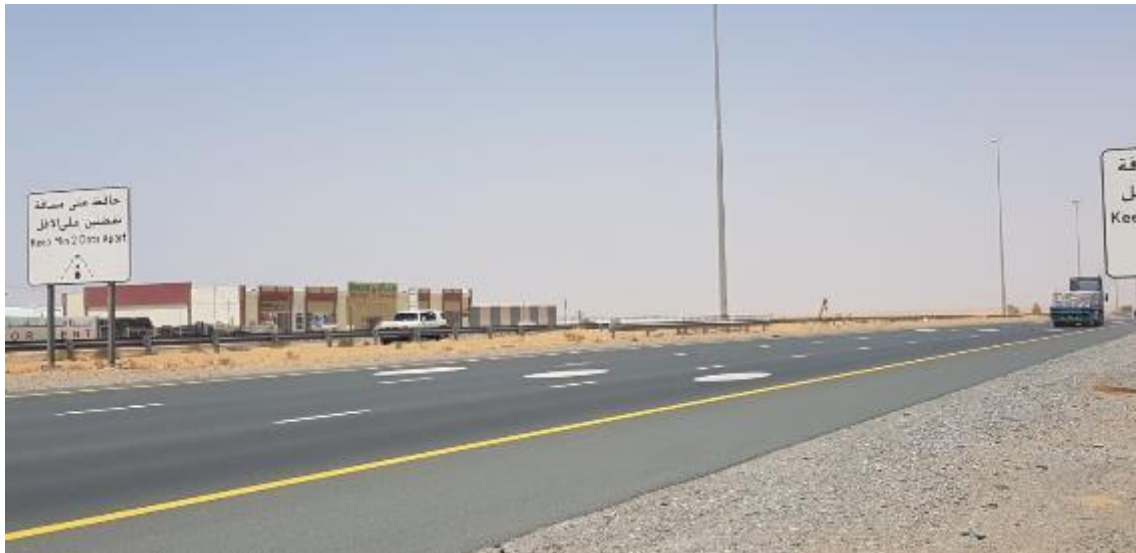
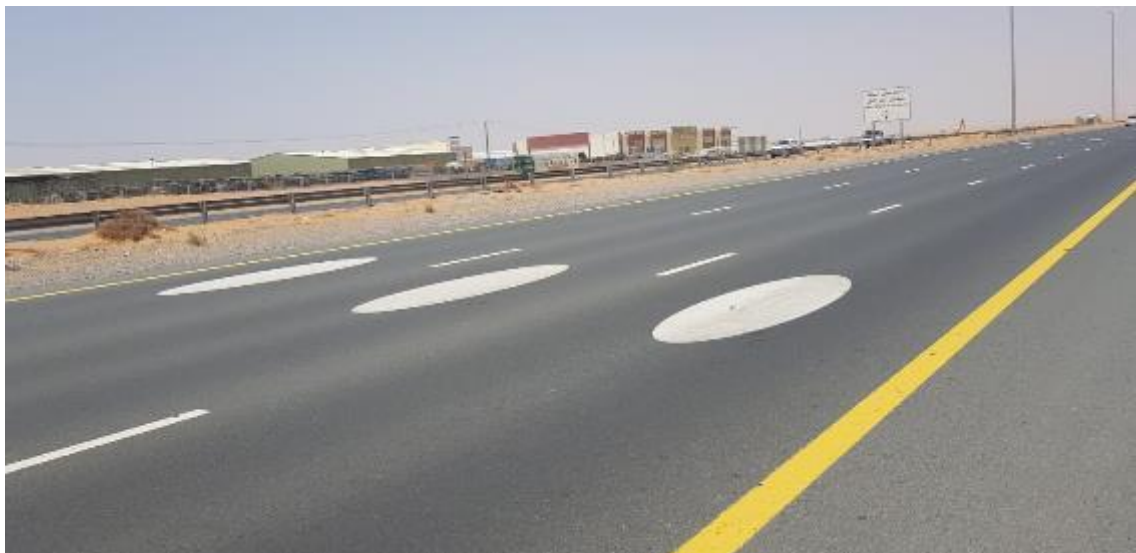
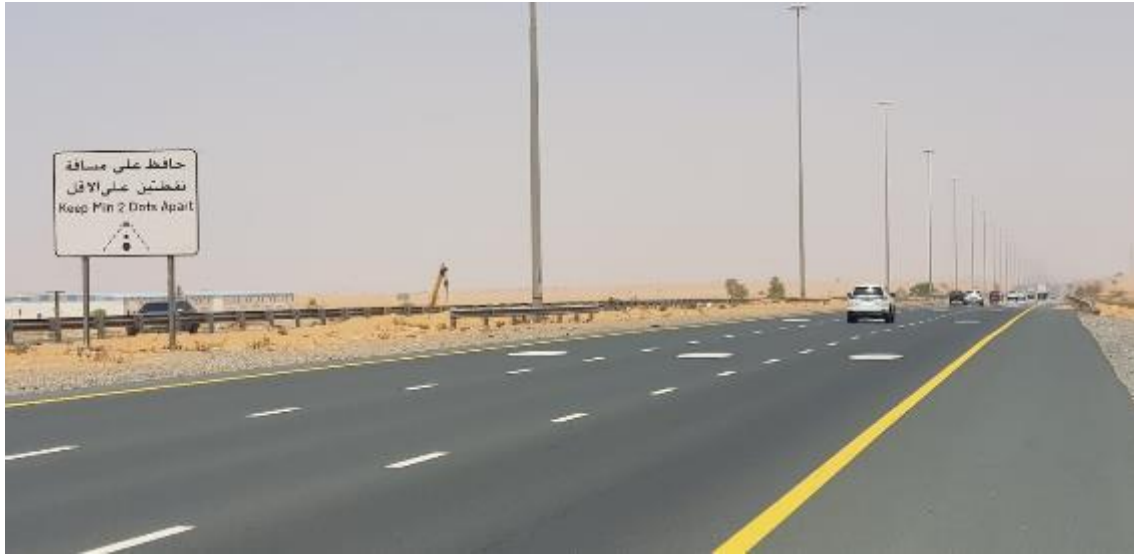
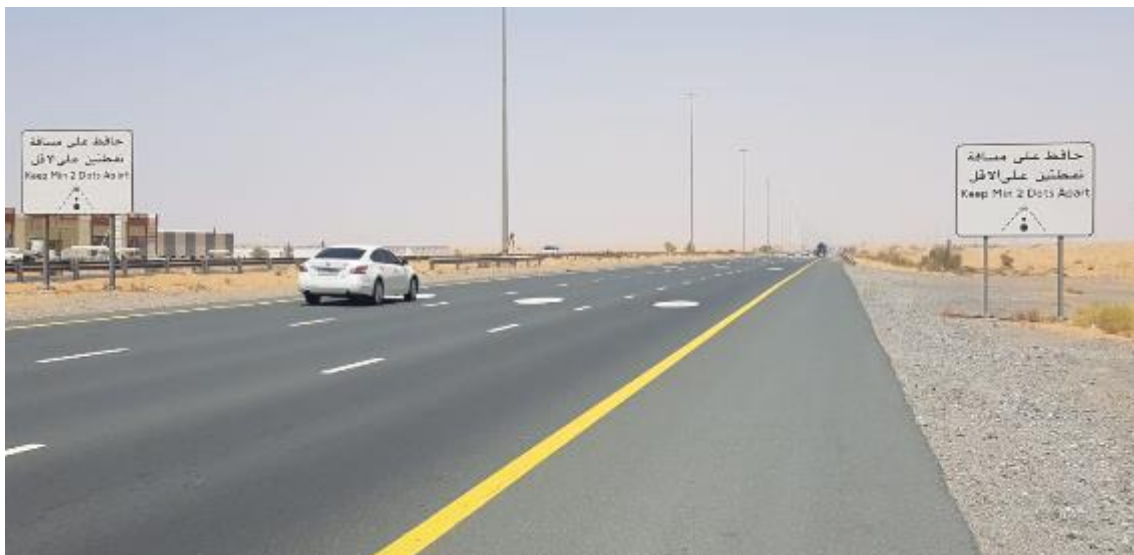
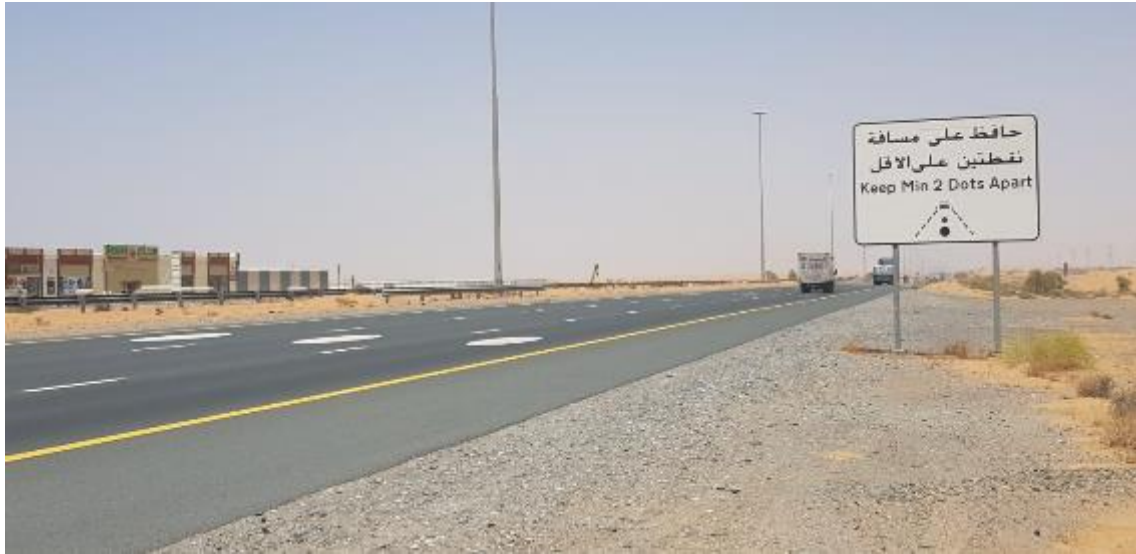
In order to keep enough safety distance between vehicles in the road, the installation of white dots in the middle of the lanes were painted. Signboards warning the drivers to keep at least 2 dots between cars (which makes a 100m distance) were installed. This way of measure the minimum distance can be easily detected by the drivers as well as police (for enforcement purposes).

*Figure 6.288 - White dots to keep safety distance. Sheikh Mohammed Bin Zayed Road (Umm Al Quwain). Detail 1*

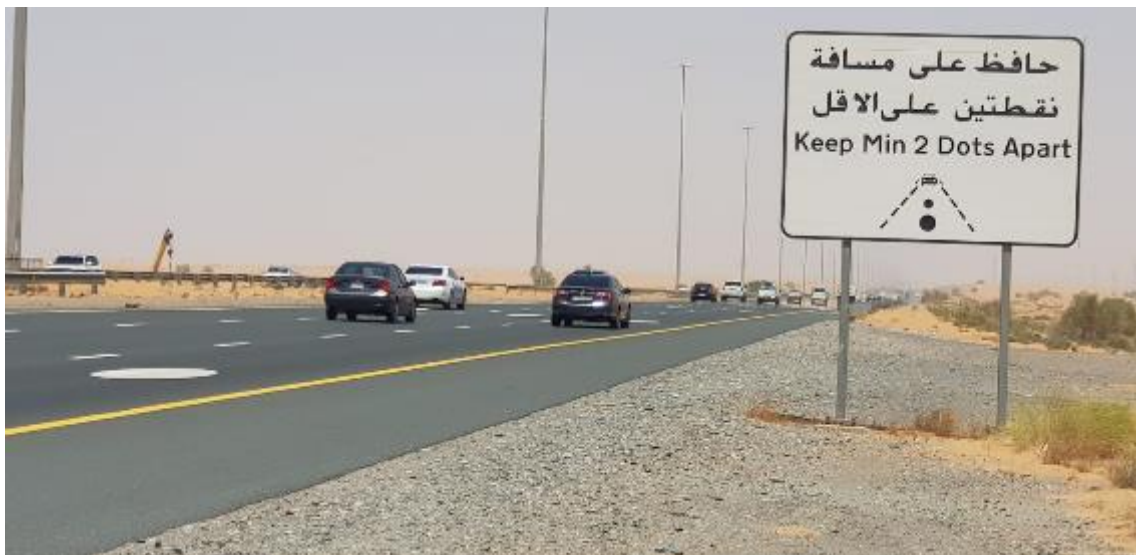
Figure 6.293 - White dots to keep safety distance. Sheikh Mohammed Bin Zayed Road (Umm Al Quwain). Detail 6

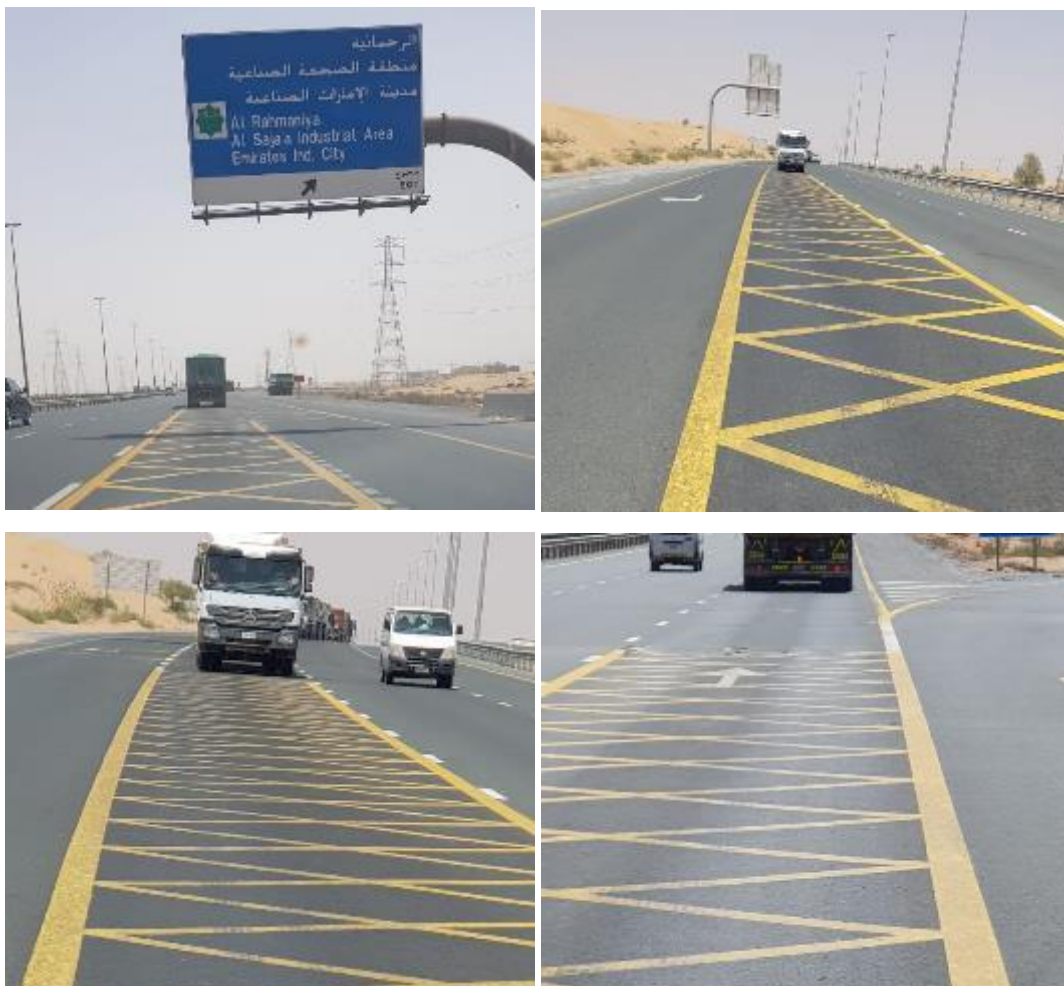
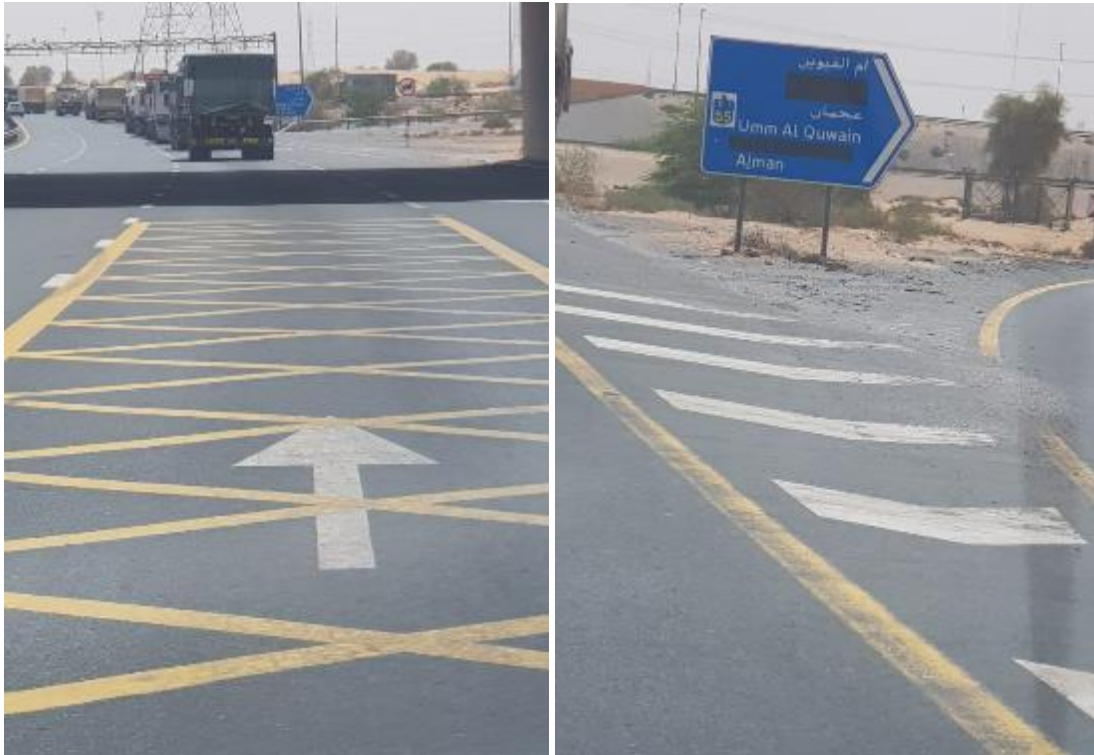
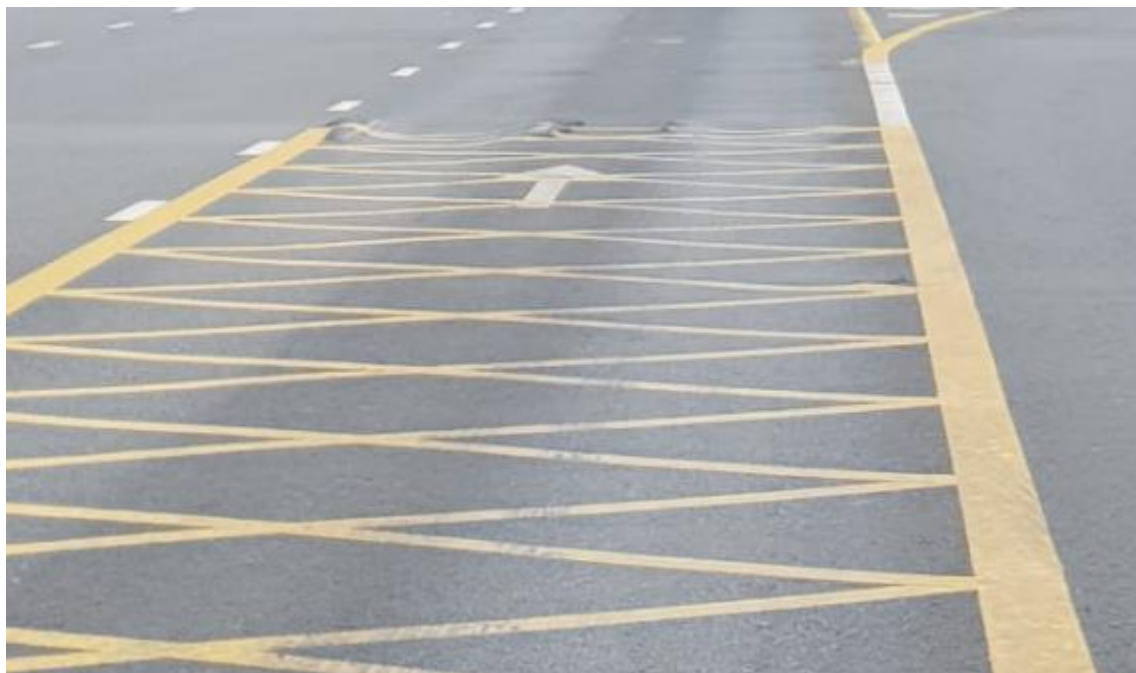
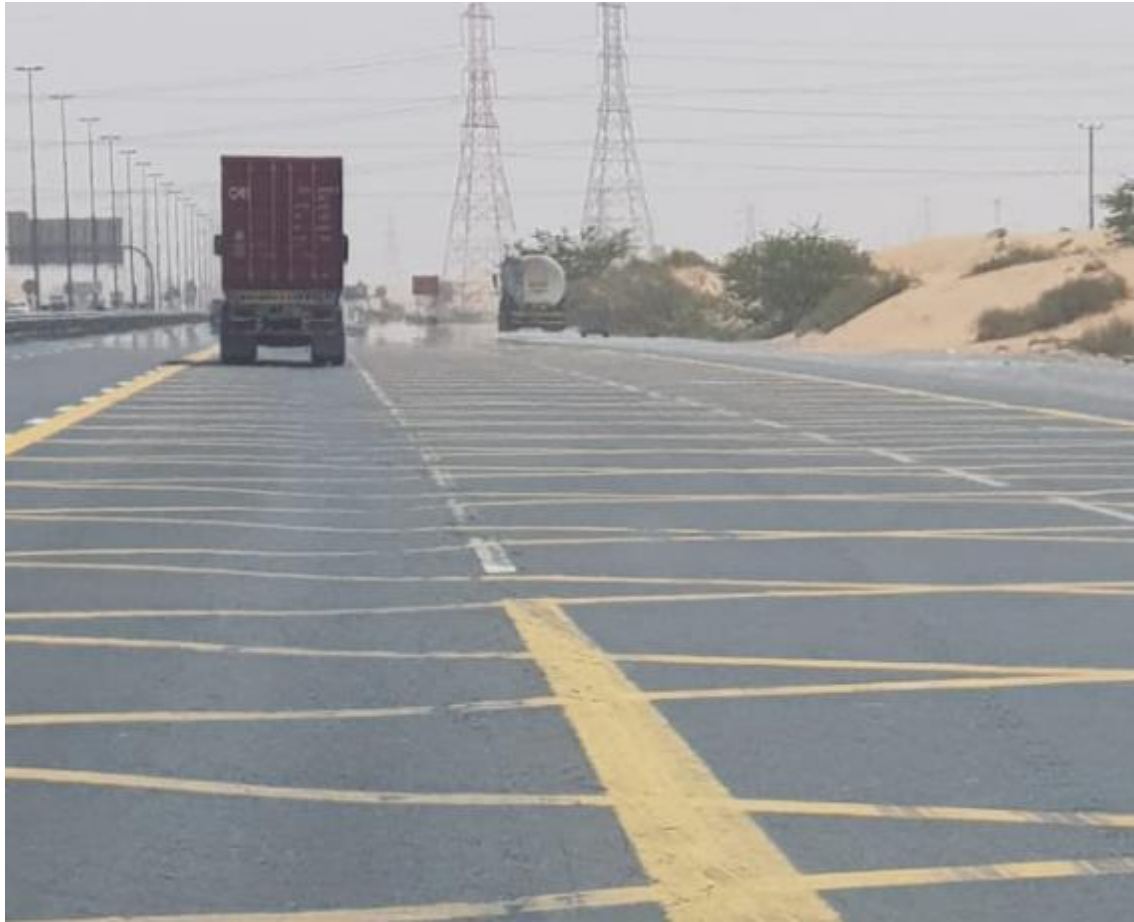
Another road marking action was implemented. This time with the objective to open the space between trucks (during the peak hours) in certain important junctions. Lack of these marks, make a continuous queue of trucks leaving null space for cars using the junction to go inside the road and to move to the middle and fast lanes of the highway. Vehicles incorporating to the main body of the highway did this manoeuvre without visibility creating really high probability accidents spots, by collision from the vehicles with higher speed using the carriageway. Currently the trucks using the slow lane can't invade those spaces unless they detect there is enough space for them to cross it. In this way lightest vehicles can cross fast those spaces to the main road and the trucks keep occupied the slow lane the same time. During the peak hours this lane can accumulate more than 500 trucks during the same period crossing at least 3 intersections of this type. Sensation of safer driving is present in these points at that time.

Figure 6.296 - Yellow marks to avoid invasion of heavy vehicles when having traffic jam in the slow lane (increasing of safety from drivers coming from the link road). Detail 1

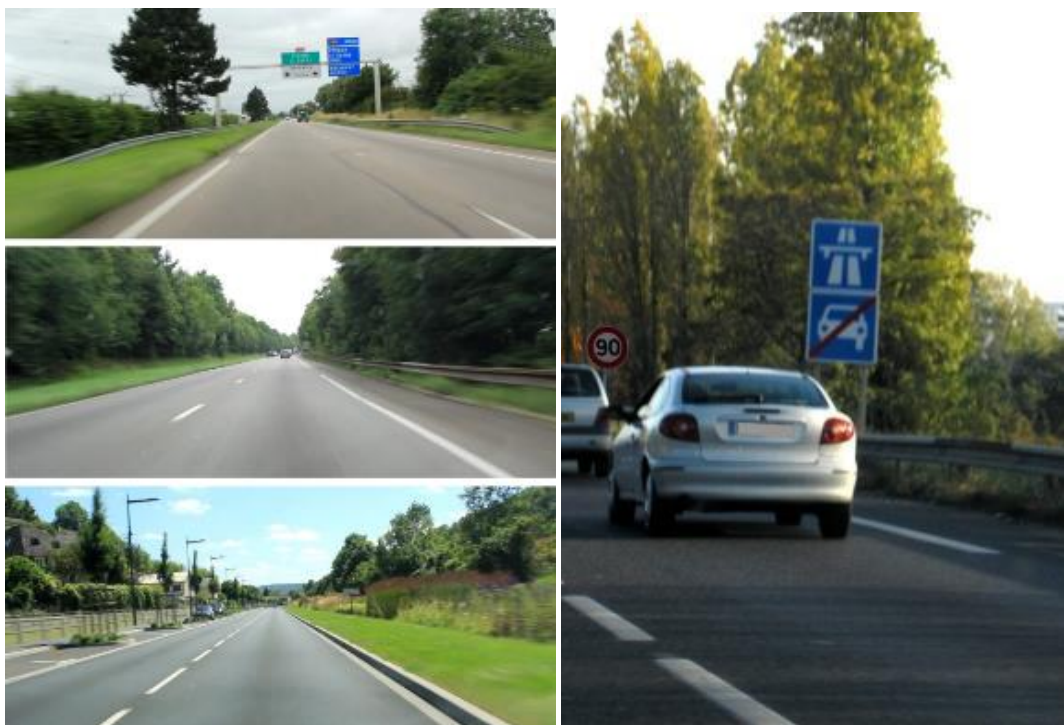
Figure 6.302 - Example of pictures with ambiguities (at left) and of an inconsistent situation (at right). At left, on the lower picture, the ambiguity has been obtained by deleting the town sign. At right, the inconsistency results of the fact that the drivers enter on motorway (motorway sign) with 90 km/h speed limit.

In this context, in 2013, 44 participants completed a questionnaire showing 73 photos of real sections of motorways (21 photos), divided highways (39 photos, motorways are excluded) and undivided rural roads (13 photos). The aim was to determine the road elements from which drivers base their speed choice.

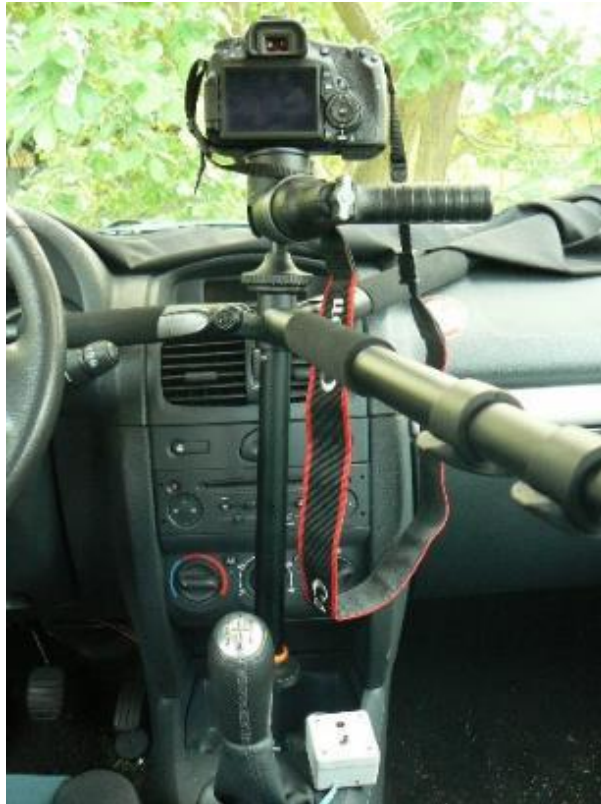
*Figure 6.303 - View of the digital camera (canon EOS 60D) used to make videos from where the pictures have been extracted. A black protection has been placed on dashboard in order to minimize reflections.*

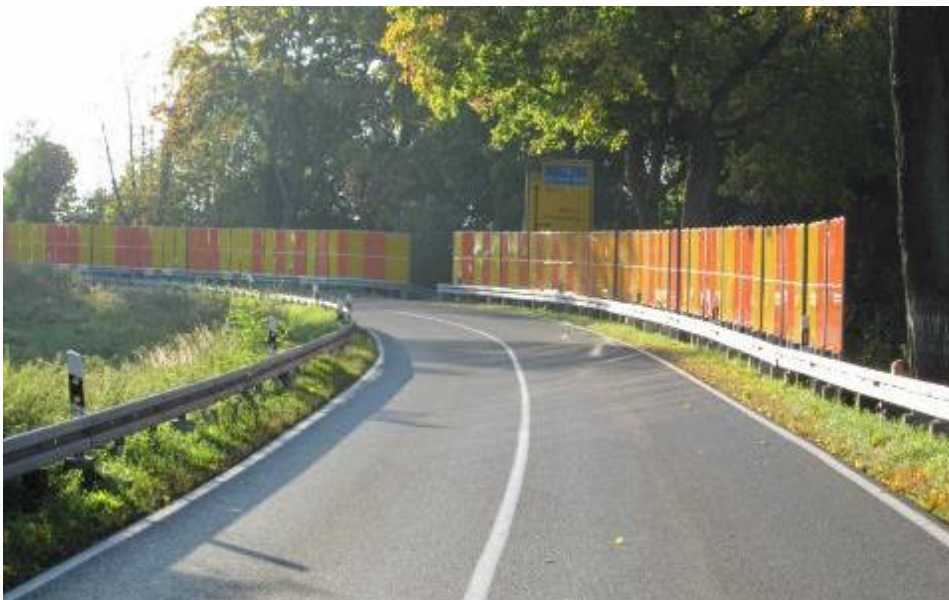
*Figure 6.304 - Optical guiding frame in a curve with fatal accidents with integrated optical break (source: Birth, S., Demgensky, B. & Wähler, U., 2016)*

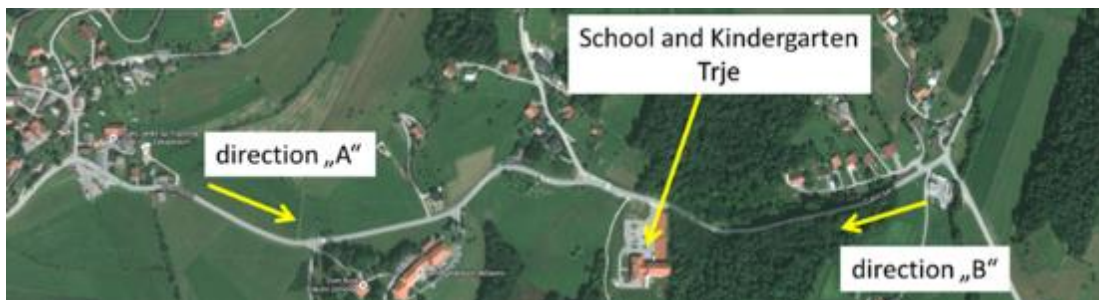
Figure 6.305: Location of School and Kindergarten alongside the road and direction of travel

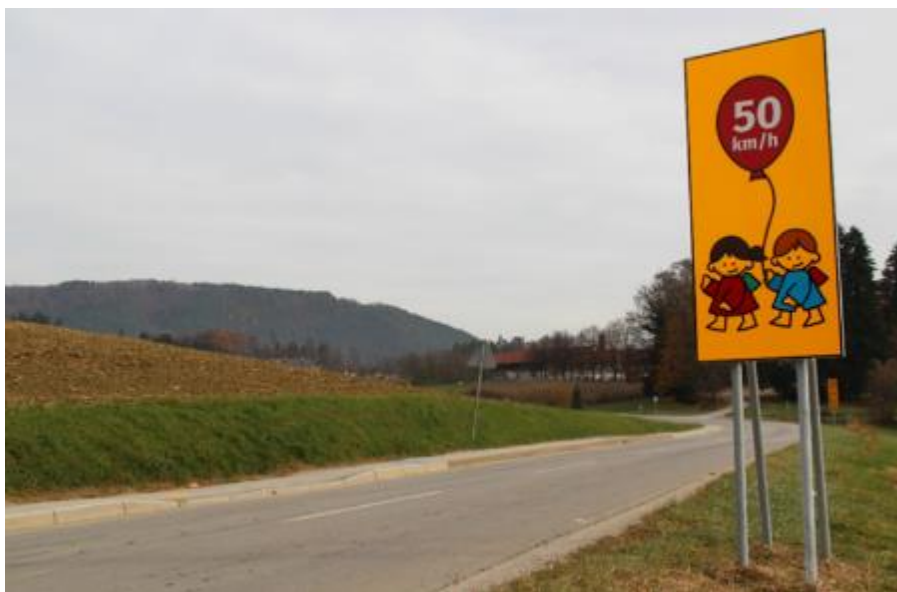
In addition, self-explaining information signs were set up at the beginning from each direction of travel towards the School and Kindergarten. From information signs, all the way to School and Kindergarten where pupils walk to and from School, and kindergarten children take their daily stroll, colourful circles, with additional anti-skid elements, were marked on the pavement, as shown in figures 3 and 5 below. Circles were separated apart (raster / distance between them), so that children could not play on the pavement, by jumping from one circle to another.

*Figure 6.306: Information signs*

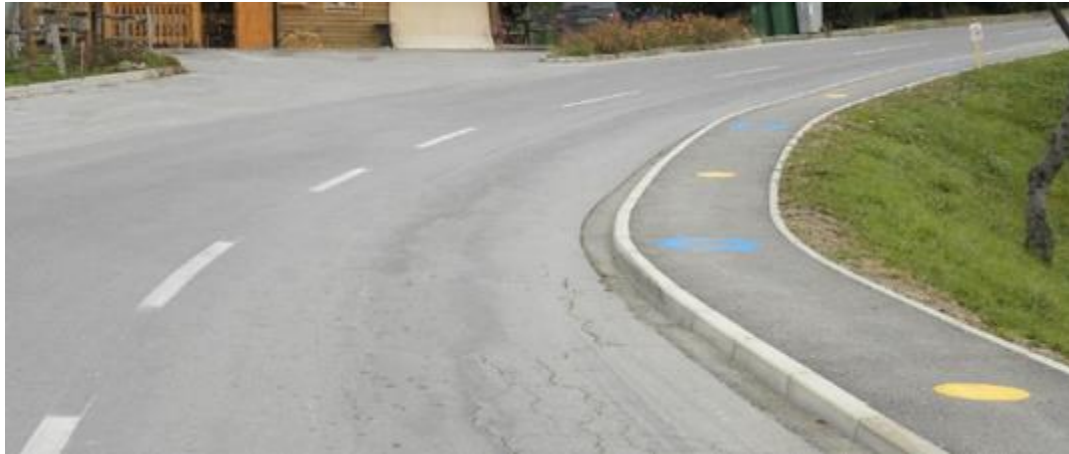
*Figure 6.307: Pavement markings (blue and yellow circles)*

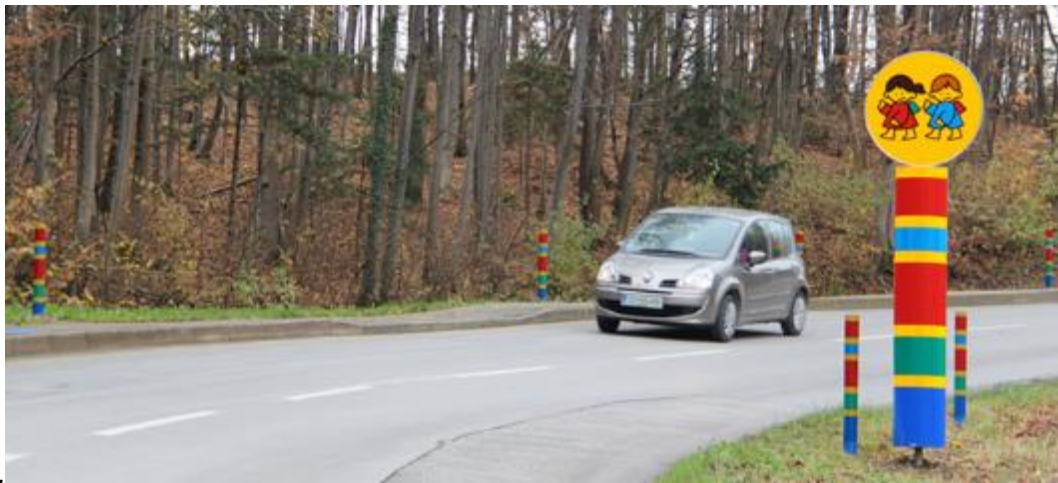
In near vicinity of school (near pedestrian crossing, bus-stops and junction to school), totems were set up, with colourful bollards as shown in figure 4. Also red colour surfaces before the junction were applied and pedestrian crossing was made on blue contrast surface (figure 5 and 6). Existing traffic signs were replaced with new ones and repositioned on more suitable locations. Also some traffic signs (for pedestrian crossing and bus-stop) were made with yellow fluorescent background, to be more conspicuous.

*Figure 6.308: Totem with colourful bollards*

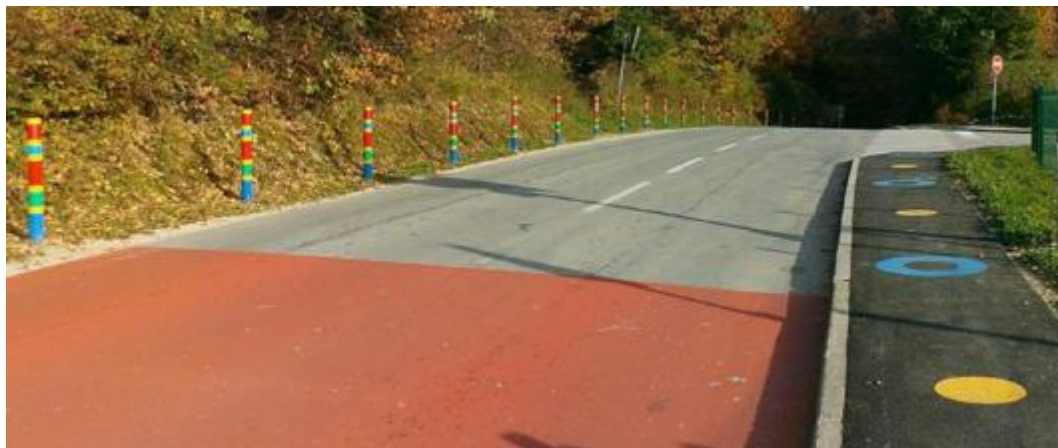
*Figure 6.309: Colourful bollards, red surface before the school junction with colourful circles on the pavement*

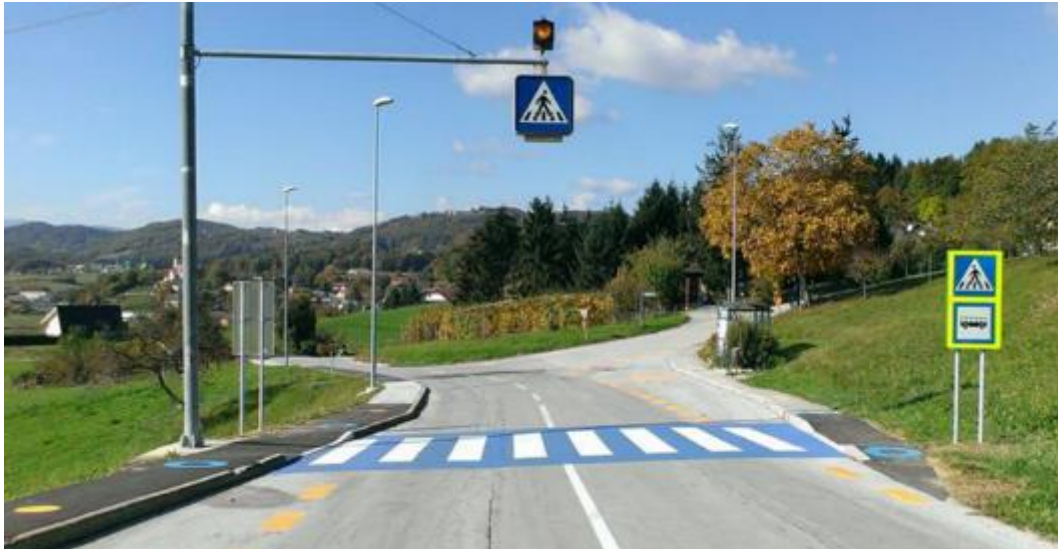
Figure 6.310: Pedestrian crossing on blue contrast and new traffic sign

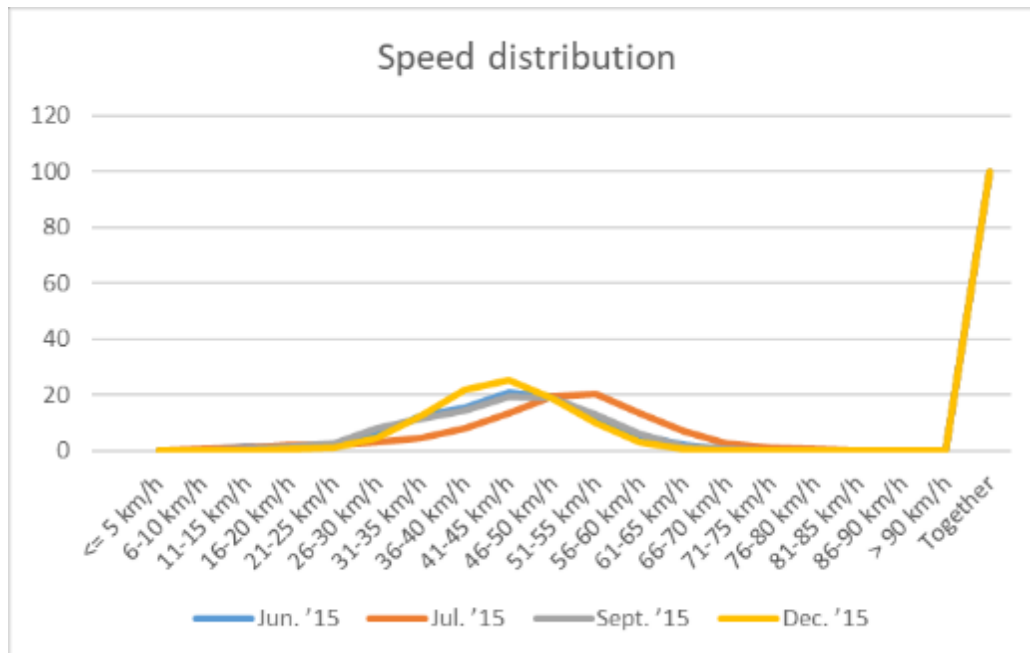
Graph 6.13 - Speed distribution (before/after)

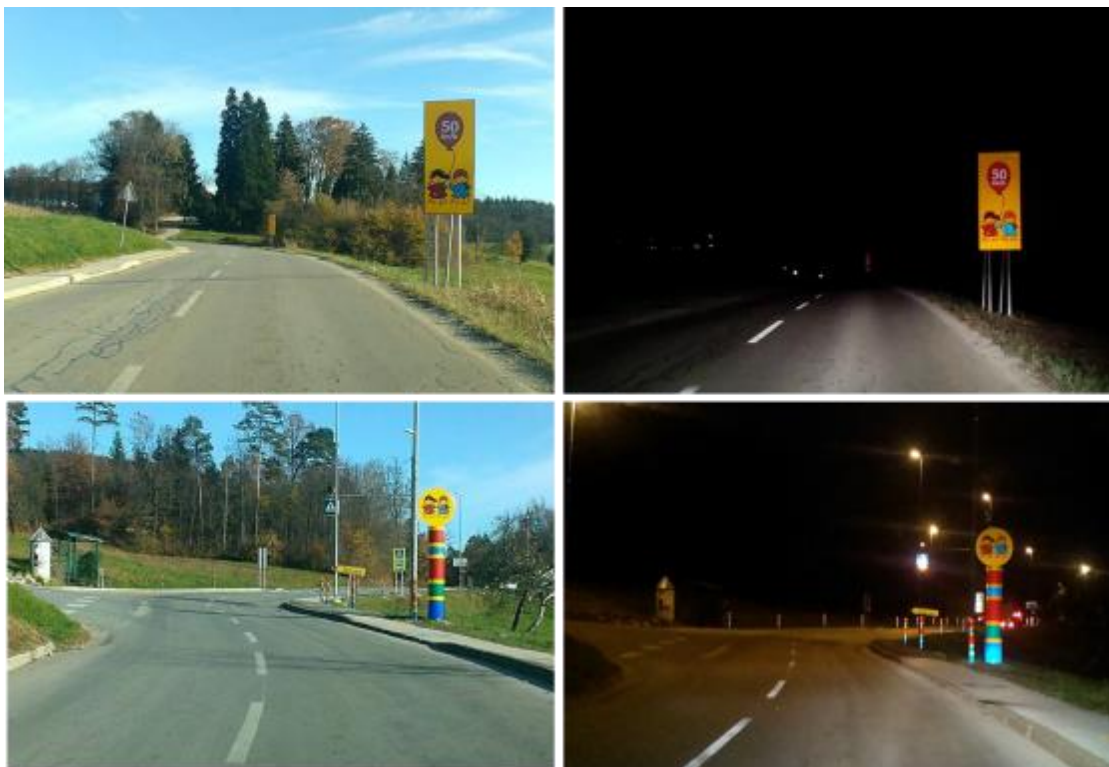
*Figure 6.311 - Day / night visibility of information sign, totem and bollards*

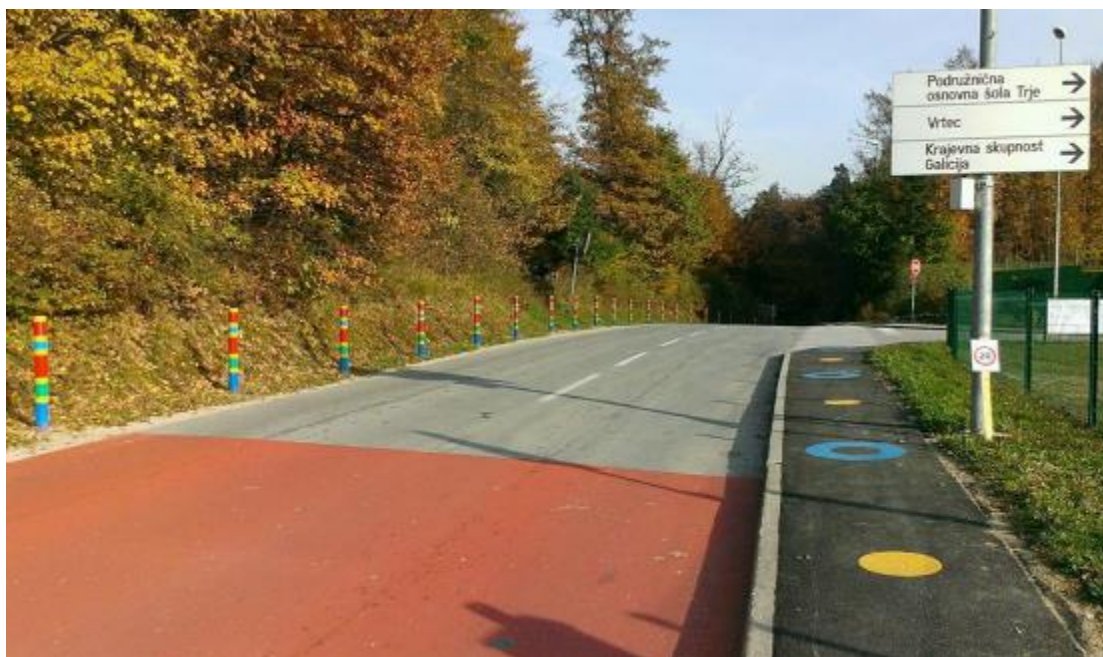
Figure 6.312 - Colorful road environment near the junction to School

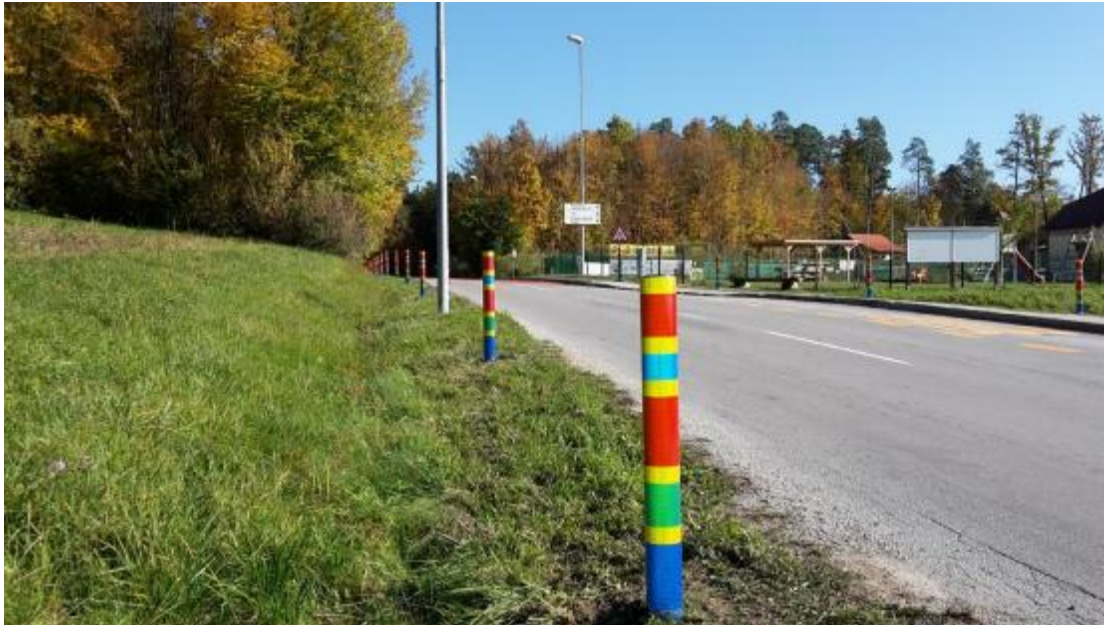
*Figure 6.316 - Colorful bollards with School and Kindergarten behind*

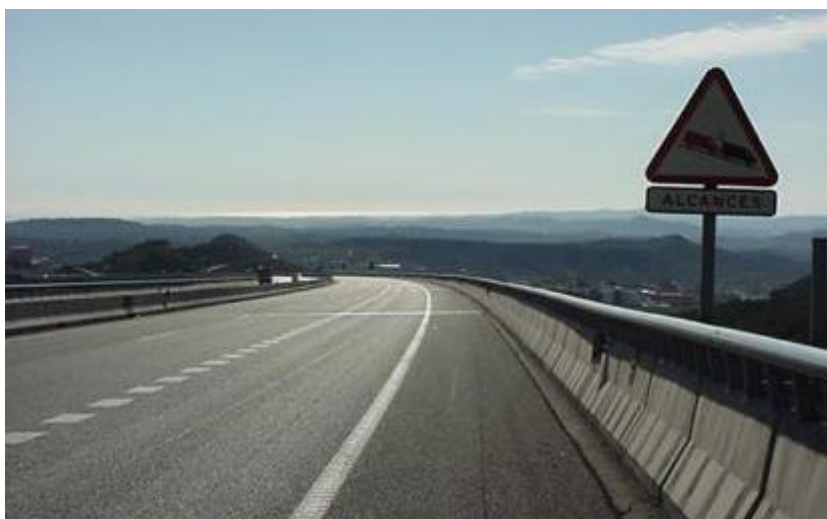
Vertical signing reinforcement was tested in some sections of National Road Network where road collision accidents between vehicles occurred frequently (some of them were identified as high accident concentration sections). Selected sections were sections with a high ascending longitudinal slope or large length in which, depending vehicle weight/power ratio, vehicles decelerated progressively until reaching what is known as "sustained ramp speed". The main target was verifying if a specific signing was more effective than a general one in described situations. The first option was to provide the signal type P-31 accompanied by a complementary board with "SCOPE" word located at the bottom (in Spanish “ALCANCES”). It highlights the specific risk that the signal intends warn.

Figure 6.319 - A-3 high way, kilometer point 316 (Valencia). P-31 vertical sign with complementary board

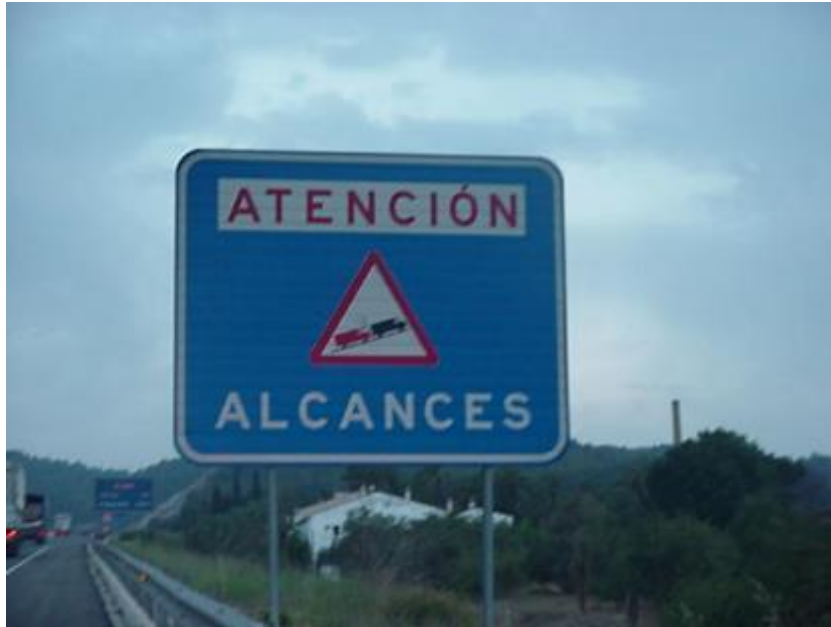
Another option was the use of advertising boards with yellow background with high retroreflectivity. They included specific messages or intuitive drawings characterizing the kind of accident whose risk one wanted to warn about. There are not a standardized design, so it is possible to find different boards with similar designs and contents but different from each other. Some examples are the following ones:

Figure 6.320 - N-340 road, kilometre point 854 (Valencia). Advertising board

These boards were effective in the most of studied cases. There, not only traffic accidents were reduced, even circulation speeds.

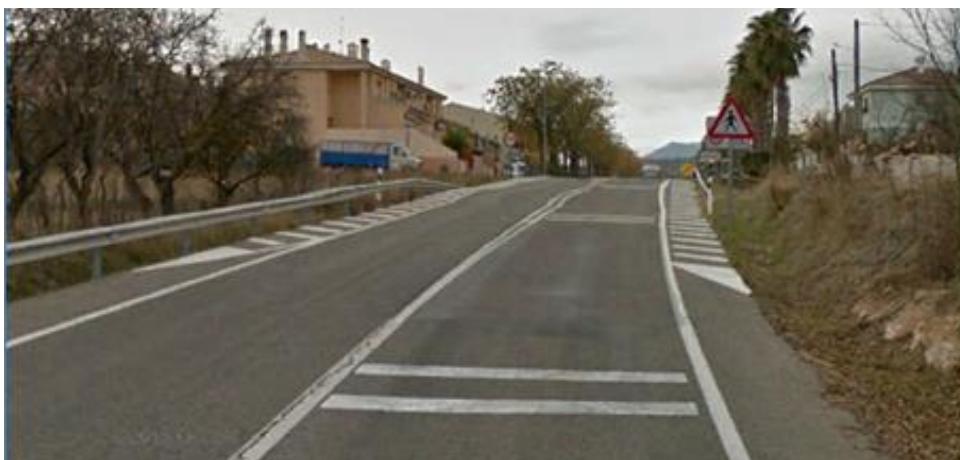
Even though, punctual narrowings separated from each other a maximum of 50 meters should be used to avoid drivers increase their speed when reduction affects a homogeneous section of a certain length (an urban area or a junction provided with central lanes for left turns). However, in this case, action will be able to be extended to the entire section if length is greater than 200 m. It is necessary an enough relative displacement of horizontal edge and axis signing (lane inside) too. Striped horizontal signing is necessary too because it defined areas excluded from traffic.

*Figure 6.323 - National road N-330. Entrance to urban zone of Jarafuel*

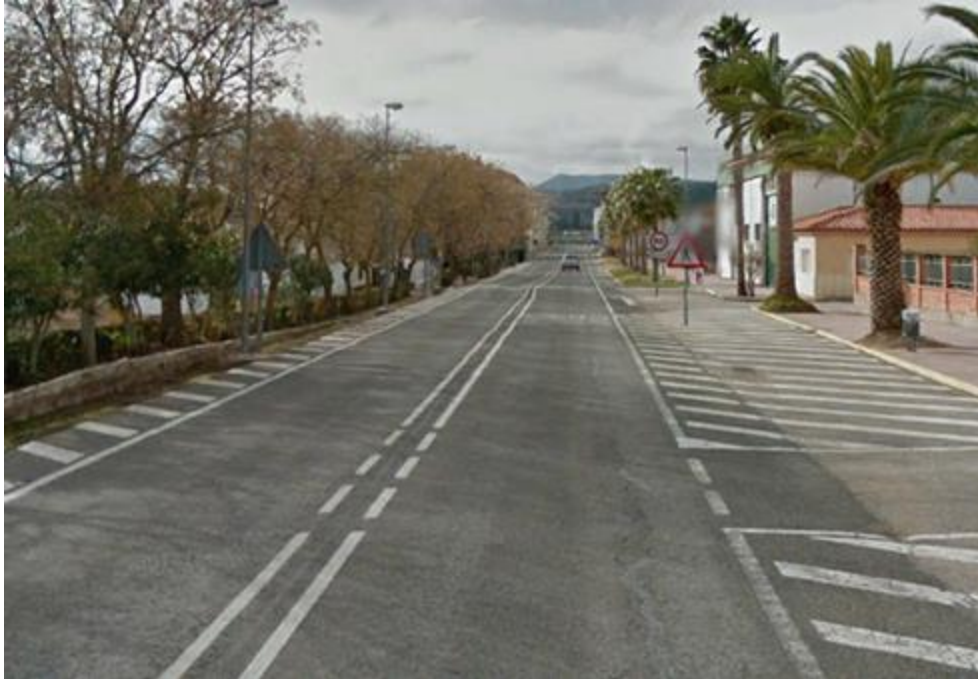
Figure 6.324 - National road N-330. Urban zone of Jarafuel

Adopted solution consists on arranging two continuous parallel longitudinal lines on carriageway axis. These become discontinuous in the areas where turning movements are allowed. The marks have been arranged with a separation of 30 centimeters between them, without inner striped horizontal signing, because some tests considered that this kind of horizontal marking was suitable for separations equal to or greater than 50 cm.

It has been found that it is necessary that the narrowing is clearly noticeable by the drivers. Otherwise drivers do not reduce their speed sufficiently. Therefore, it is necessary to provide vertical signing that reinforce perception of the entrance to an urban area, such as village signing, maximum speed signing and warning of danger due to the presence of pedestrians signing. If the narrowing is strong, specific warning signing of this circumstance should be installed.
