# CATALOGUE OF CASE STUDIES

*Road safety improvements relevant to Vulnerable Road Users, Human Factors and Low- and Middle-Income Countries*

**TECHNICAL COMMITTEE C.2 DESIGN AND OPERATION OF SAFER ROAD INFRASTRUCTURE**

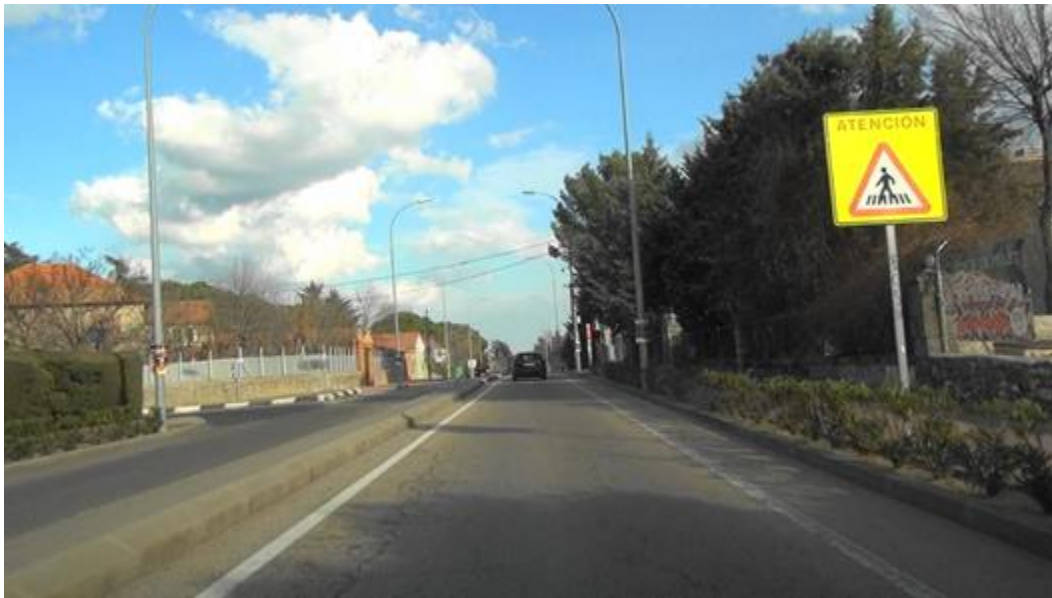
*Figure 6.326 - Example of narrowing of lines*

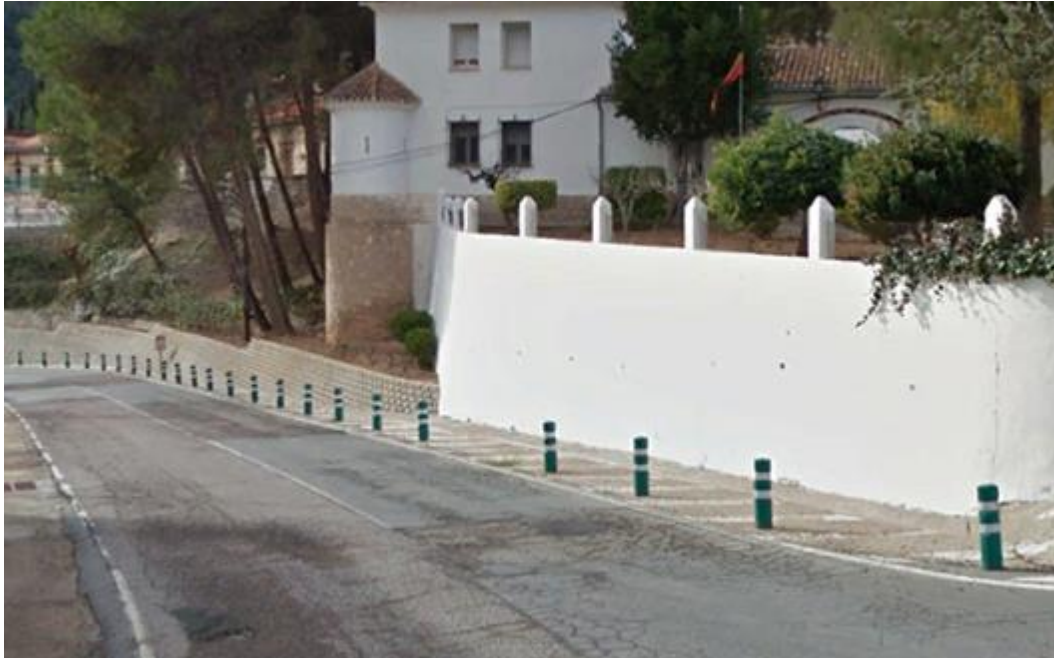
Another situation detected is that in the outer zones some drivers take advantage of space excluded from traffic to park their vehicles. It limits visibility and generates a risk near pedestrian crossings and junctions. In these areas it is considered appropriate to exclude them completely from use, so pavements can be extended or simply use traffic guidance elements to delimit them.

*Figure 6.327 - Example of traffic guidance equipment to avoid car parking in zones excluded from traffic*

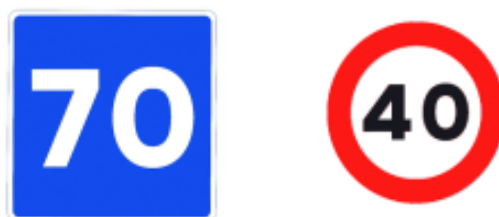
As it has been indicated, it is recommended to replace S-7 vertical signing (speed recommendation) with an R-301 vertical signing (maximum permitted speed).

Figure 6.331 – Left: S-7, vertical sign, Right: R-301, vertical sign

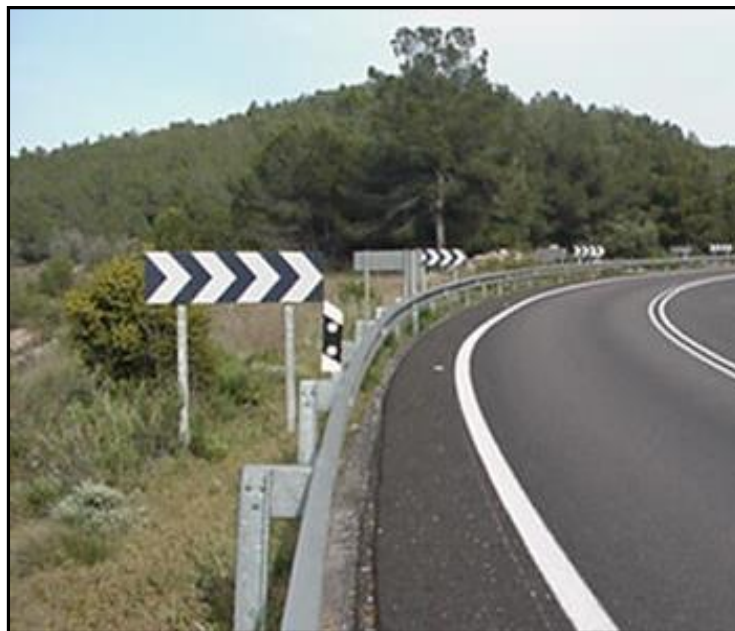
- Road hazard markers in curves are always arranged perpendicular to the driver.
- Road hazard markers are arranged along the curve. Their separation will be approximately one tenth of the curve radius, so that a driver can always see a minimum of three panels at the same time.

- Vertical separation between the superimposed panels (placed at the beginning of the curve) will be 15 cm, because smaller distances can overlap panels vision and give the sensation of indicating that the curve is of the opposite direction

*Figure 6.332 – Example of implemented road chevrons*

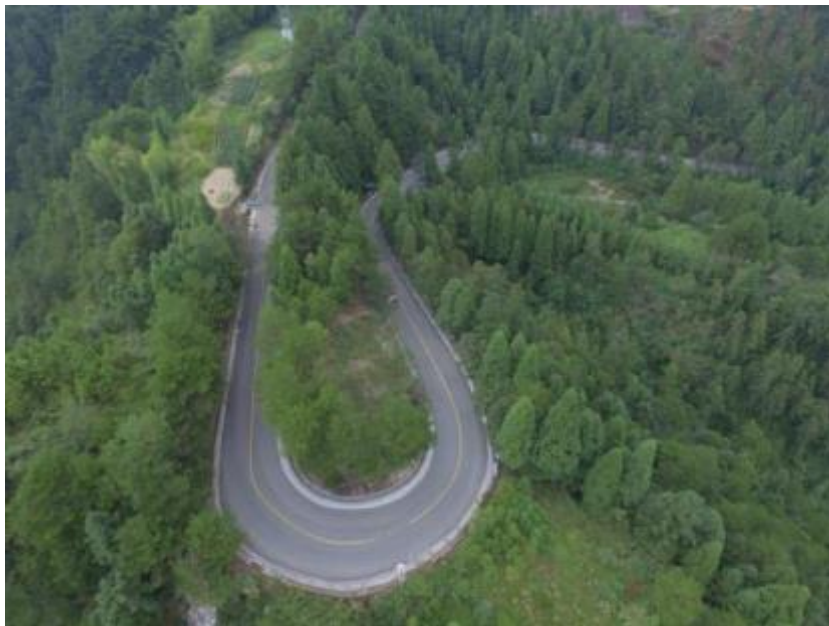
This road is one section of the G322 in Zhejiang province. It is a part of the continuous curved sections with steep slopes and sharp turns. It locates in the mountainous and hilly area and also adjacent to the cliff. It is the 4th class highway with a poor visibility. Moreover, the signs and markings and other safety facilities are not perfect, as shown in Figure 6.333. Vehicles are prone to collision accidents when passing through this section.

*Figure 6.333 – The full view of the road before any measures*

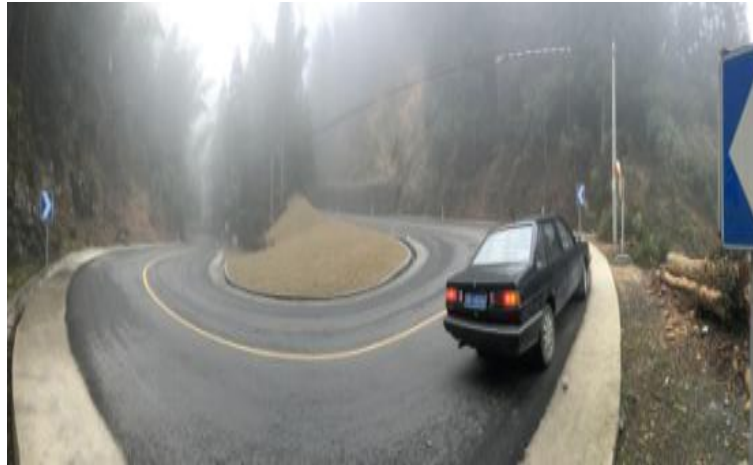
- Cut the mountain and build a horizon platform to improve the visibility, as shownFigure 6.334.

*Figure 6.334 - To build a horizon platform*

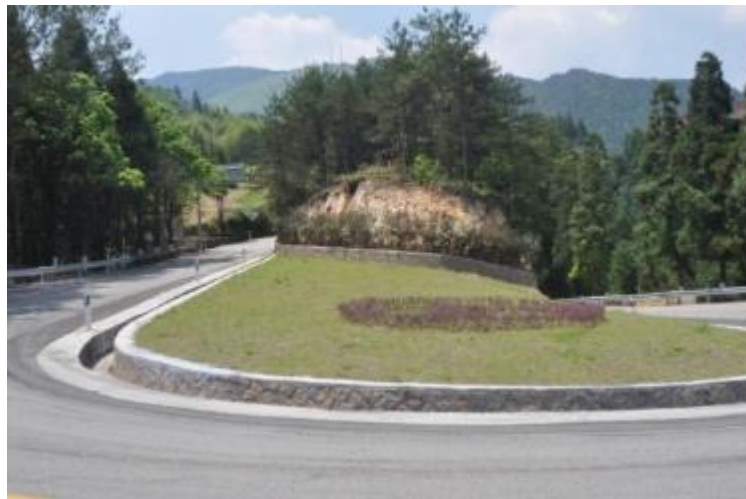
- Green the newly built horizon platform, as shown in Figure 6.335.

*Figure 6.335 - To Green the horizon platform*

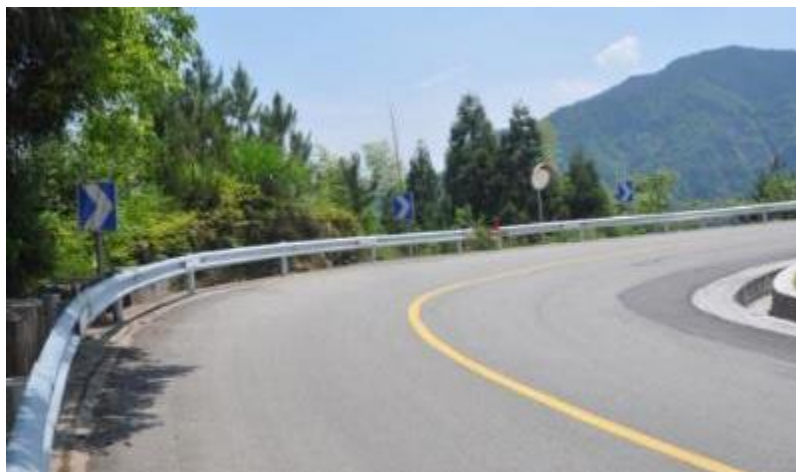
Set up visual guiding devices and a convex mirror, etc. Widen and strengthen the shoulders. Set up class A w-beam guardrails on the side of the cliff with reflective visual guiding devices. Set the column delineator on the side of the mountain, as shown in Figure 6.336 ~ Figure 6.338.

*Figure 6.336 - To set guardrails, visual guiding devices, delineators, convex mirrors and other facilities*

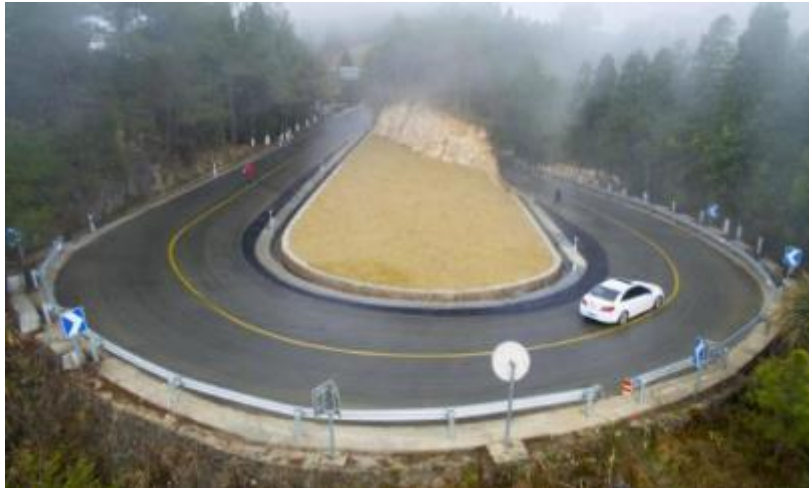
*Figure 6.337 - The full view of the road after completion*

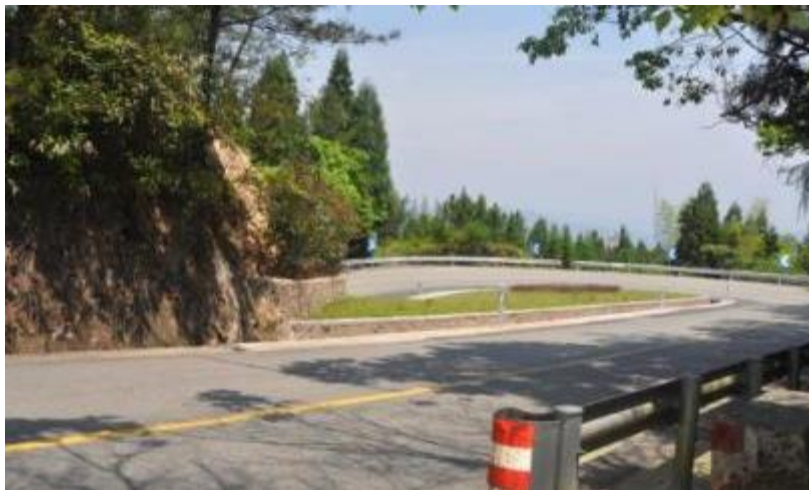
*Figure 6.338 - The visual effect after completion*

The measures have effectively improved the road safety and comfort when driving to sharp turn and steep slope section. The new horizon platform is integrated with the natural landscape. The construction of the horizon platform has effectively reduced the traffic conflicts in the poor visibility sections of the curved line. The marking, visual guiding devices, delineation and other devices enhance the road visibility and the night driving safety. The safety facilities such as guardrails can reduce the rate of the falling accidents.

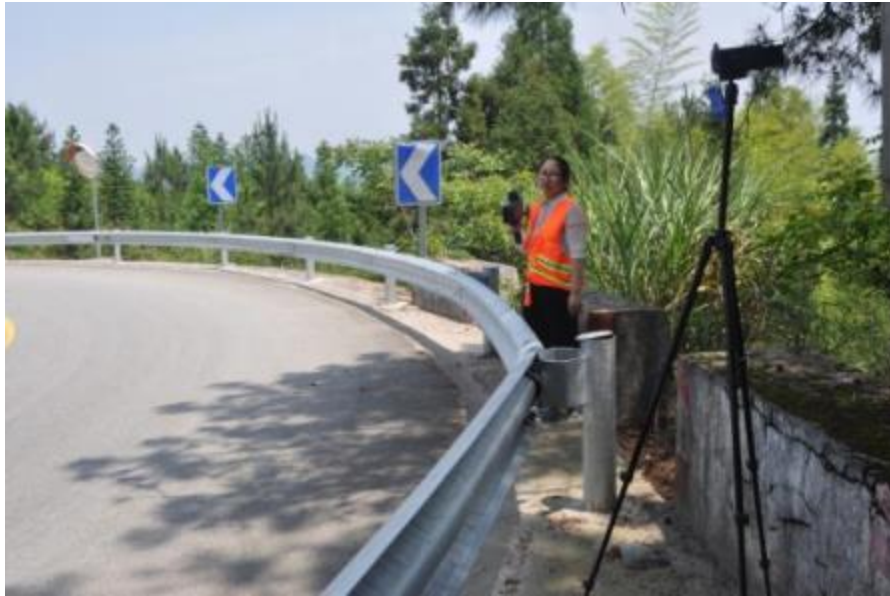
The project team conducted observations after implementation. The observation point is facing the horizon platform, as shown in Figure 6.339. The project team observed the traffic flow passing through the road in both directions. The observation took one hour (16:00~17:00). The results are shown in Tab 1.

Figure 6.339 - Traffic flow observation

Vehicle Type	Car / downhill	Car/ uphill	Medium bus	Large bus	Heavy truck	Medium truck	Light truck/ downhill	Light truck/ uphill	Motor tricycle
proportion	33.73%	49.40%	1.20%	1.20%	-	1.20%	6.02%	3.61%	3.61%
Average speed (km/h)	45	31	31	25		41	43	27	29

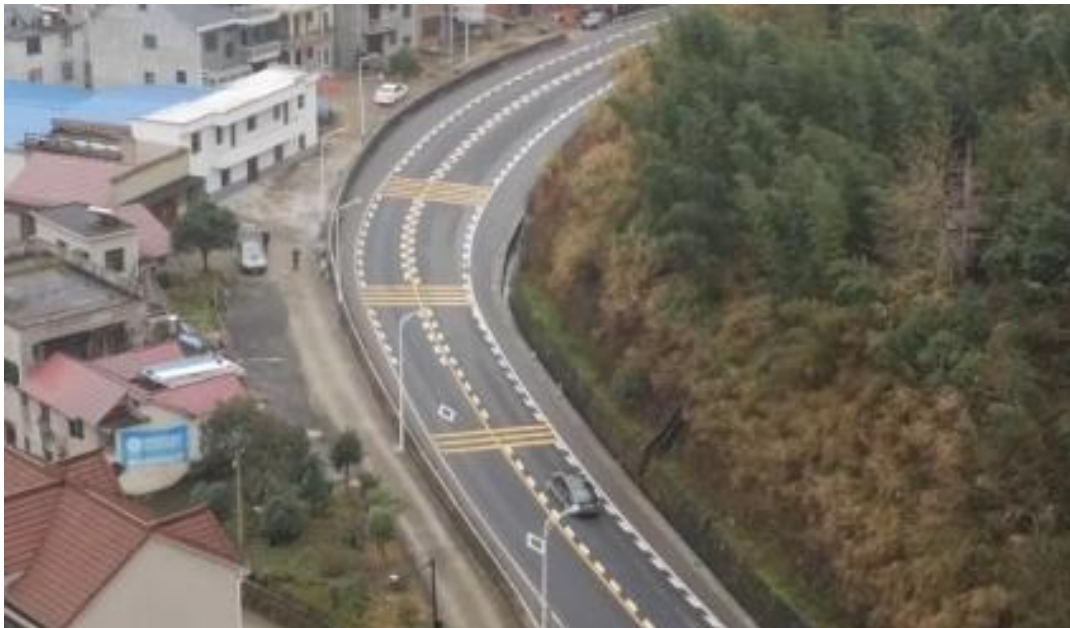
The project is a section of Line S210, located in Zhejiang province. It is a long downhill section with sharp turns, steep slopes and a limited sight distance, as shown in Fig 1. It is difficult to guarantee the stopping sight distance in case of emergencies. Large trucks are prone to brake failure and the driving speed is hardly to control. There is a residential area on one side of the road. Once the vehicle exits the road, it will cause a secondary accident. This section is the provincial black spot. There were 4 fatal accidents from 2011 to 2013. All of the accident vehicles are large trucks and the cause of the accidents is similar, vehicle mechanical failure (brake failure) and driver improper operation, when driving to the sharp turns. As a result, the vehicle rollover accidents occurred.

*Figure 6.340 - A full view of the road section before the implementation*

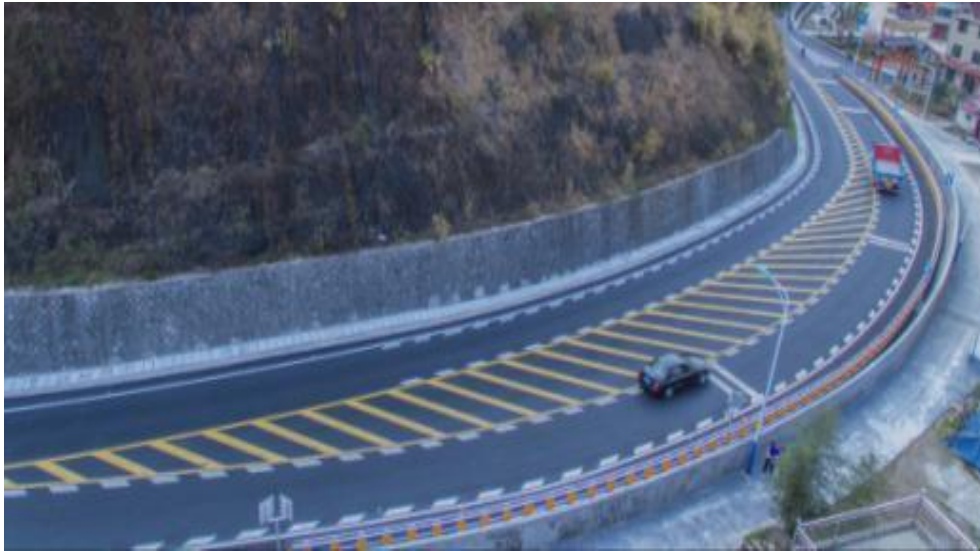
- In accordance with local conditions, taking advantage of the existing concrete pavement, widen the effective road surface by 3.5m. Move the downhill lane outward and improve the sight distance. Change the single road center yellow line to a virtual canalization island filled with yellow diagonals. No vehicle allows to drive onto the solid lines or enter this area, as shown in Figure 6.341.

*Figure 6.341 - The wider lane and the new virtual canalization island*

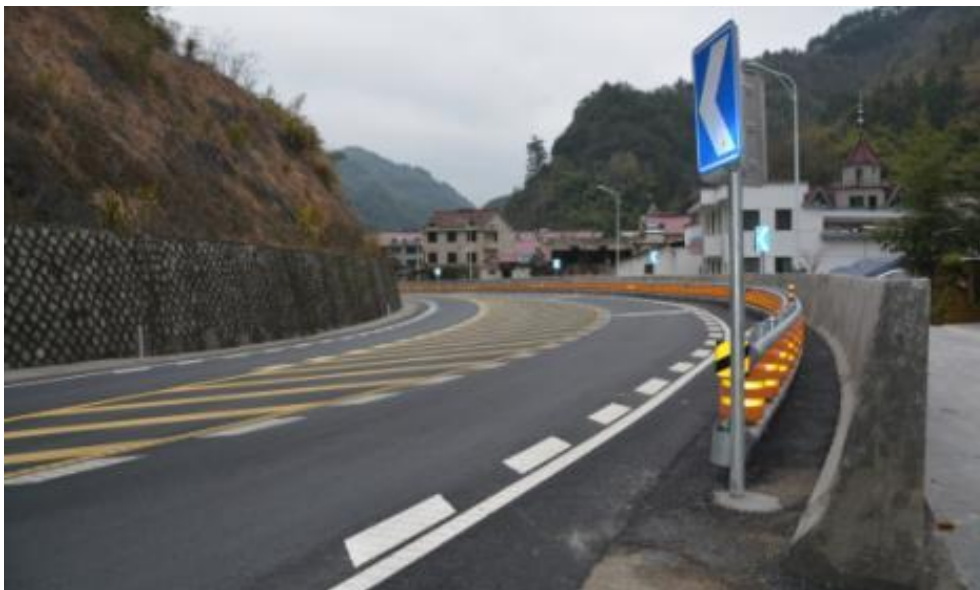
*Figure 6.342 - The location of the concrete bump wall and visual guiding devices*

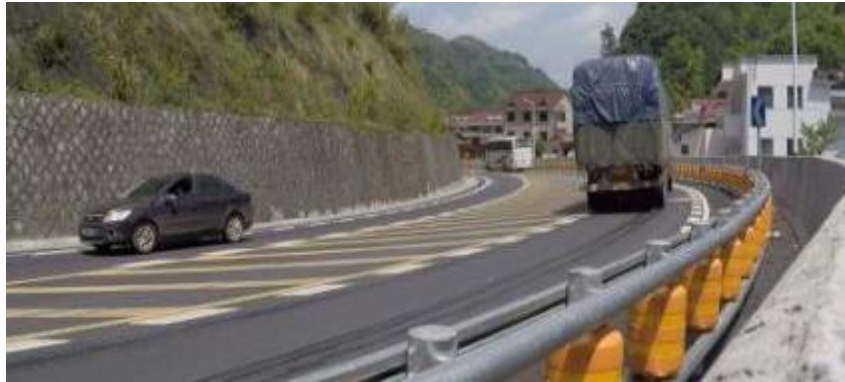
- Based on road widening project, the existing concrete bump wall is moved outwards and the height of the concrete wall is increased. The bump wall with seat type foundation is integrated with the road shoulder wall. Put up the new type of guardrail and visual guiding devices to enhance the function of protection, alerting and guiding, as shown in Figure 6.342 and Figure 6.343.

*Figure 6.343 - The crash barrier after the implementation*

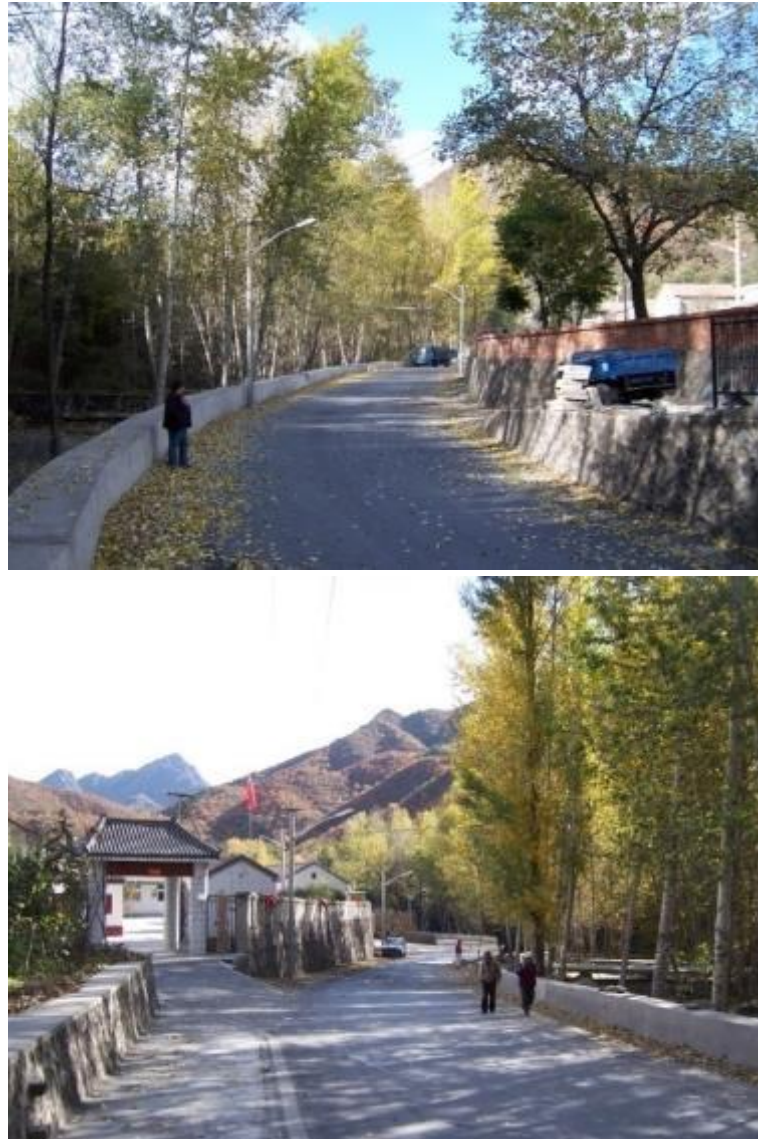
The road (Daxi Road) is located in the surrounding area of Beijing. It is the only way from the village of Xidamo to the outside world. There was no warning or speed control measure at the beginning of the village entrance. According to the observation, the average truck speed was about 30km/h and maximum was close to 50km/h. It leads to the occurrence of severe traffic accidents between the motor vehicles and non-motor vehicle, the motor vehicles and pedestrians.

*Figure 6.354 - Lack of warning and speed control measures*

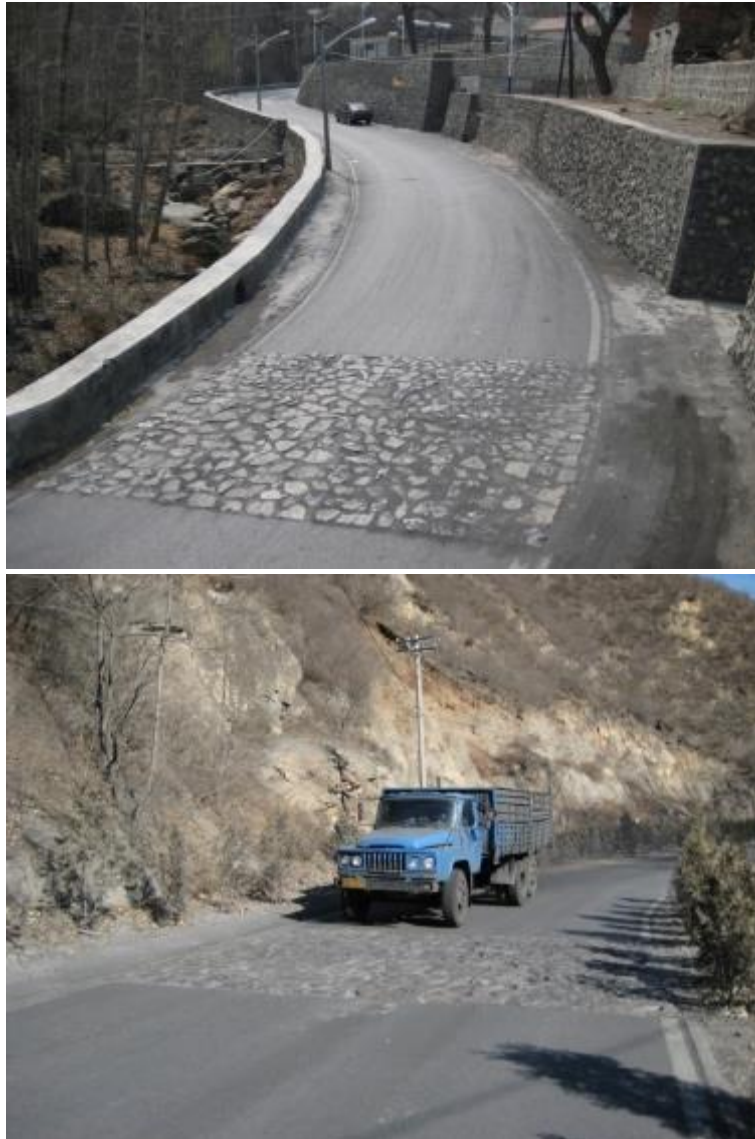
*Figure 6.355 - The dimension stone pavement section in the front of the entrance to Xidamo village*

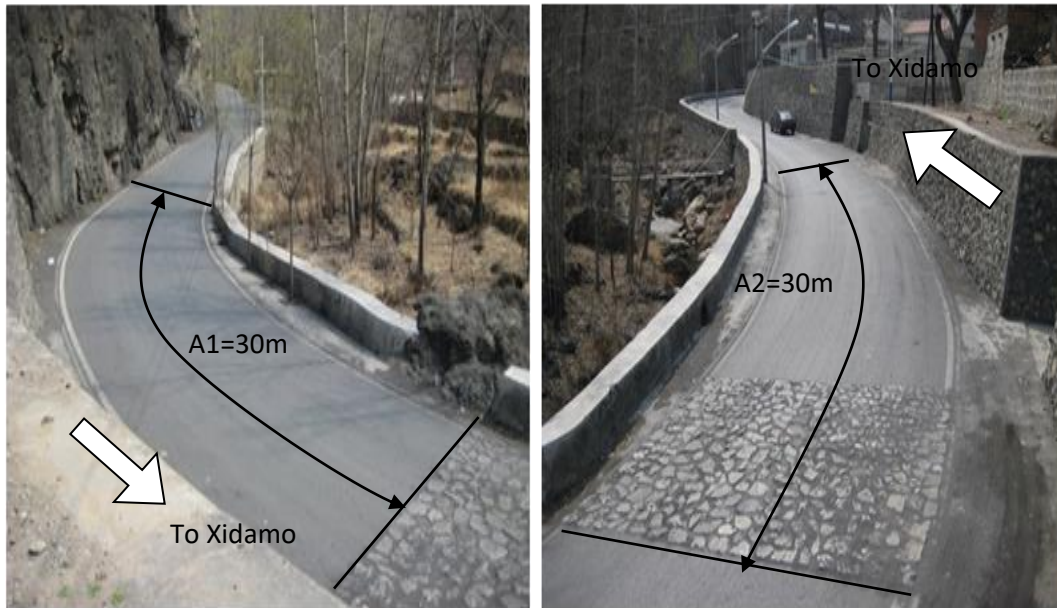
After the implementation of the project, the project team observed the traffic flow at the entrance of the village. Two sections (A1 and A2, 30 meters each) was denoted, as shown in Fig 3, the results are shown in Tab 1.

Figure 6.356 - Observing Plan

Vehicle	Loading	Quantity of samples	A1 section speed (km/h)			A2 section speed (km/h)		
			Highest	Lowest	Average	Highest	Lowest	Average
Medium Truck	None	10	45	24	33	49	25	40
Light Truck	None	4	33	21	26	58	48	54
Car		7	41	21	30	57	34	42
Motorcycle		1	20	20	20	21	21	21

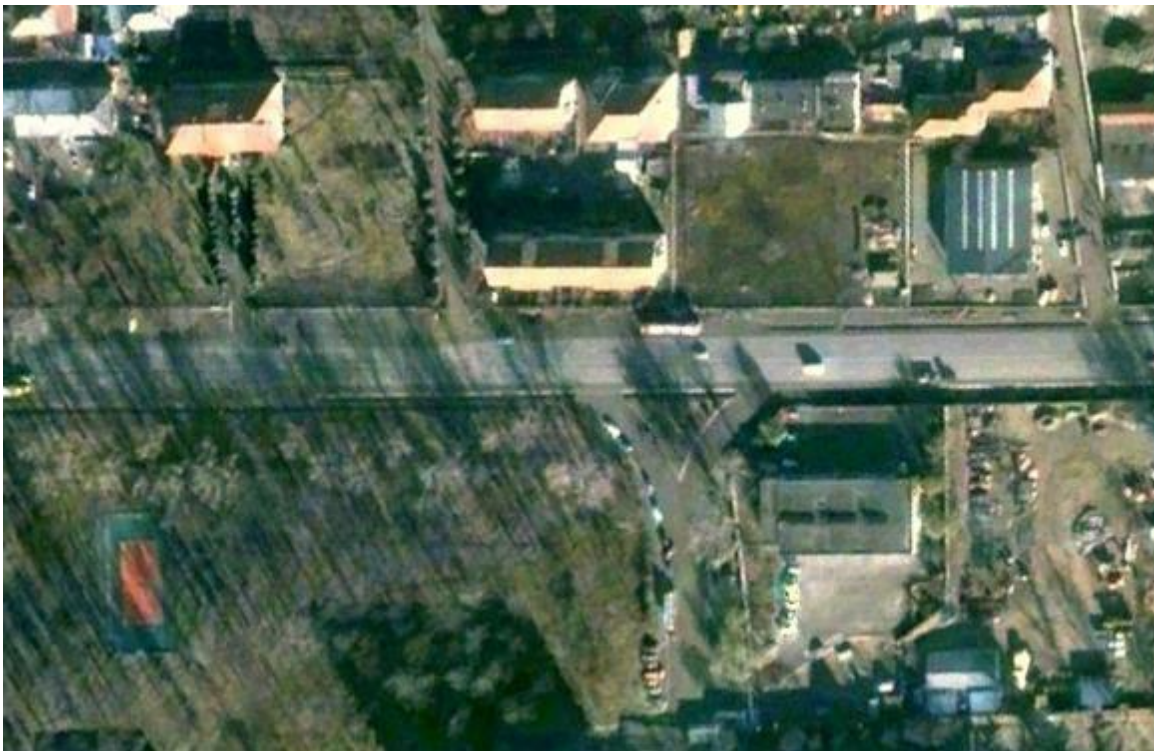
*Figure 6.357 – Before the intervention. Turning point top view*

- The width of the national road platform was increased in order to keep two lanes for each traffic direction;
- The length of the area where the changes were implemented = 210.00 m
- Left turn belt length = 15.00 + 40.00 m (constant width + variable width)
- Outside radius of turning curve = 12.00 m
- The traffic speed in the turning point area was limited to 30 km/h.

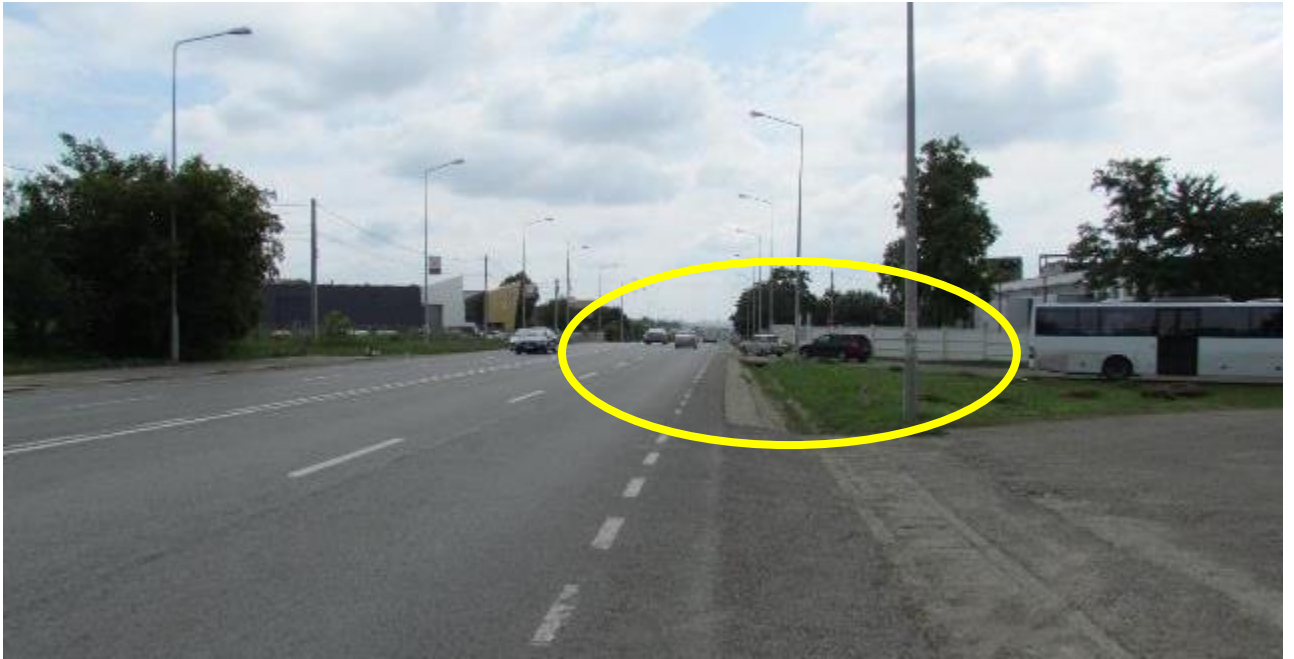
Figure 6.362 – Before the intervention. Road view at turning point. Example of car turning back, phase 1

Due to economic reasons, no such arrangements have been made yet. Therefore, for the provisional solution of the situation, a turning point was executed at km 65 + 400, so that traffic on the left side of DN 28 in Valea Lupului can be directed to Iași in almost safe conditions.

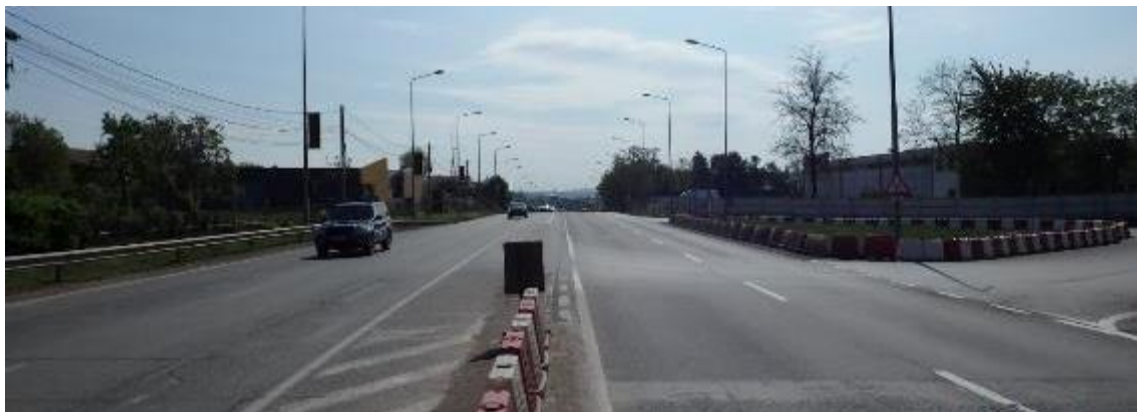
Figure 6.363 – Turning point after the intervention

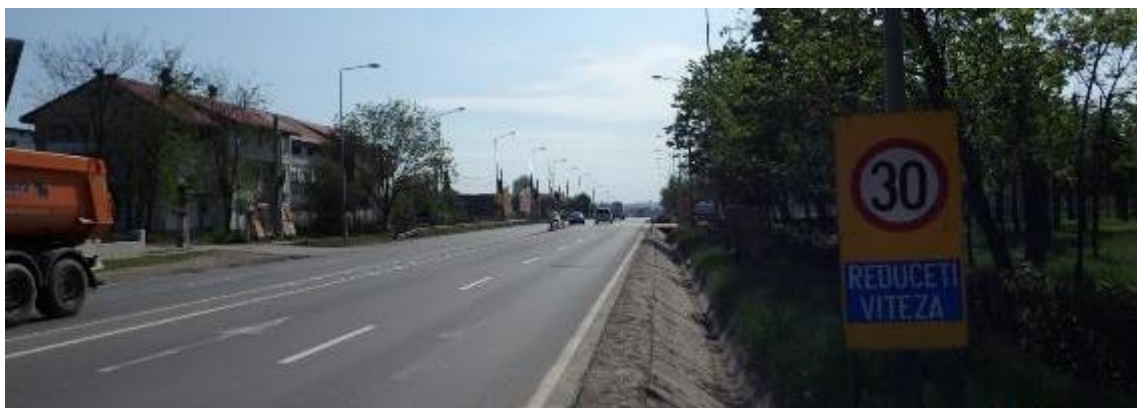
Figure 6.364 – After the intervention. Road view before the turning point

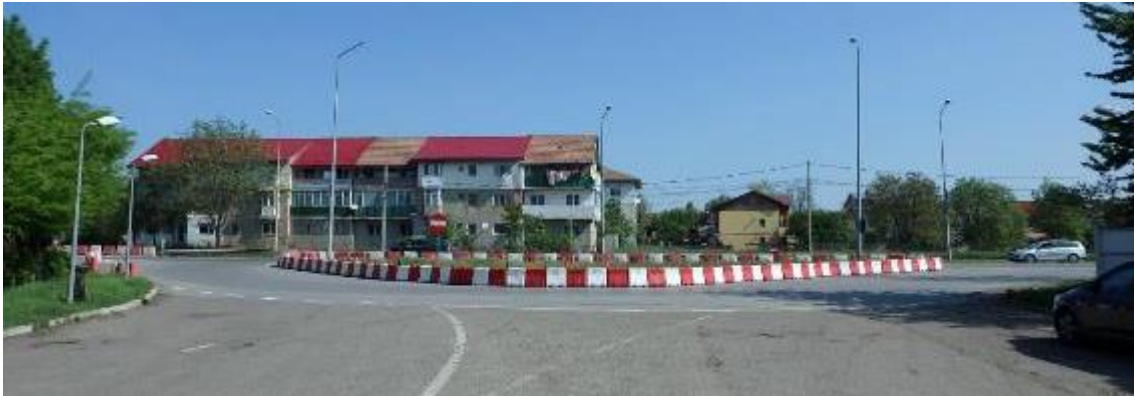
Figure 6.366 – After the intervention. Turning point construction detail
